DTC B0110/43 SHORT IN SIDE SQUIB (RH) CIRCUIT

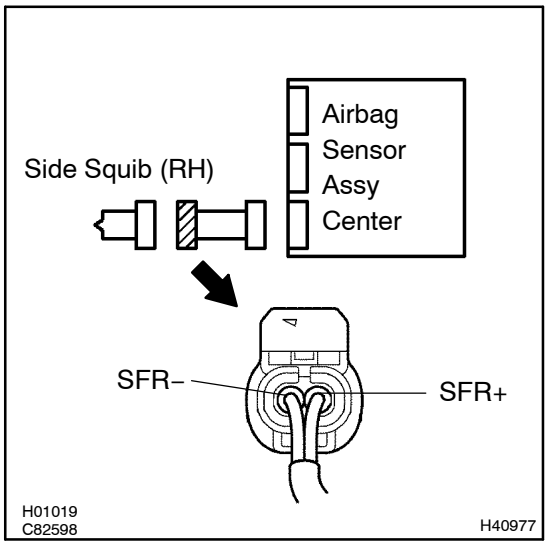
1	CHECK SIDE SQUIB(RH) CIRCUIT(AIRBAG SENSOR ASSY CENTER – FRONT SEAT AIRBAG ASSY RH)

(a) Disconnect the negative (–) terminal cable from the battery, and wait at least for 90 seconds.
(b) Disconnect the connectors between the airbag sensor assy center and the front seat airbag assy (RH).
(c) Release the airbag activation prevention mechanism of the connector (on the airbag sensor assy center side) between the airbag sensor assy center and the front seat airbag assy (RH) (See page 05–758).
(d) For the connector (on the front seat airbag assy side) between the airbag sensor assy center and the front seat airbag assy (RH), measure the resistance between SFR+ and SFR–.
OK:
Resistance: 1 MΩ or Higher

NG	REPAIR OR REPLACE WIRE HARNESS(AIRBAG SENSOR ASSY CENTER – FRONT SEAT AIRBAG ASSY RH)

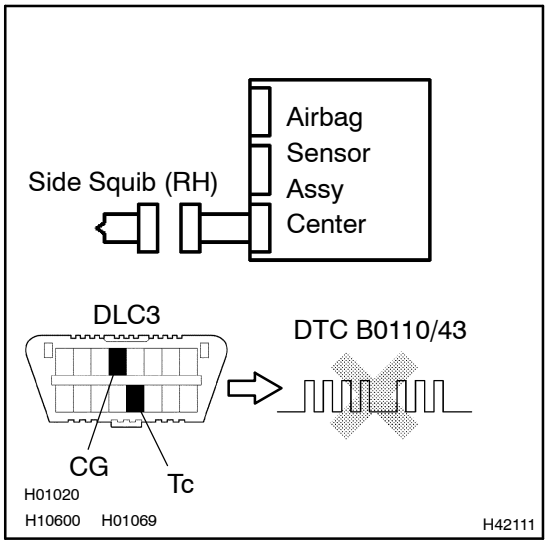
2	CHECK AIR BAG SENSOR ASSY CENTER

(a) Connect the the connector to the airbag sensor assy center.
(b) Connect the negative (–) terminal cable to the battery, and wait at least for 2 seconds.
(c) Turn the ignition switch to ON, and wait at least for 20 seconds.
(d) Clear the DTC stored in memory (See page 05–758).
(e) Turn the ignition switch to LOCK, and wait at least for 20 seconds.
(f) Turn the ignition switch to ON, and wait at least for 20 seconds.
(g) Check the DTC (See page 05–758).
OK:
DTC B0110/43 is not output.

NG	REPLACE AIR BAG SENSOR ASSY CENTER

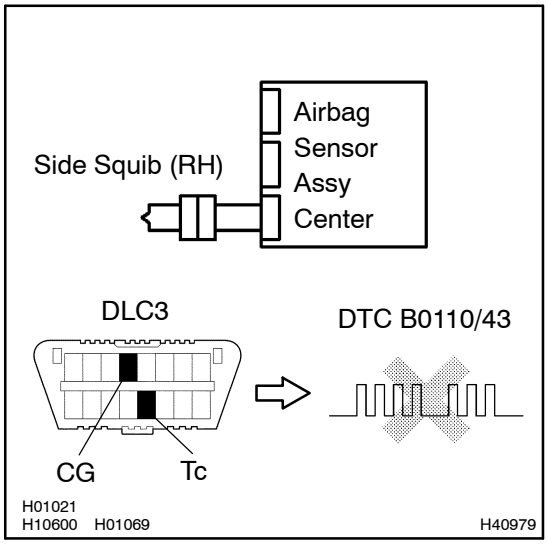
3	CHECK SIDE SQUIB(RH)

(a) Turn the ignition switch to LOCK.
(b) Disconnect the negative (–) terminal cable from the battery, and wait at least for 90 seconds.
(c) Connect the front seat airbag assy (RH) connector.
(d) Connect the negative (–) terminal cable to the battery, and wait at least for 2 seconds.
(e) Turn the ignition switch to ON, and wait at least for 20 seconds.
(f) Clear the DTC stored in memory (See page 05–758).
(g) Turn the ignition switch to LOCK, and wait at least for 20 seconds.
(h) Turn the ignition switch to ON, and wait at least for 20 seconds.
(i) Check the DTC (See page 05–758).
OK:
DTC B0110/43 is not output.

NG → **REPLACE SEPARATE TYPE FRONT SEAT BACK ASSY**
