2007-08 ACCESSORIES AND EQUIPMENT

Frame - Element

FRAME BRACE REPLACEMENT

2007 Honda Element EX

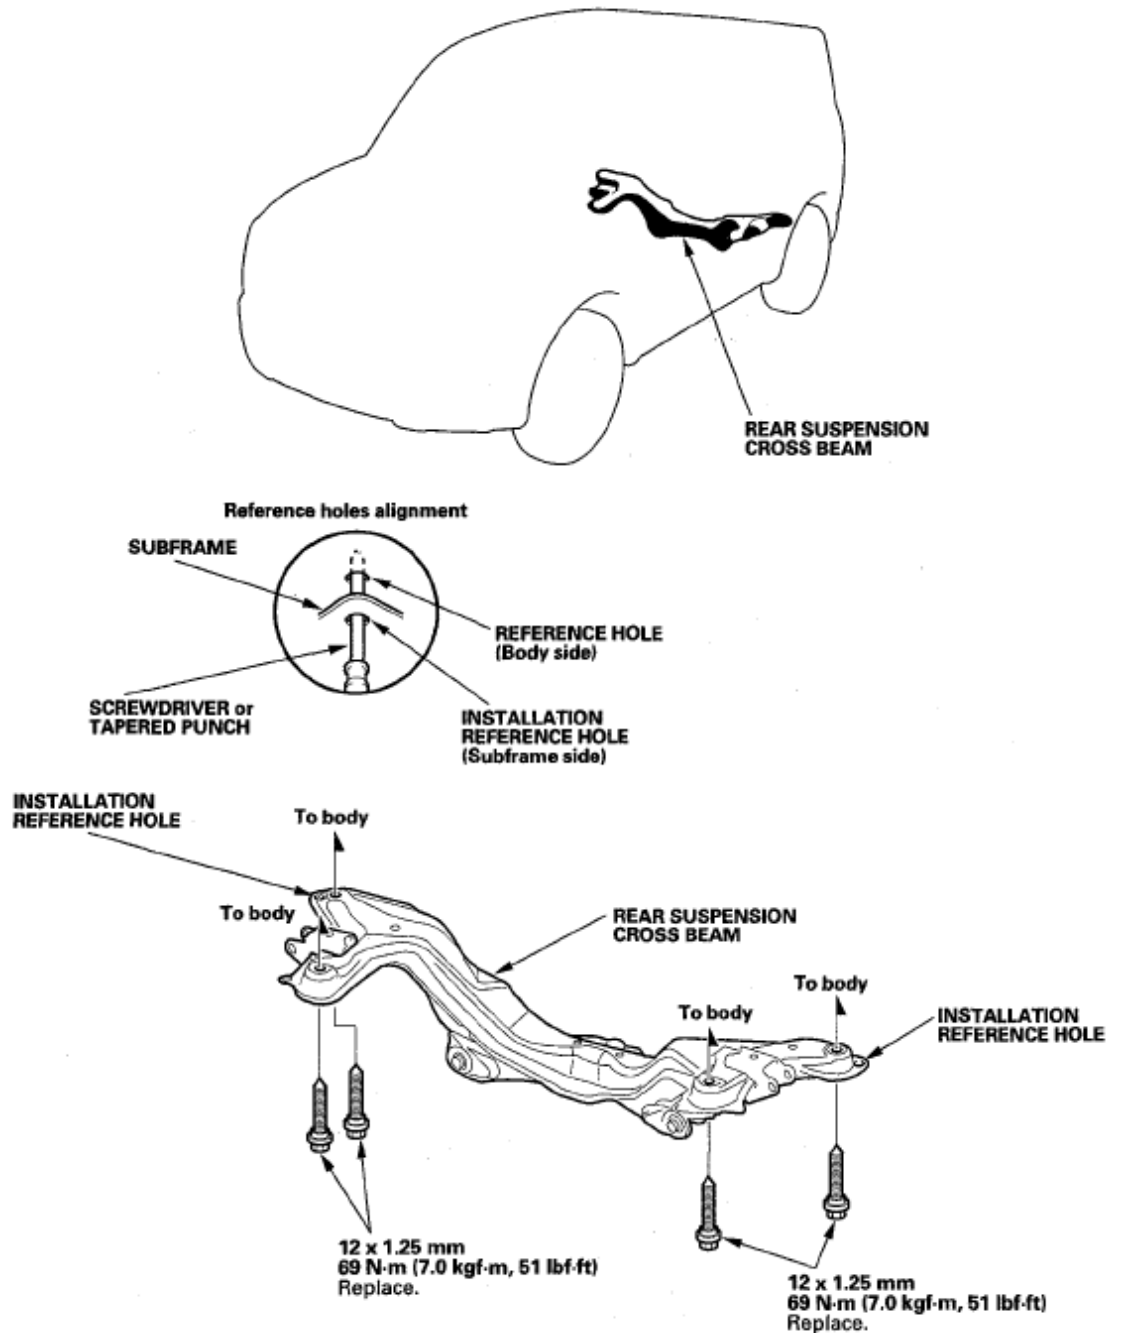
REAR SUBFRAME TORQUE

- After loosening the subframe mounting bolts, be sure to replace them with new ones.
- When installing, align both installation reference holes in the subframe with the reference holes in the body using a screwdriver or tapered punch

as a guide.

Fig. 3: Identifying Subframe Components With Torque Specifications
