DTC	B0112/41	SHORT IN SIDE SQUIB (RH) CIRCUIT (TO GROUND)

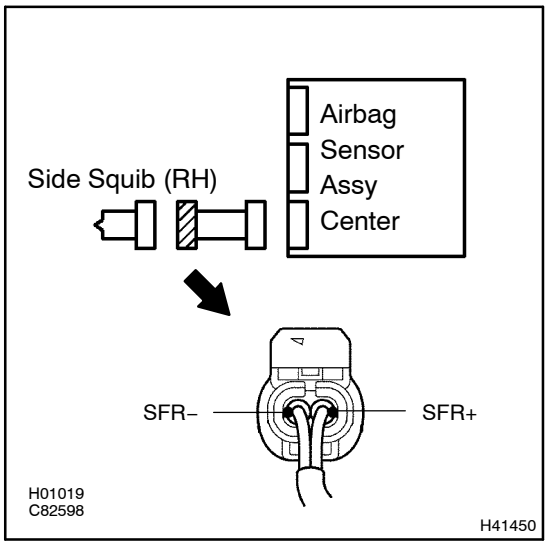
The side squib (RH) circuit consists of the airbag sensor assy center and front seat airbag assy (RH).
It causes the SRS to deploy when the SRS deployment conditions are satisfied.
DTC B0112/41 is recorded when a ground short is detected in the side squib (RH) circuit.

DTC No.	DTC Detecting Condition	Trouble Area
B0112/41	• Short circuit in side squib (RH) wire harness (to ground) • Side squib (RH) malfunction • Airbag sensor assy center malfunction	• Front seat airbag assy (RH) • Airbag sensor assy center • Wire harness

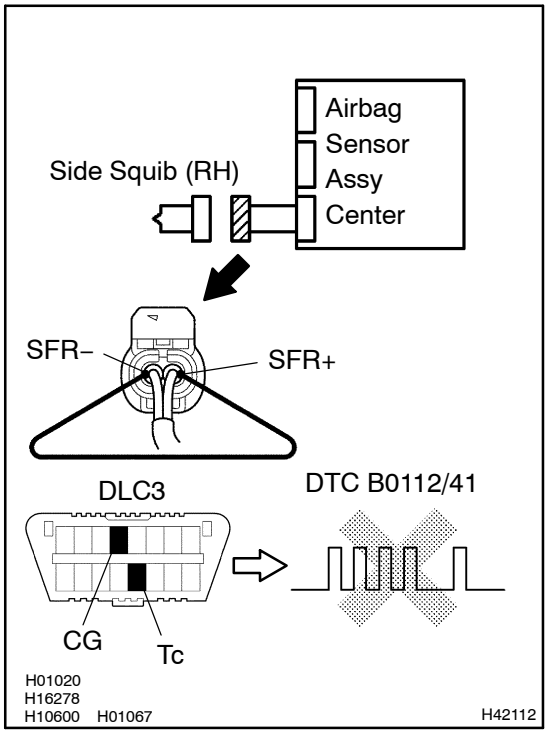
2 CHECK AIR BAG SENSOR ASSY CENTER

(a) Connect the connector to the airbag sensor assy center.
(b) Using a service wire, connect SFR+ and SFR– of the connector (on the front seat airbag assy side) between the airbag sensor assy center and the front seat airbag assy (RH).
(c) Connect the negative (–) terminal cable to the battery, and wait at least for 2 seconds.
(d) Turn the ignition switch to ON, and wait at least for 20 seconds.
(e) Clear the DTC stored in memory (See page 05–758).
(f) Turn the ignition switch to LOCK, and wait at least for 20 seconds.
(g) Turn the ignition switch to ON, and wait at least for 20 seconds.
(h) Check the DTC (See page 05–758).

DTC B0112/41 is not output.

NG → **REPLACE AIR BAG SENSOR ASSY CENTER**

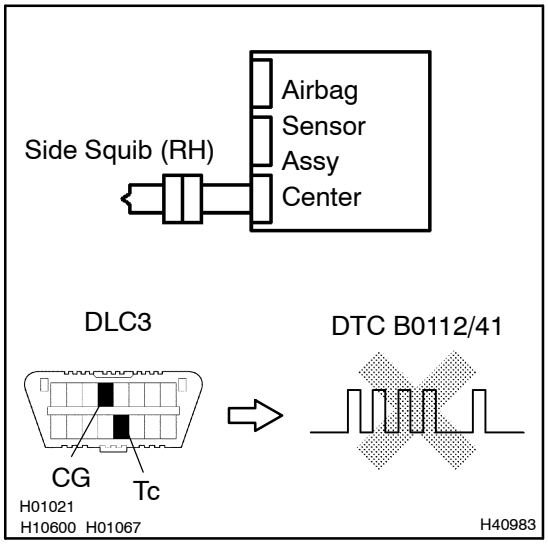
3	CHECK SIDE SQUIB(RH)

(a) Turn the ignition switch to LOCK.
(b) Disconnect the negative (–) terminal cable from the battery, and wait at least for 90 seconds.
(c) Connect the front seat airbag assy (RH) connector.
(d) Connect the negative (–) terminal cable to the battery, and wait at least for 2 seconds.
(e) Turn the ignition switch to ON, and wait at least for 20 seconds.
(f) Clear the DTC stored in memory (See page 05–758).
(g) Turn the ignition switch to LOCK, and wait at least for 20 seconds.
(h) Turn the ignition switch to ON, and wait at least for 20 seconds.
(i) Check the DTC (See page 05–758).

DTC B0112/41 is not output.

NG → **REPLACE SEPARATE TYPE FRONT SEAT BACK ASSY**
