DTC	B1242	Wireless Door Lock Tuner Circuit Malfunction	
RECORDINA

DESCRIPTION

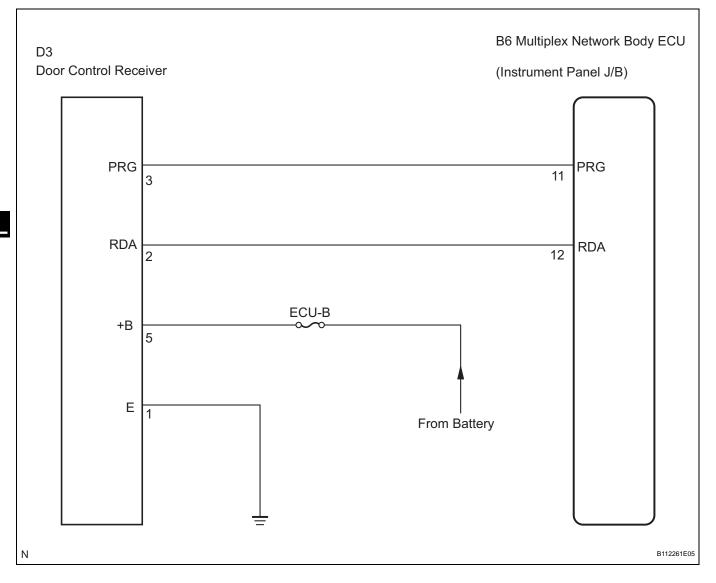
WIRING DIAGRAM

When a RDA signal is not input to the door control receiver within 1 second after the multiplex network body ECU outputs a PRG signal, this DTC is set.

DTC No.	DTC Detection Condition	Suspected Area
B1242	Within 1 second after PRG signal is output from multiplex network body ECU during self-diagnostic mode, corresponding RDA signal is not input	Wire harnessDoor control receiverMultiplex network body ECU
