DTC	B0137/71	SHORT IN P/T SQUIB (LH) CIRCUIT (TO GROUND)

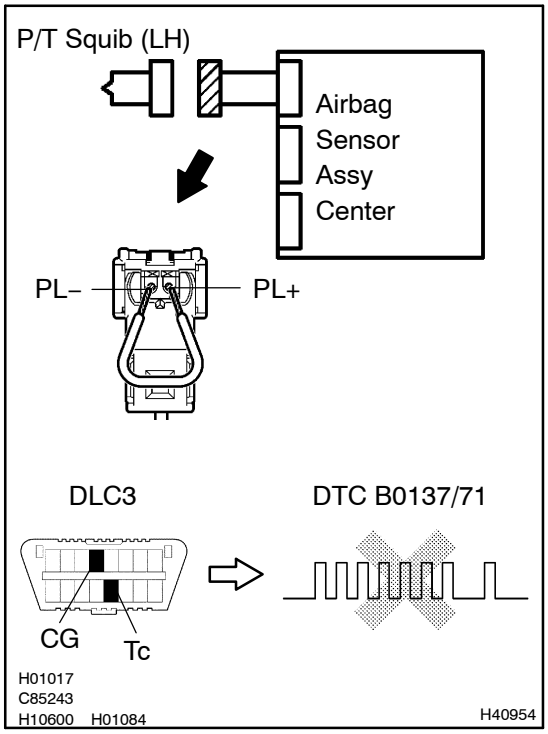
2 CHECK AIR BAG SENSOR ASSY CENTER

(a) Connect the connector to the airbag sensor assy center.
(b) Using a service wire, connect PL+ and PL– of the connector (on the seat belt pretensioner side) between the airbag sensor assy center and the seat belt pretensioner (LH).
(c) Connect the negative (–) terminal cable to the battery, and wait at least for 2 seconds.
(d) Turn the ignition switch to ON, and wait at least for 20 seconds.
(e) Clear the DTC stored in memory (See page 05–758).
(f) Turn the ignition switch to LOCK, and wait at least for 20 seconds.
(g) Turn the ignition switch to ON, and wait at least for 20 seconds.
(h) Check the DTC (See page 05–758).

DTC B0137/71 is not output.

NG → **REPLACE AIR BAG SENSOR ASSY CENTER**

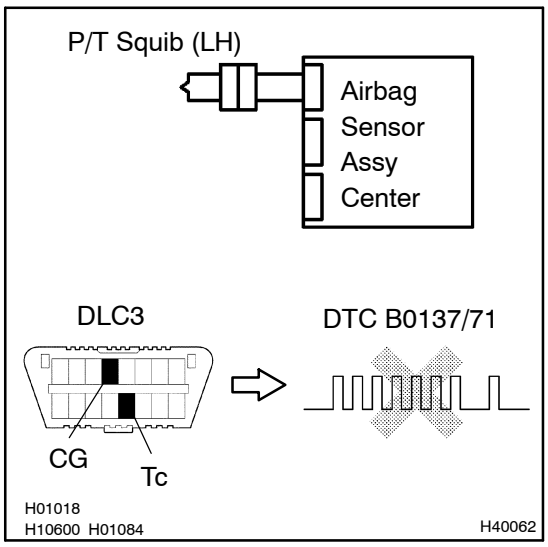
3 CHECK P/T SQUIB (LH)

(a) Turn the ignition switch to LOCK.
(b) Disconnect the negative (–) terminal cable from the battery, and wait at least for 90 seconds.
(c) Connect the seat belt pretensioner (LH) connector.
(d) Connect the negative (–) terminal cable to the battery, and wait at least for 2 seconds.
(e) Turn the ignition switch to ON, and wait at least for 20 seconds.
(f) Clear the DTC stored in memory (See page 05–758).
(g) Turn the ignition switch to LOCK, and wait at least for 20 seconds.
(h) Turn the ignition switch to ON, and wait at least for 20 seconds.
(i) Check the DTC (See page 05–758).
OK:
DTC B0137/71 is not output.

NG → **REPLACE FRONT SEAT OUTER BELT ASSY LH**
