Odo / Trip Switch Malfunction

WIRING DIAGRAM

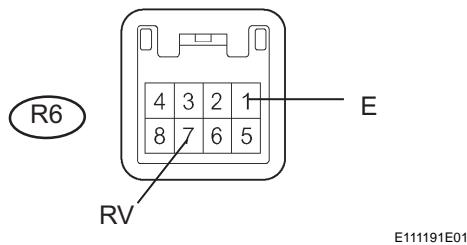
Connector Front View:

ODO/TRIP SWITCH

(a) Remove the light ODO/TRIP switch with connector still connected.

(b) Measure the resistance according to the value(s) in the table below.

Tester Connection	Condition	Specified Condition
R6-1 (E) - R6-7 (RV)	ODO/TRIP switch OFF → ON	10 kΩ or higher → Below 1 Ω

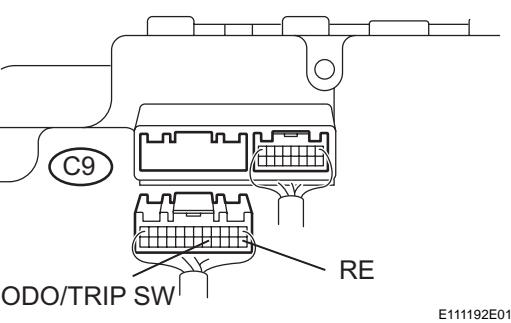
Combination Meter Assembly Wire Harness View:

(a) Disconnect the C9 and R6 connectors.

(b) Measure the resistance according to the value(s) in the table below.

Tester connection	Condition	Specified condition
C9-13 (RE) - R6-1 (E)	Always	Below 1 Ω
C9-17 (ODO/TRIP SW) - R6-4 (RSET)	Always	Below 1 Ω
