TURNING ON LIGHT SWITCH DOES NOT LIGHT UP NIGHT TIME ILLUMINATION OF RADIO RECEIVER

INSPECTION PROCEDURE

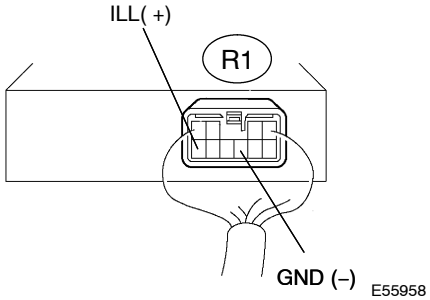
(b) Check the voltage between the terminals of the R1 connector.

Symbols (Terminal No.)	Condition	Specified Condition
ILL+ (R1–10) ⇔ GND (R1–7)	light control switch TAIL	20 – 28 V

NG → **REPAIR OR REPLACE HARNESS AND CONNECTOR**

REPAIR OR REPLACE RADIO RECEIVER ASSY
