GROUP 54

CHASSIS ELECTRICAL

OUTLINE OF CHANGES

IMMOBILIZER SYSTEM <Diesel-powered Vehicles>

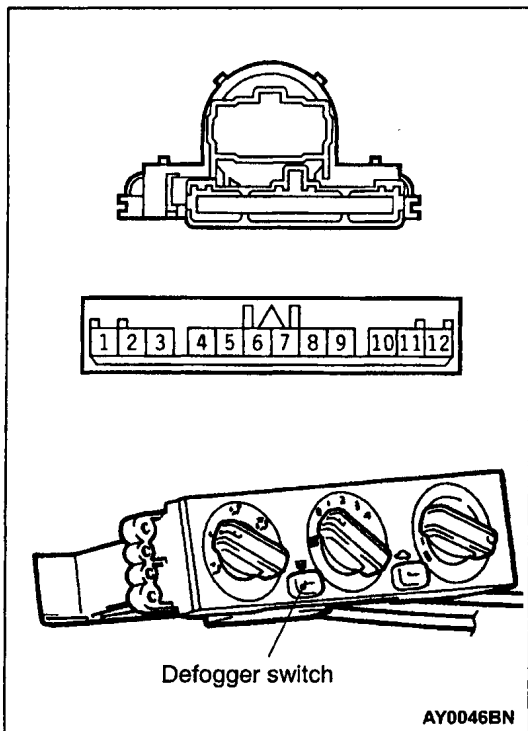
DEFOGGER SWITCH CONTINUITY CHECK

Switch position	Terminal No.		
	10	11	12
OFF	○	IND ⊕	○
ON	○	IND ⊕	○ ○
