4EAT TRANSMISSION DIAGNOSIS - PART II

Video Reference Booklet

TECHNICAL TRAINING

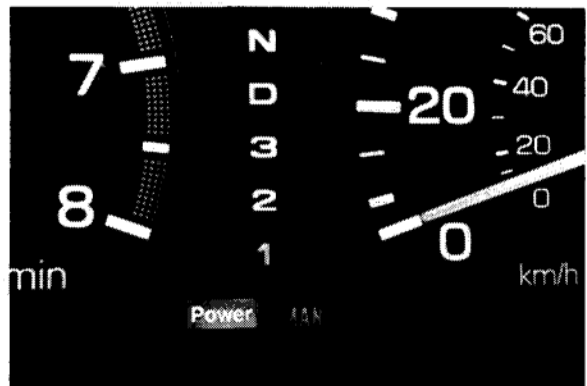
Power Light "Flashing"

In this case, when the "Power Light" flashes 16 times upon start up, this is a clue that an electrical problem is indicated and it is most likely the cause.

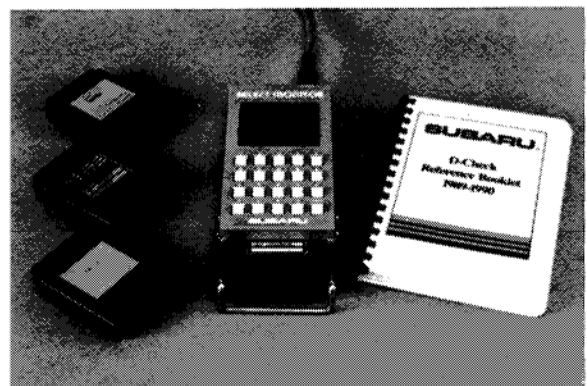
Select Monitor and D-Check Manual

Use the Select Monitor or perform memory and D-checks in order to locate an electrical trouble code. By using the applicable 4EAT cartridge in the Select Monitor we found Trouble Code 24 in the U-Check Mode as well as in Memory.

Trouble Code	Item	Content of Diagnosis	Abbr. (Select Monitor)
11	Duty solenoid A	Detects open or shorted drive circuit, as well as valve seizure.	PL
12	Duty solenoid B	Detects open or shorted drive circuit, as well as valve seizure.	L/U
13	Shift solenoid 3	Detects open or shorted drive circuit, as well as valve seizure.	OVR
14	Shift solenoid 2	Detects open or shorted drive circuit, as well as valve seizure.	SFT2
15	Shift solenoid 1	Detects open or shorted drive circuit, as well as valve seizure.	SFT1
21	ATF temperature sensor	Detects open or shorted input signal circuit.	ATFT
*22	Atmospheric sensor	Detects open or shorted input signal circuit.	BARO. P
23	Engine revolution signal	Detects open or shorted input signal circuit.	EREV
24	Duty solenoid C	Detects open or shorted drive circuit, as well as valve seizure.	4WD
31	Throttle sensor	Detects open or shorted input signal circuit.	THV
32	Vehicle speed sensor 1	Detects open or shorted input signal circuit.	VSP1

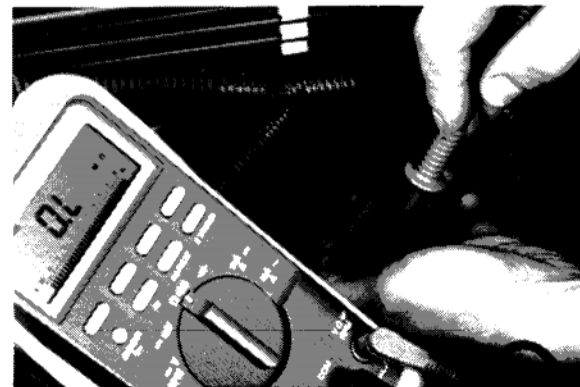
Probing Intermediate Connector

The ohm meter is still reading infinity. This would seem to indicate that the harness between the TCU and the intermediate connector is probably OK at this time.

The problem is now isolated to either the last section of the harness or to duty solenoid "C". With what we know now, the previous repair inside the extension housing may have some impact on our current problem.

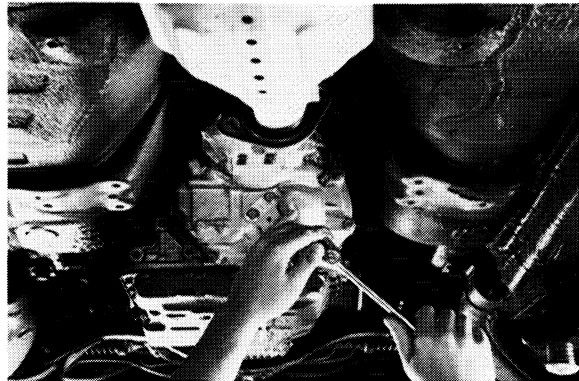
Removing Rear Housing

In this case, we placed the vehicle on a lift and followed the removal procedures outlined in the Subaru Service Manual.

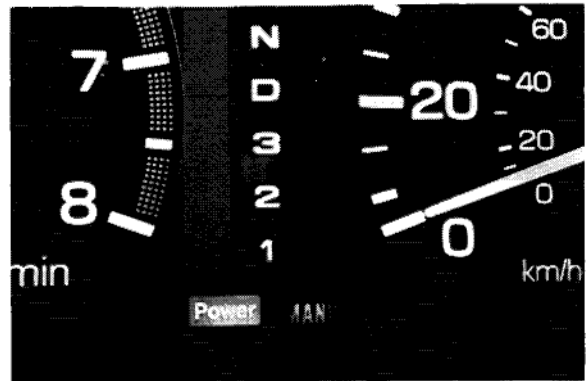
Power Light "ON"/"OFF"

In this case however, the "Power Light" operates normally. It does not flash upon start up. In accordance with the complaint, this indicates a probable mechanical failure.

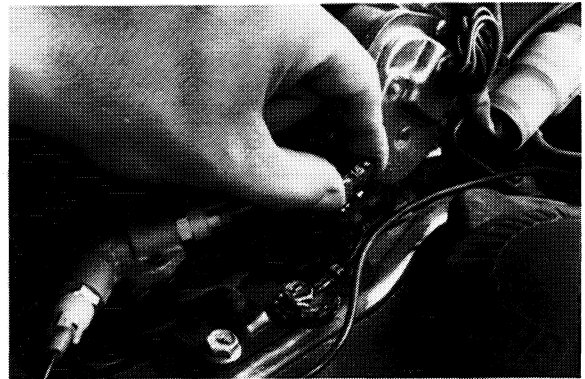
Removing FWD Fuse

After removing the forced Front Wheel Drive fuse installed earlier, we now road test the vehicle with the pressure gauge.

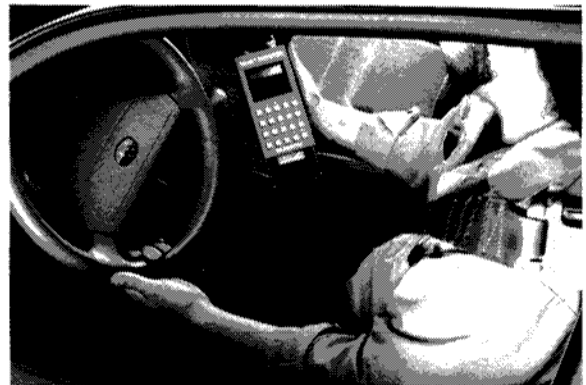
Verifying Repair

As always, we verified the repair with a final road test where we noted the correct pressure range and the correct Select Monitor readings.

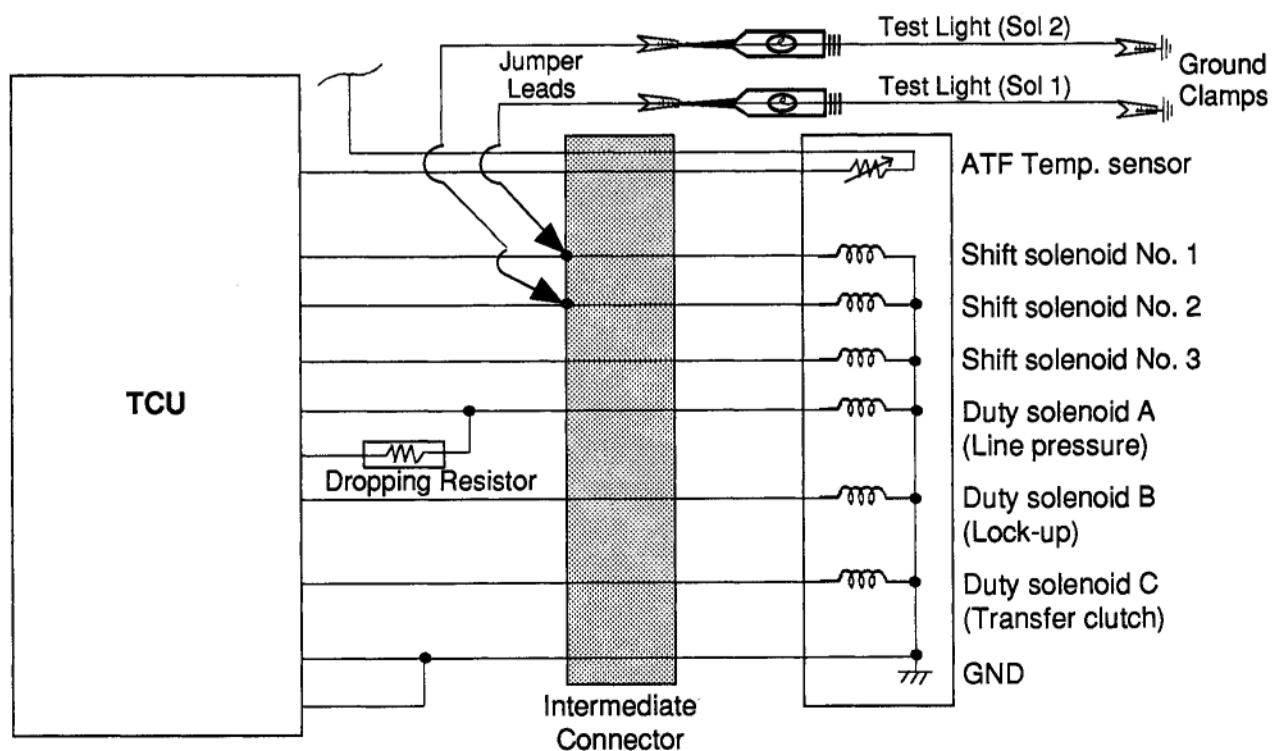
1. Make sure the vehicle is within the proper temperature range before conducting any tests.
2. Locate the intermediate wiring harness connector between the TCU and the transmission. It is found in the engine compartment near the front of the bellhousing.

5. Attach the grounding clamps of each test light to a good body ground.
6. With a piece of masking tape or the like, mark each test light to correspond with the shift solenoid it is monitoring.

7. With the selector lever in "D" range, drive the vehicle and observe the On/Off pattern of the test lights. A normal On/Off pattern should match the shift control chart found in the Subaru Service Manual (Sec. 3-2) or on page 18 of this booklet. It is advisable to have a helper come along on the road test to monitor test light operation due to the fact that it can be a distraction while driving.

NOTE: REFER TO THE APPROPRIATE MODEL YEAR SERVICE MANUAL FOR PROPER WIRE COLOR AND CONNECTOR LOCATION IN ORDER TO PERFORM THE ABOVE PROCEDURE.

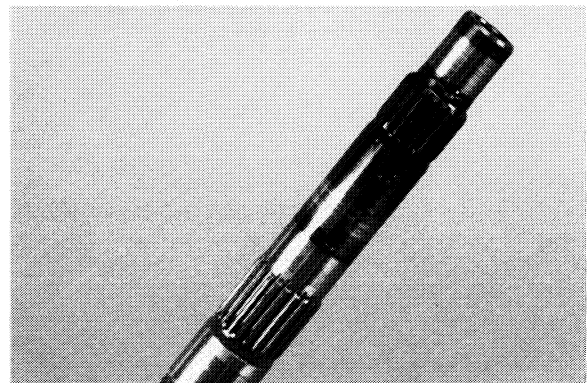
Discolored Input Shaft

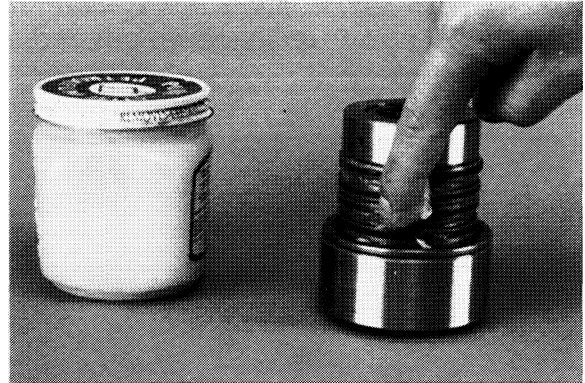
Use petroleum jelly to liberally lubricate the seal rings on the OWC 1-2 inner race prior to installation.

Lubricating Seal Rings

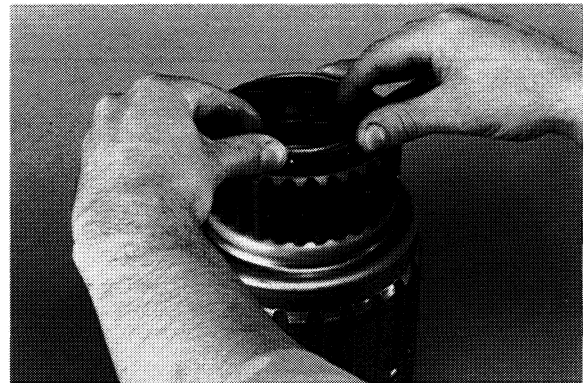
Carefully install the forward clutch drum over the seal rings and on to the OWC 1-2 inner race. Take care not to cock the drum and damage the seal rings.

Installing Forward Clutch Drum

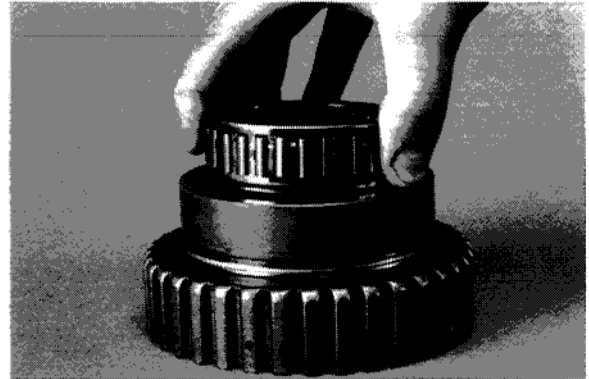
Install the OWC 3-4 in its outer race, (also known as the forward clutch hub). With the splines of the forward clutch hub facing downward, the OWC 3-4 is installed with the ridge facing upward.

Installing OWC 3-4

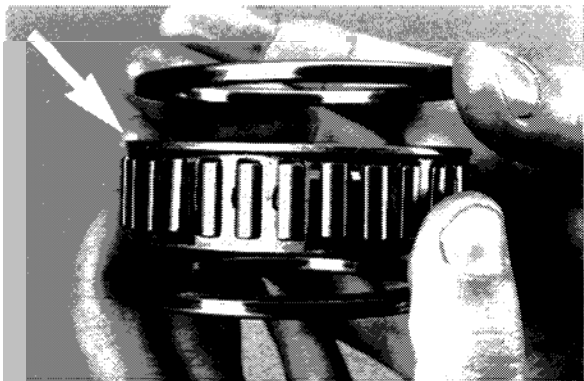
Whenever installing OWC 3-4 confirm proper direction of the ridge.

OWC 3-4 Assembly

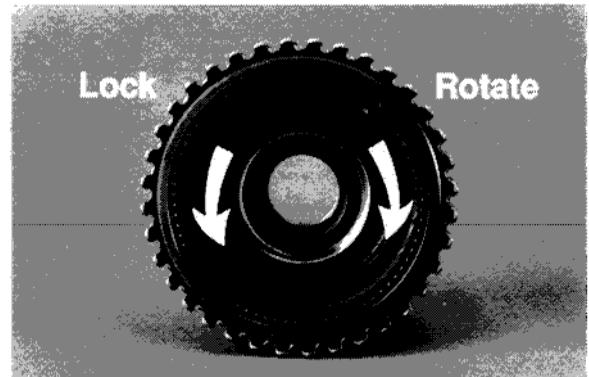
Then check for proper rotation of the OWC 3-4 inner race (also known as rear internal gear). It must rotate clockwise (CW) within the forward clutch hub when viewed from the front and lock when rotated counter clockwise (CCW).

Checking OWC 3-4 Rotation (CW)
