DTC B0116/48 OPEN IN SIDE SQUIB (LH) CIRCUIT

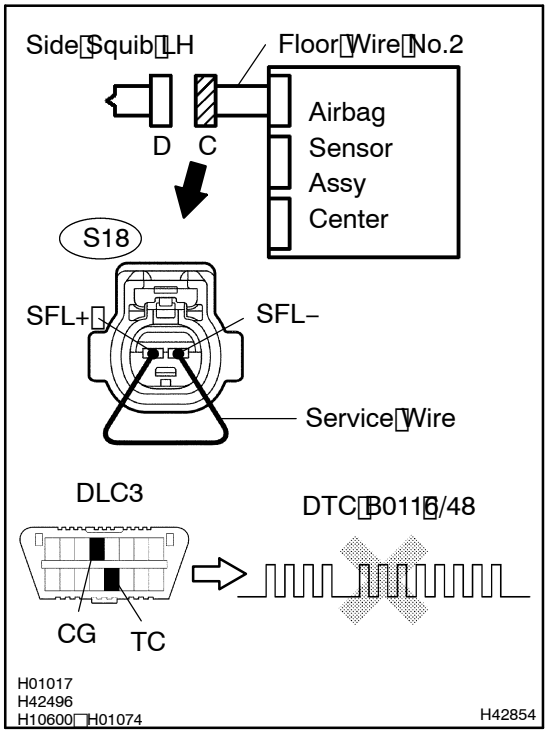
1 CHECK FLOOR WIRE NO.2 (SIDE SQUIB LH CIRCUIT)

(a) Turn the ignition switch to the LOCK position.
(b) Disconnect the negative (–) terminal cable from the battery, and wait for at least 90 seconds.
(c) Disconnect the connectors from the airbag sensor assy center and the separate type front seat back assy (side squib LH).
(d) Measure the resistance according to the value(s) in the table below.

Tester connection	Condition	Specified condition
S18–1 (SFL+) – S18–2 (SFL–)	Always	Below 1 Ω

NG → **REPAIR OR REPLACE FLOOR WIRE NO.2**

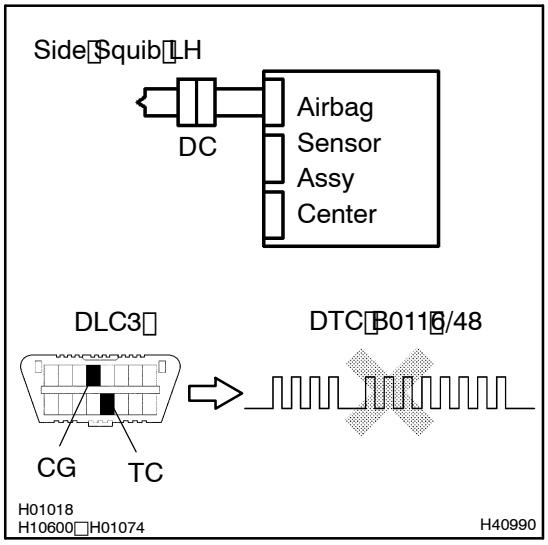
3	CHECK SEPARATE TYPE FRONT SEAT BACK ASSY (SIDE SQUIB LH)

(a) Turn the ignition switch to the LOCK position.
(b) Disconnect the negative (–) terminal cable from the battery, and wait for at least 90 seconds.
(c) Disconnect the service wire from connector "C".
(d) Connect the connector to the separate type front seat back assy (side squib LH).
(e) Connect the negative (–) terminal cable to the battery, and wait for at least 2 seconds.
(f) Turn the ignition switch to the ON position, and wait for at least 60 seconds.
(g) Clear the DTCs stored in memory (see page 05–513).
(h) Turn the ignition switch to the LOCK position.
(i) Turn the ignition switch to the ON position, and wait for at least 60 seconds.
(j) Check the DTCs (see page 05–513).

DTC B0116/48 is not output.

NG	REPLACE SEPARATE TYPE FRONT SEAT BACK ASSY
