DTC	B0117/45	SHORT IN SIDE SQUIB (LH) CIRCUIT (TO GROUND)

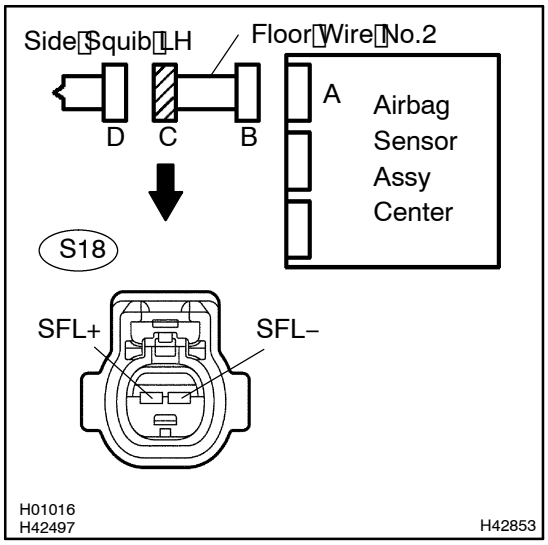
The side squib LH circuit consists of the airbag sensor assy center and the separate type front seat back assy (side squib LH).

DTC B0117/45 is recorded when a short to ground is detected in the side squib LH circuit.

DTC No.	DTC Detecting Condition	Trouble Area
B0117/45	• Short circuit in side squib (LH) wire harness (to ground) • Side squib (LH) malfunction • Airbag sensor assy center malfunction	• Separate type front seat back assy (Side squib LH) • Airbag sensor assy center • Floor wire No.2

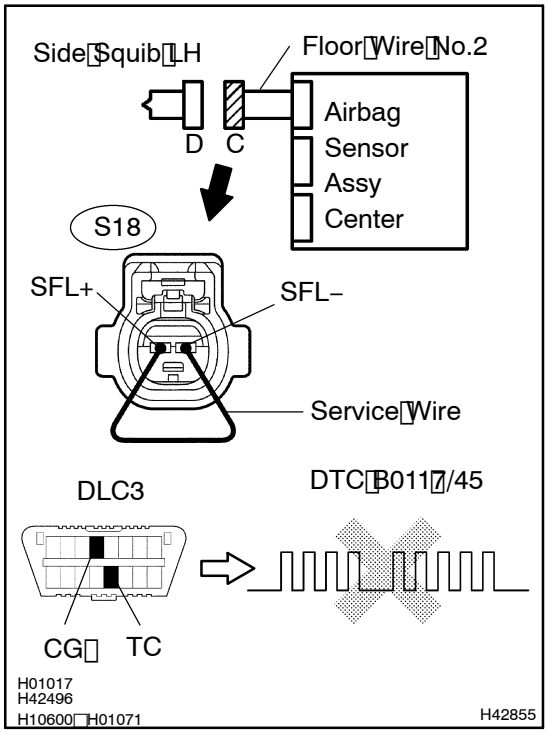
1	CHECK FLOOR WIRE NO.2 (SIDE SQUIB LH CIRCUIT)

(d) Measure the resistance according to the value(s) in the table below.

Tester connection	Condition	Specified condition
S18–1 (SFL+) – Body ground	Always	1 MΩ or Higher
S18–2 (SFL–) – Body ground	Always	1 MΩ or Higher

NG → **REPAIR OR REPLACE FLOOR WIRE NO.2**

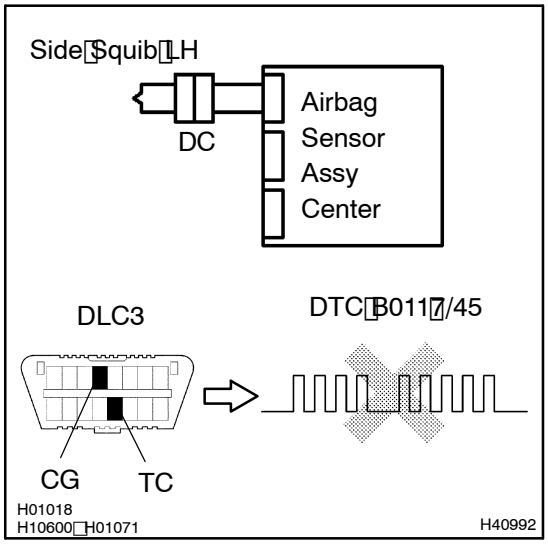
3	CHECK SEPARATE TYPE FRONT SEAT BACK ASSY(SIDE SQUIB LH)

(a) Turn the ignition switch to the LOCK position.
(b) Disconnect the negative (–) terminal cable from the battery, and wait for at least 90 seconds.
(c) Disconnect the service wire from connector "C".
(d) Connect the connector to the separate type front seat back assy (side squib LH).
(e) Connect the negative (–) terminal cable to the battery, and wait for at least 2 seconds.
(f) Turn the ignition switch to the ON position, and wait for at least 60 seconds.
(g) Clear the DTCs stored in memory (see page 05–513).
(h) Turn the ignition switch to the LOCK position.
(i) Turn the ignition switch to the ON position, and wait for at least 60 seconds.
(j) Check the DTCs (see page 05–513).

DTC B0117/45 is not output.

NG	REPLACE SEPARATE TYPE FRONT SEAT BACK ASSY
