## Failsafe Pertaining to Setting Moon Roof Glass Position Data

## Moon Roof Glass and Side Garnish

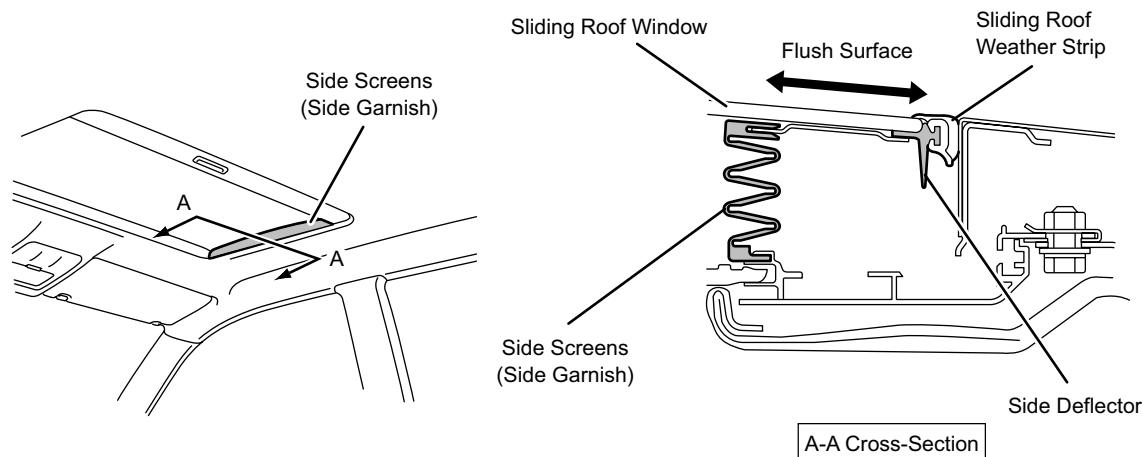
- The offset between the sliding roof glass and the weatherstrip has been reduced to enhance the appearance from the vehicle exterior.
- A side deflector and a side screen (side garnish) are provided along the sides of the sliding roof glass to reduce wind noise during a tilt-up and to enhance the appearance from the vehicle interior.
