DTC	B2797	COMMUNICATION MALFUNCTION NO.1
------------	--------------	---------------------------------------

CIRCUIT DESCRIPTION

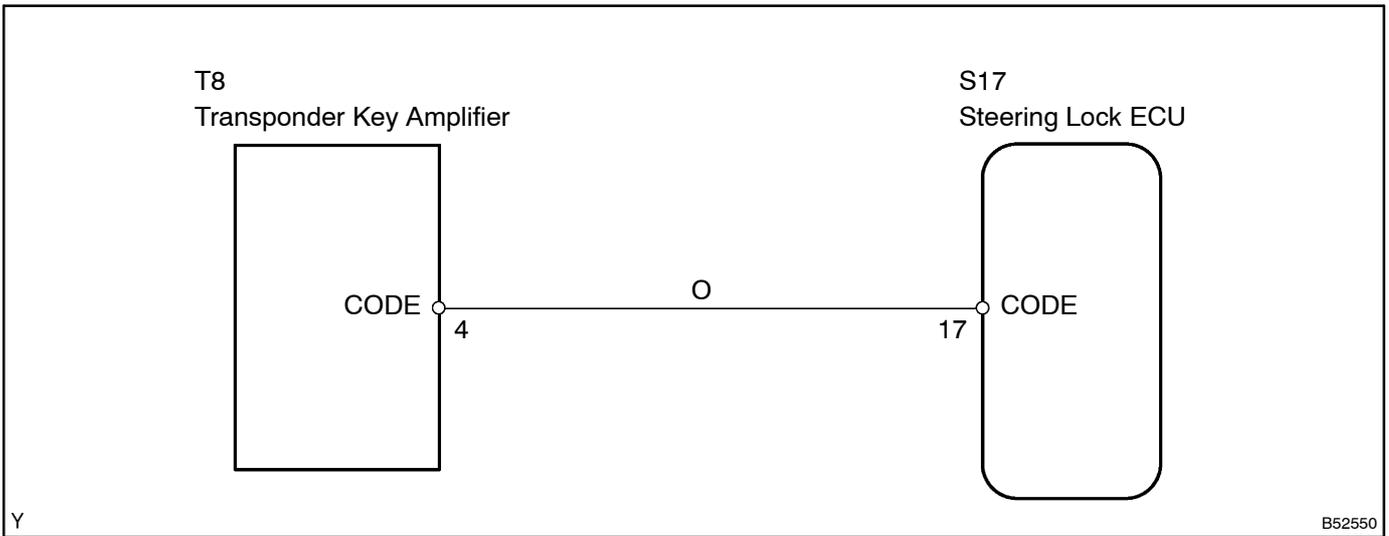
WIRING DIAGRAM

This DTC is output when a communication error occurs between the transponder key amplifier and steering lock ECU. Some possible reasons for the communication error are: 1) two or more smart keys are positioned too close together, or 2) noise is occurring in the communication line. Follow the inspection procedure below.

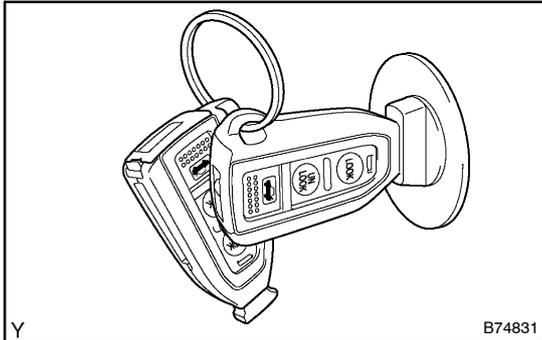
1 CHECK KEYS

- (a) Check if the smart key being used is near other smart keys as shown in the illustration. Also, check if the key ring is in contact with the key grip.

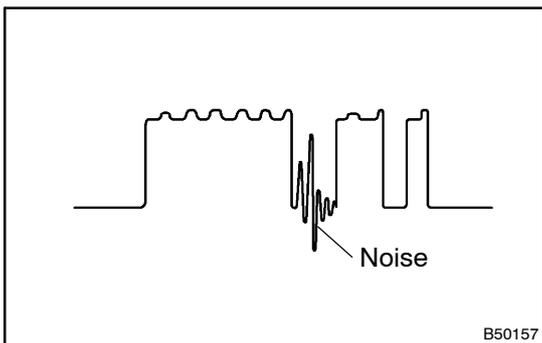
3 CHECK STEERING LOCK ECU

- (a) Using an oscilloscope or the hand-held tester check the waveform between the terminals of T8 amplifier connector and S17 ECU connector. The waveform should be similar to the illustration on the left.

OK: No noise is present (see illustration on the left).

Tester Connection	Specified Condition
S17-17 (CODE) - T8-4 (CODE)	No noise is present

Tool Setting	10 V/DIV., 20 ms/DIV.
Condition	Ignition switch OFF → ON

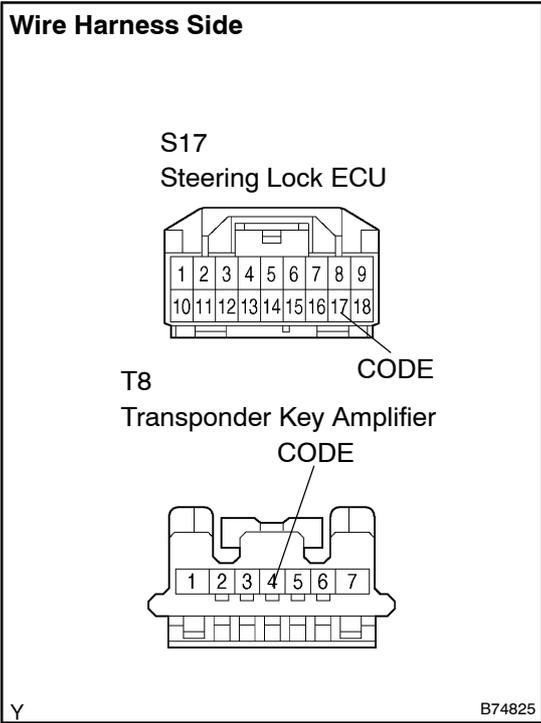
4 CHECK WIRE HARNESS (STEERING LOCK ECU - TRANSPONDER KEY AMPLIFIER)

- (a) Disconnect the S17 ECU and T8 amplifier connectors.
- (b) Measure the resistance between the terminals of the connectors.

Tester Connection	Specified Condition
S17-17 (CODE) - T8-4 (CODE)	Below 1 Ω
