DTC	B0112/41	SHORT IN SIDE SQUIB (RH) CIRCUIT (TO GROUND)

CIRCUIT DESCRIPTION

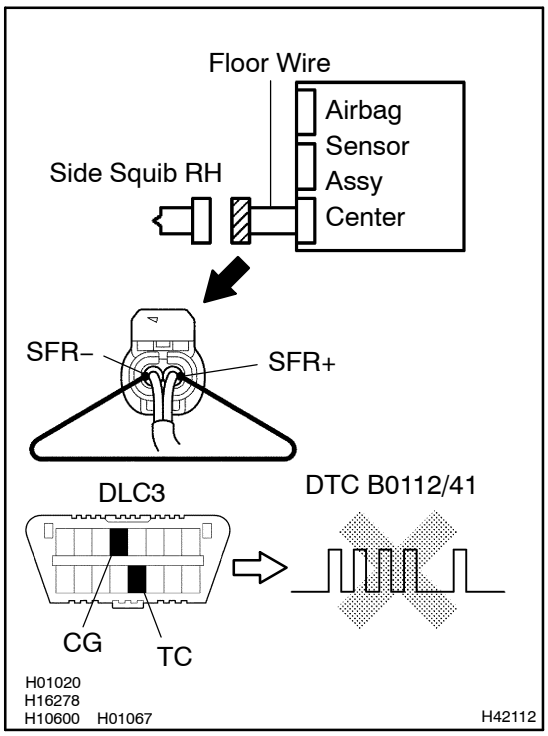
2 CHECK AIR BAG SENSOR ASSY CENTER

(a) Connect the connector to the airbag sensor assy center.
(b) Using a service wire, connect SFR+ and SFR– of the floor wire connector on the front seat airbag assy RH side.
(c) Connect the negative (–) terminal cable to the battery, and wait at least for 2 seconds.
(d) Turn the ignition switch to ON, and wait at least for 10 seconds.
(e) Clear the DTC stored in memory (See page 05–1122).
(f) Turn the ignition switch to LOCK, and wait at least for 10 seconds.
(g) Turn the ignition switch to ON, and wait at least for 10 seconds.
(h) Check the DTC (See page 05–1122).

OK:

DTC B0112/41 is not output.

NG → **REPLACE AIR BAG SENSOR ASSY CENTER**

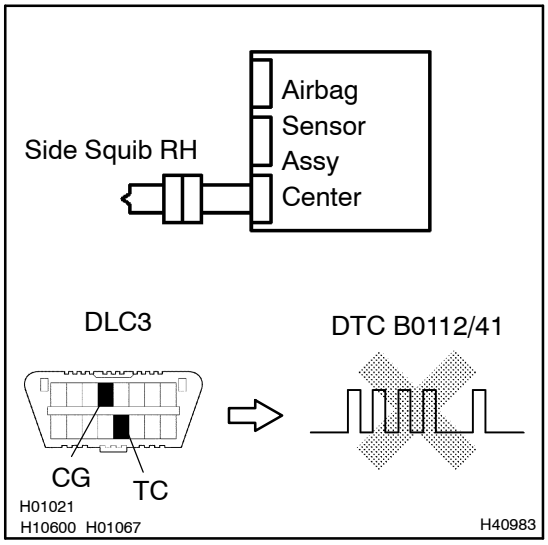
3	CHECK SIDE SQUIB (RH)

(a) Turn the ignition switch to LOCK.
(b) Disconnect the negative (–) terminal cable from the battery, and wait at least for 90 seconds.
(c) Connect the front seat airbag assy RH connector.
(d) Connect the negative (–) terminal cable to the battery, and wait at least for 2 seconds.
(e) Turn the ignition switch to ON, and wait at least for 10 seconds.
(f) Clear the DTC stored in memory (See page 05–1122).
(g) Turn the ignition switch to LOCK, and wait at least for 10 seconds.
(h) Turn the ignition switch to ON, and wait at least for 10 seconds.
(i) Check the DTC (See page 05–1122).
OK:
DTC B0112/41 is not output.

NG → **REPLACE FRONT SEAT BACK ASSEMBLY RH**
