DTC B0131/64 OPEN IN P/T (RH) CIRCUIT

CIRCUIT DESCRIPTION

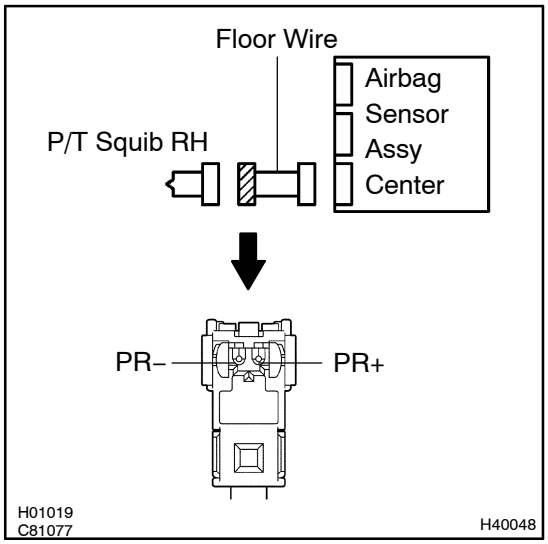
The P/T squib RH circuit consists of the airbag sensor assy center and the seat belt pretensioner RH.
It causes the SRS to deploy when the SRS deployment conditions are satisfied.
DTC B0131/64 is recorded when an open is detected in the P/T squib RH circuit.

DTC No.	DTC Detecting Condition	Trouble Area
B0131/64	• Open in P/T squib RH circuit • P/T squib RH malfunction • Airbag sensor assy center malfunction	• Seat belt pretensioner RH (P/T squib RH) • Airbag sensor assy center • Floor wire

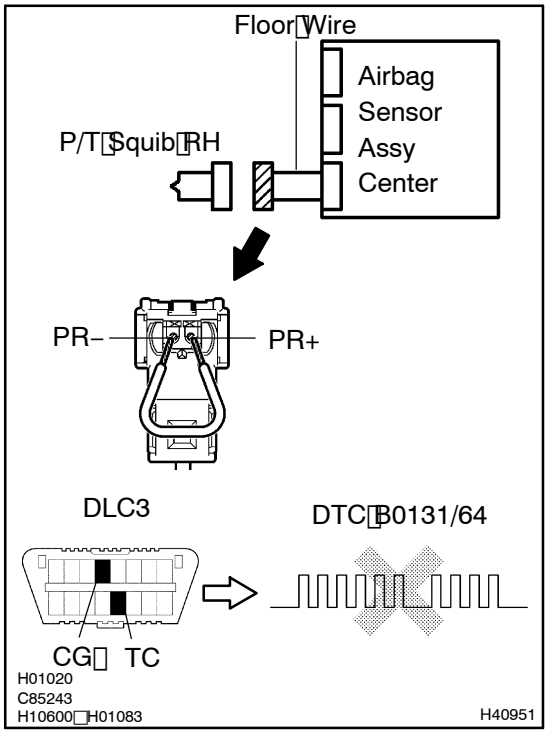
2	CHECK AIR BAG SENSOR ASSY CENTER

(a) Connect the connector to the airbag sensor assy center.
(b) Using a service wire, connect PR+ and PR– of the floor wire connector on the seat belt pretensioner RH side.
(c) Connect the negative (–) terminal cable to the battery, and wait at least for 2 seconds.
(d) Turn the ignition switch to ON, and wait at least for 10 seconds.
(e) Clear the DTC stored in memory (See page 05–1122).
(f) Turn the ignition switch to LOCK, and wait at least for 10 seconds.
(g) Turn the ignition switch to ON, and wait at least for 10 seconds.
(h) Check the DTC (See page 05–1122).

DTC B0131/64 is not output.

NGN → **REPLACE AIR BAG SENSOR ASSY CENTER**

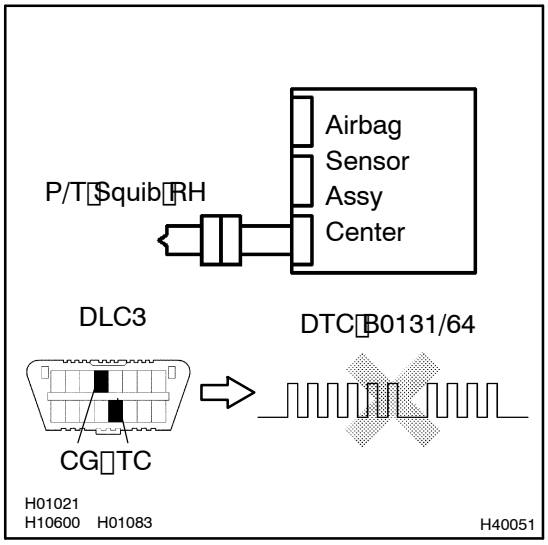
3	CHECK P/T SQUIB (RH)

(a) Turn the ignition switch to LOCK.
(b) Disconnect the negative (–) terminal cable from the battery, and wait at least for 90 seconds.
(c) Connect the seat belt pretensioner RH connector.
(d) Connect the negative (–) terminal cable to the battery, and wait at least for 2 seconds.
(e) Turn the ignition switch to ON, and wait at least for 10 seconds.
(f) Clear the DTC stored in memory (See page 05–1122).
(g) Turn the ignition switch to LOCK, and wait at least for 10 seconds.
(h) Turn the ignition switch to ON, and wait at least for 10 seconds.
(i) Check the DTC (See page 05–1122).

DTC B0131/64 is not output.

NG → **REPLACE FRONT SEAT OUTER BELT ASSY RH**
