| <b>DTC</b> | <b>C1210 / 36</b> | <b>Zero Point Calibration of Yaw Rate Sensor Undone</b> |

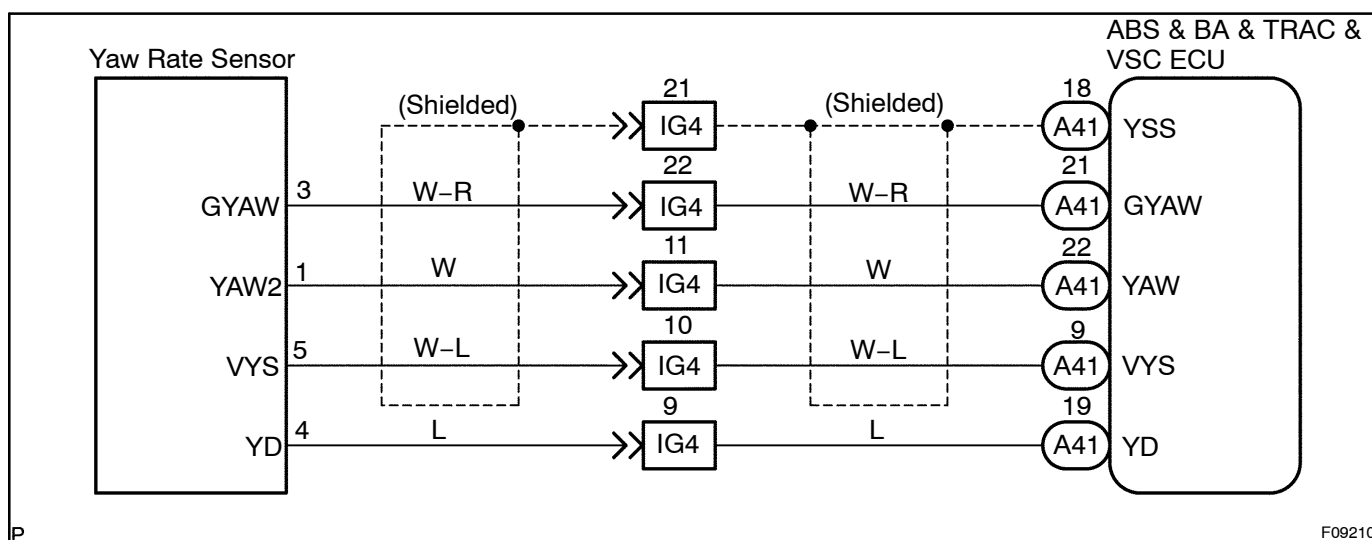
## WIRING DIAGRAM

| DTC No. | DTC Detecting Condition | Trouble Area |
|---|---|---|
| C1210 / 36 | When any of following 1. through 2. is detected:<br>1. After battery terminal was connected, when the shift lever was moved other than to P position within 15 sec. soon after ECU terminal IG1 become ON for the first time.<br>2. When the yaw rate sensor zero point recorded in ECU is deleted. | <ul style="list-style-type: none"> <li>• Yaw rate sensor</li> <li>• Yaw rate sensor circuit</li> <li>• PNP switch circuit (P position)</li> </ul> |

Check for open and short circuit in harness and connector between PNP switch (P position) and ABS & BA & TRAC & VSC ECU and ECM (See page [IN-34](#)).

Check for open and short circuit in harness and connector between yaw rate sensor and ABS & BA & TRAC & VSC ECU (See page [IN-34](#)).
