DTC	B0137/71	SHORT IN P/T SQUIB (LH) CIRCUIT (TO GROUND)

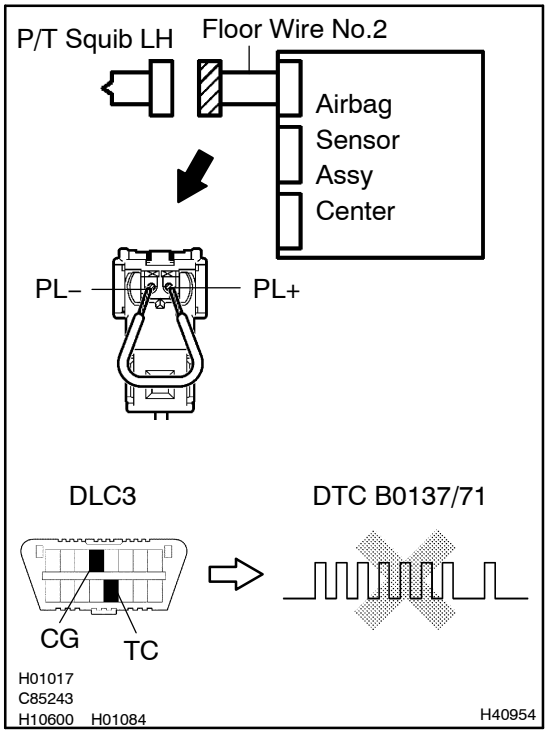
2 CHECK AIR BAG SENSOR ASSY CENTER

(a) Connect the connector to the airbag sensor assy center.
(b) Using a service wire, connect PL+ and PL– of the floor wire No.2 connector on the seat belt pretensioner LH side.
(c) Connect the negative (–) terminal cable to the battery, and wait at least for 2 seconds.
(d) Turn the ignition switch to ON, and wait at least for 10 seconds.
(e) Clear the DTC stored in memory (See page 05–1122).
(f) Turn the ignition switch to LOCK, and wait at least for 10 seconds.
(g) Turn the ignition switch to ON, and wait at least for 10 seconds.
(h) Check the DTC (See page 05–1122).

DTC B0137/71 is not output.

NG → **REPLACE AIR BAG SENSOR ASSY CENTER**

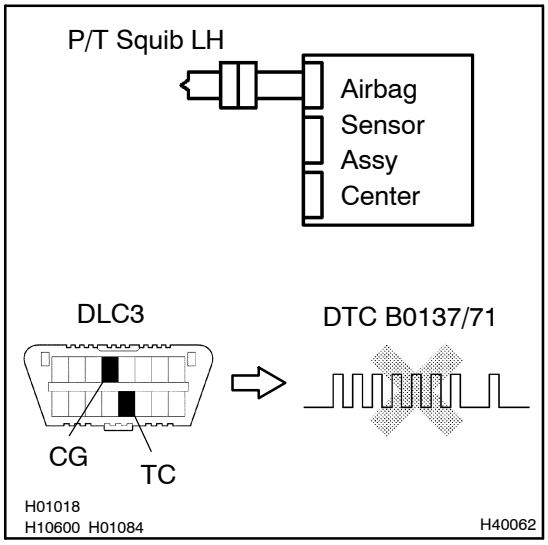
3	CHECK P/T SQUIB (LH)

(a) Turn the ignition switch to LOCK.
(b) Disconnect the negative (–) terminal cable from the battery, and wait at least for 90 seconds.
(c) Connect the seat belt pretensioner LH connector.
(d) Connect the negative (–) terminal cable to the battery, and wait at least for 2 seconds.
(e) Turn the ignition switch to ON, and wait at least for 10 seconds.
(f) Clear the DTC stored in memory (See page 05–1122).
(g) Turn the ignition switch to LOCK, and wait at least for 10 seconds.
(h) Turn the ignition switch to ON, and wait at least for 10 seconds.
(i) Check the DTC (See page 05–1122).
OK:
DTC B0137/71 is not output.

NG → **REPLACE FRONT SEAT OUTER BELT ASSY LH**
