| <b>DTC</b> | <b>C1210 / 36</b> | <b>Zero Point Calibration of Yaw Rate Sensor Undone</b> |

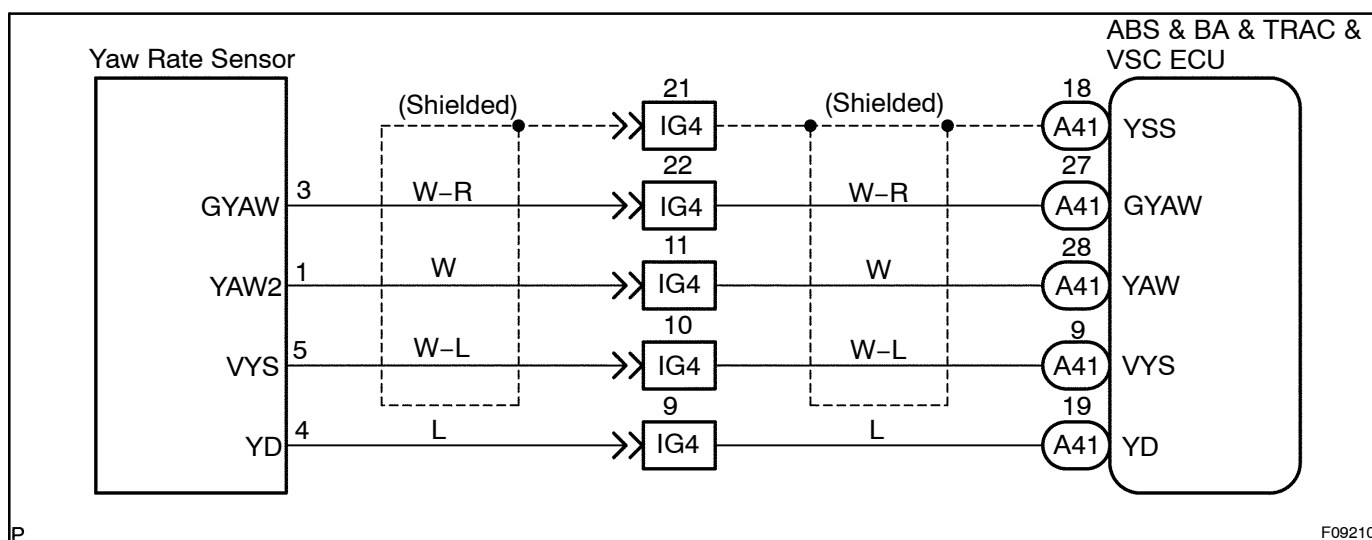
## WIRING DIAGRAM

| DTC No. | DTC Detecting Condition | Trouble Area |
|---|---|---|
| C1210 / 36 | When any of following 1. through 2. is detected:<br>1. After battery terminal was connected, when the shift lever was moved other than to P position within 15 sec. soon after ECU terminal IG1 become ON for the first time.<br>2. When the yaw rate sensor zero point recorded in ECU is deleted. | <ul style="list-style-type: none"> <li>• Yaw rate sensor</li> <li>• Yaw rate sensor circuit</li> <li>• PNP switch circuit (P position)</li> </ul> |

| 2 | Check for open and short circuit in harness and connector between PNP switch (P position) and ABS & BA & TRAC & VSC ECU and ECM (See page <a href="#">IN-34</a> ). |

| 3 | Check for open and short circuit in harness and connector between yaw rate sensor and ABS & BA & TRAC & VSC ECU (See page <a href="#">IN-34</a> ). |
