DTC	B2780	PUSH SWITCH/KEY UNLOCK WARNING SWITCH MALFUNCTION

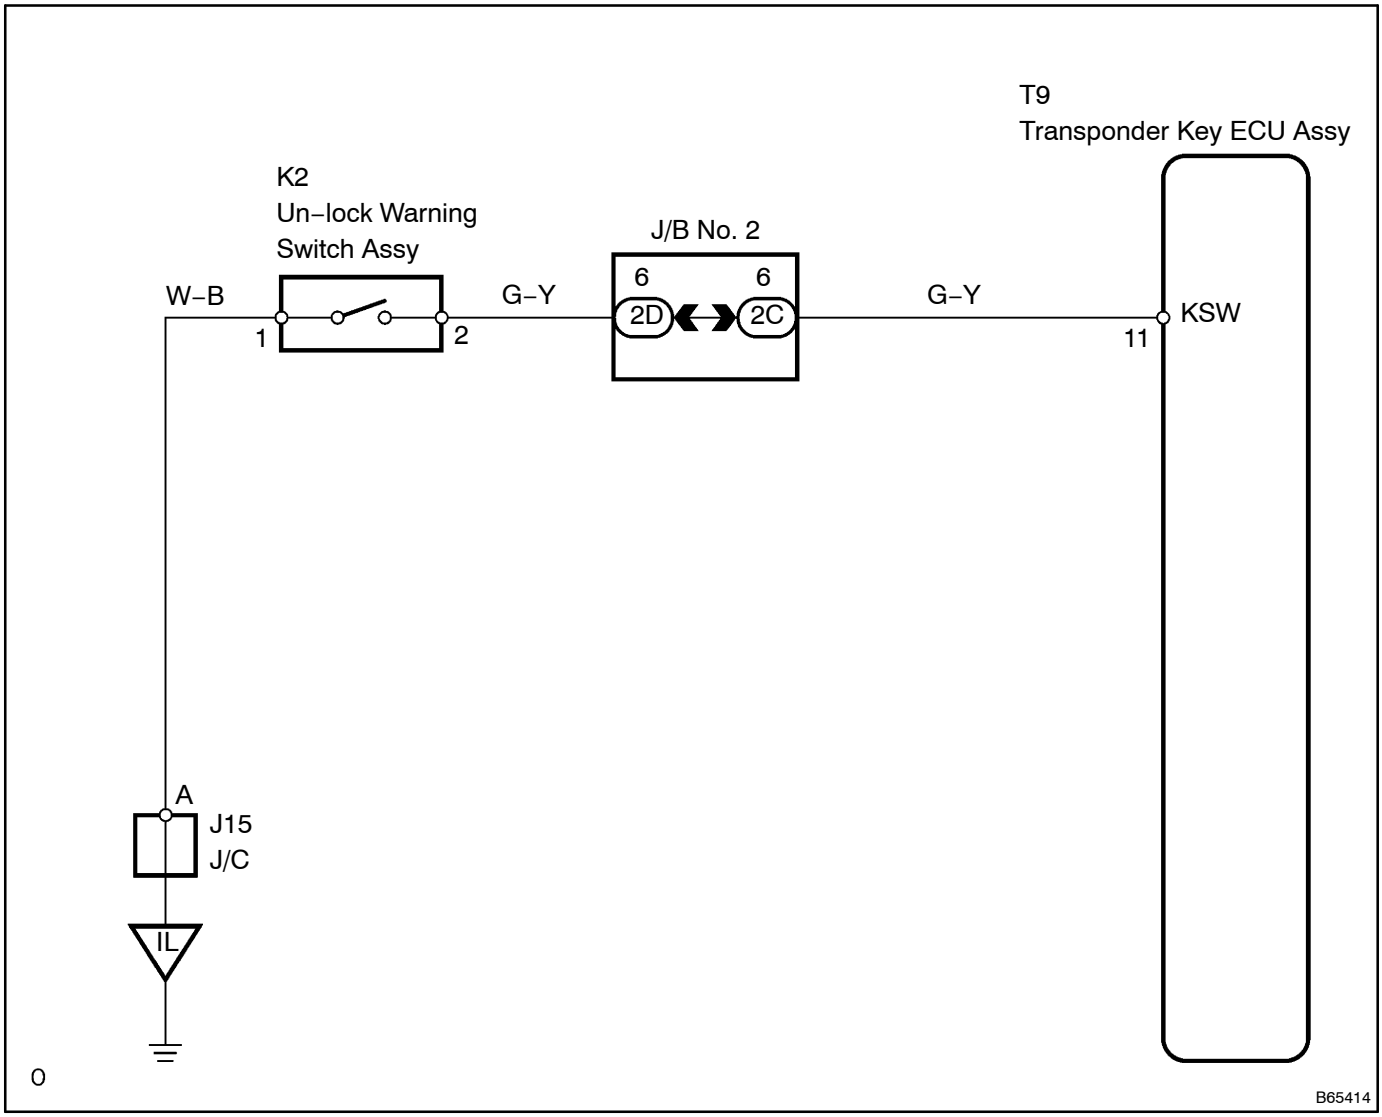
WIRING DIAGRAM

This DTC will be output if the transponder key ECU does not detect that the un–lock warning switch is ON even when the ignition switch is ON (Under the normal condition, the un–lock warning switch is ON when the ignition switch is ON).

DTC No.	DTC Detection Condition	Trouble Area
B2780	Un–lock warning switch ON is not detected when the ignition switch is ON	• Un–lock warning switch • Wire harness • Transponder key ECU assy

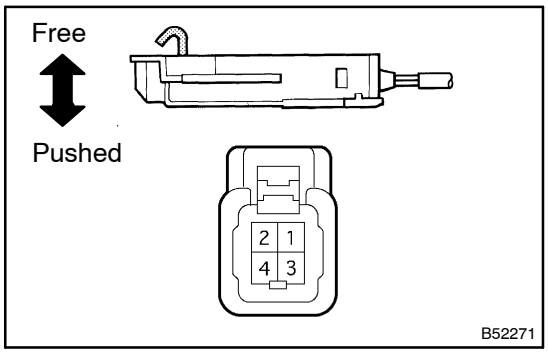
2	INSPECT UN–LOCK WARNING SWITCH ASSY

(a) Remove the un–lock warning switch.
(b) Inspect the un–lock warning switch continuity.
Standard:

Terminal No.	Condition	Specified Condition
1 ⇔ 2	Switch pushed (Key removed)	Continuity
	Switch free (Key set)	No continuity

NG → **REPLACE UN–LOCK WARNING SWITCH ASSY**
