| <b>DTC</b> | <b>B2798</b> | <b>Communication malfunction No. 2</b> |

## CIRCUIT DESCRIPTION

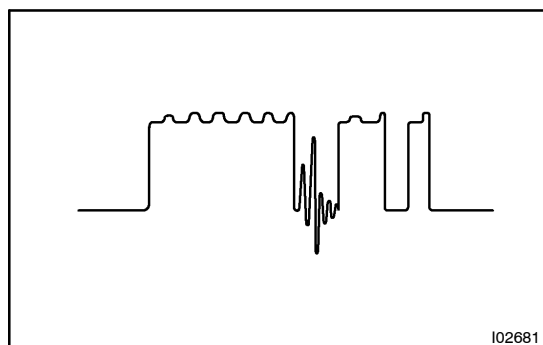
| 2 | <b>Noise check.</b> |

Insert the registered master key in the ignition key cylinder.

Using oscilloscope or the LEXUS hand-held tester, check that noise is included in the signals sent to the CODE terminal of the Transponder key ECU.
