| <b>DTC</b> | <b>B1218</b> | <b>Body ECU No. 2 communication stop</b> |

## CIRCUIT DESCRIPTION

This DTC is output when communication stops between the Body ECU (Sub) and the Body ECU (Main).

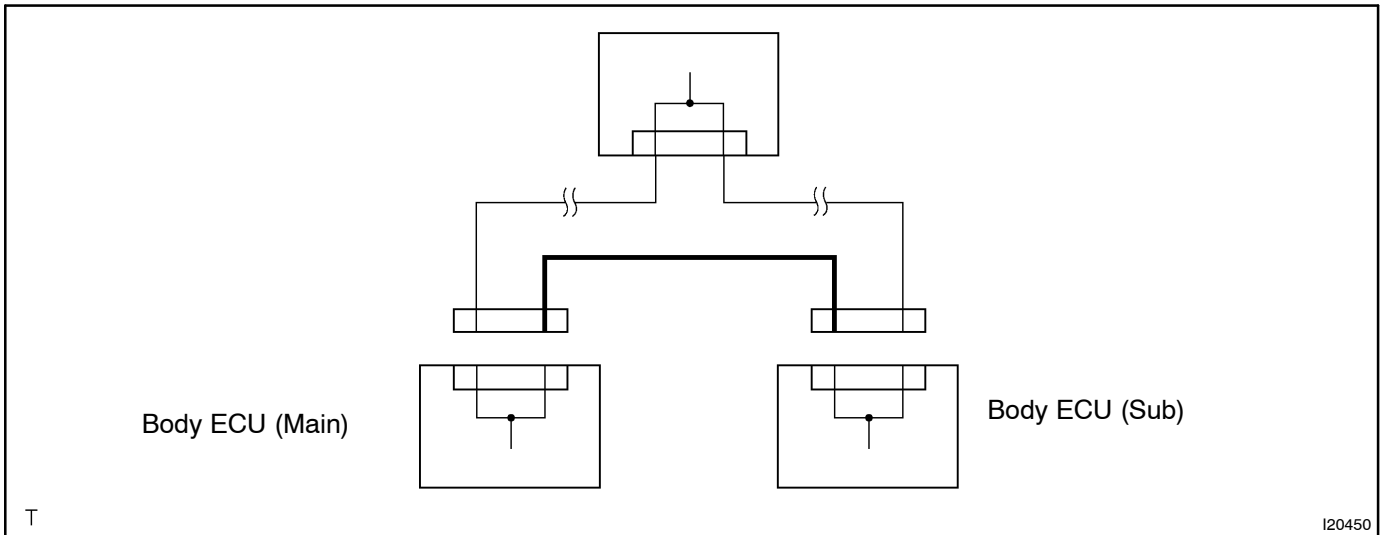
Pull out the ECU connectors below.

| Wire harness side connector of ECU | Terminal |
| Body ECU (Sub) – Body ECU (Main) | MPX+ (Z71-2) – MPX2 (B7-23) |

### CHECK:

Check continuity of the wire harness between the connectors.
