| <b>DTC</b> | <b>B2798</b> | <b>Communication malfunction No. 2</b> |

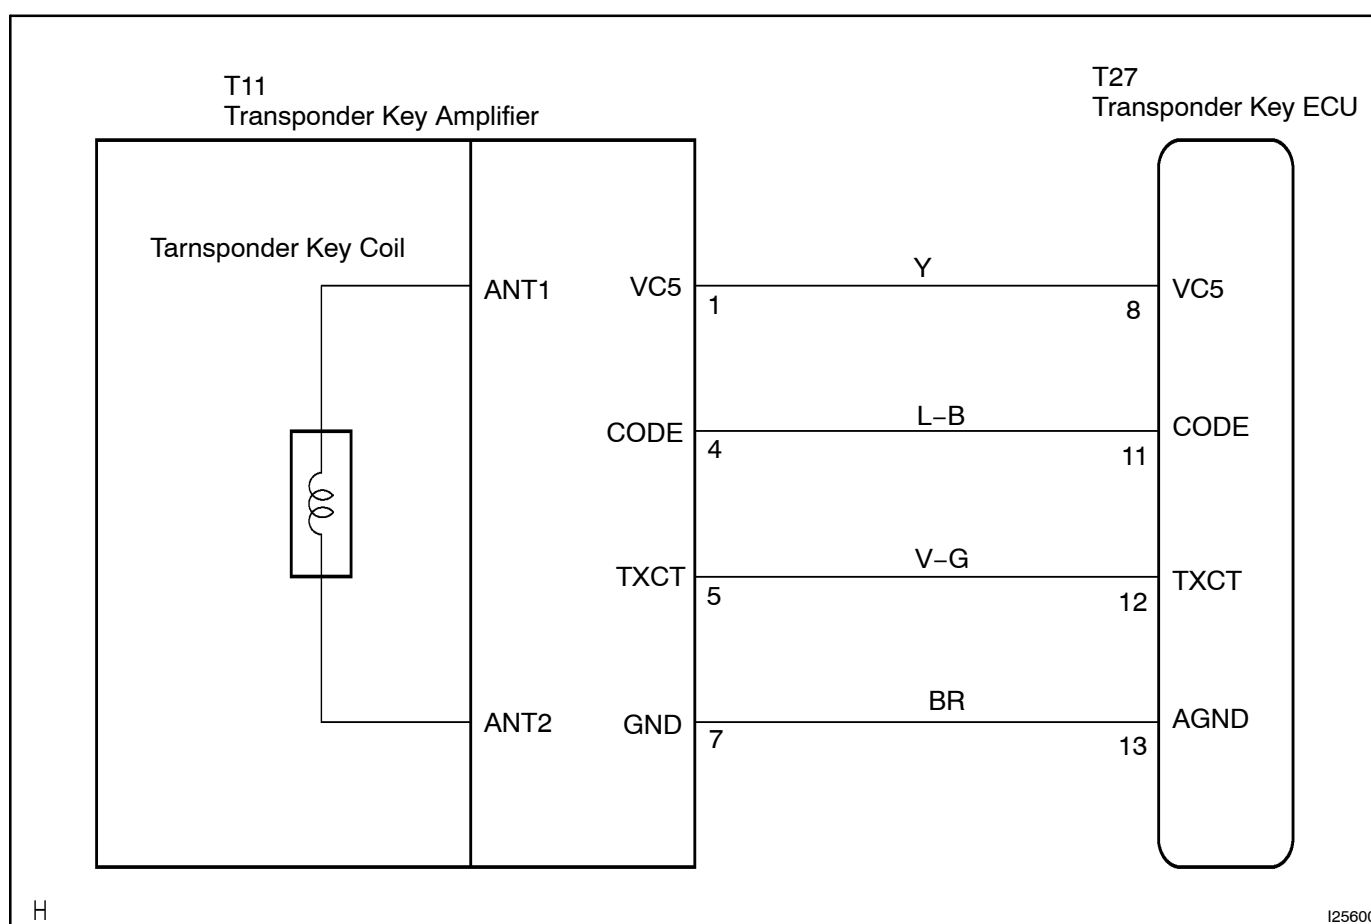
## WIRING DIAGRAM

This code is detected when an error occurs, although the communication is performed normally.  
(Example. Some noise is included in communication line.)

| DTC No. | DTC Detecting Condition | Trouble Area |
|---|---|---|
| B2798 | Communication error | <ul style="list-style-type: none"> <li>• Key</li> <li>• Transponder Key Amplifier with coil</li> <li>• Wire harness</li> <li>• Transponder key ECU</li> </ul> |

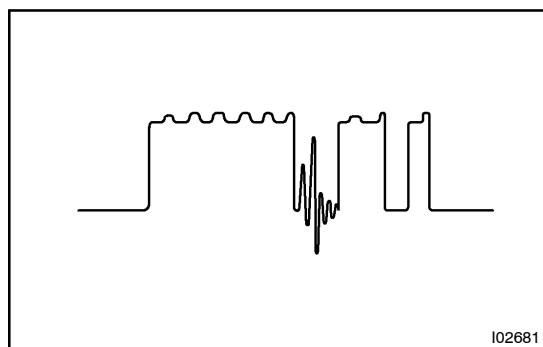
| 2 | <b>Noise check.</b> |

Insert the registered master key in the ignition key cylinder.

Using oscilloscope or the LEXUS hand-held tester, check that noise is included in the signals sent to the CODE terminal of the Transponder key ECU.

**No noise is detected.**
