| <b>DTC</b> | <b>6</b> | <b>"CODE 6. Loss of BEAN communication"</b> |

## CIRCUIT DESCRIPTION

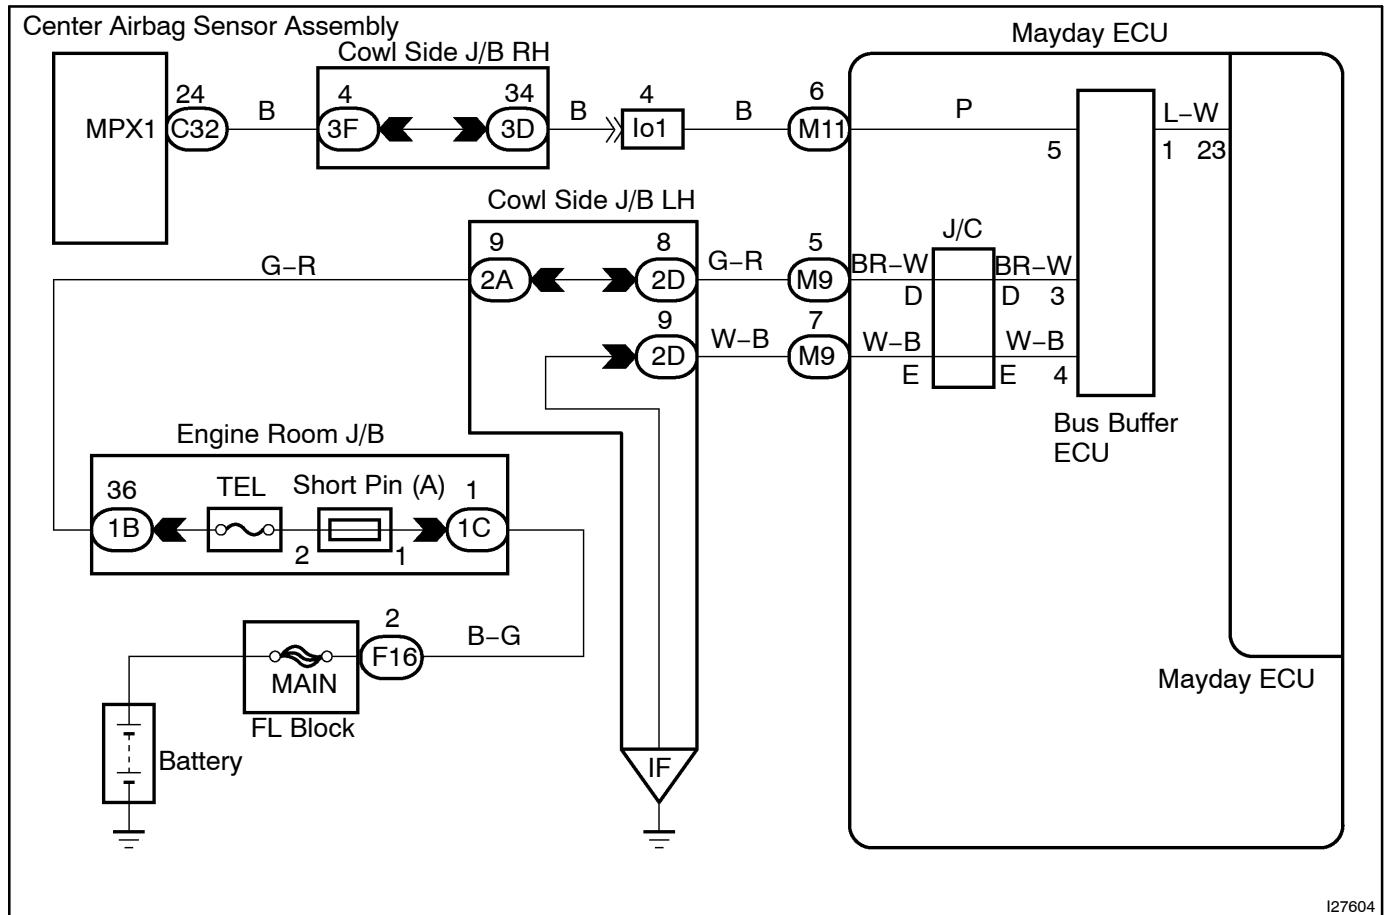
I27604

This DTC is output when communication from the airbag ECU is interrupted for 10 sec. or more. In this case, possible causes are communication interruption from the airbag ECU, a failure in the bus buffer ECU or a break of the harness between the bus buffer ECU and the telephone ECU (Mayday ECU).

## WIRING DIAGRAM

| 2 | Check for open and short circuit in wire harness and connector between telephone ECU (Mayday ECU) and bus buffer ECU (See page <a href="#">IN-36</a> ). |
