| <b>DTC</b> | <b>B1218</b> | <b>Body ECU No. 2 communication stop</b> |

This DTC is output when communication stops between the Body ECU (Sub) and the Body ECU (Main).

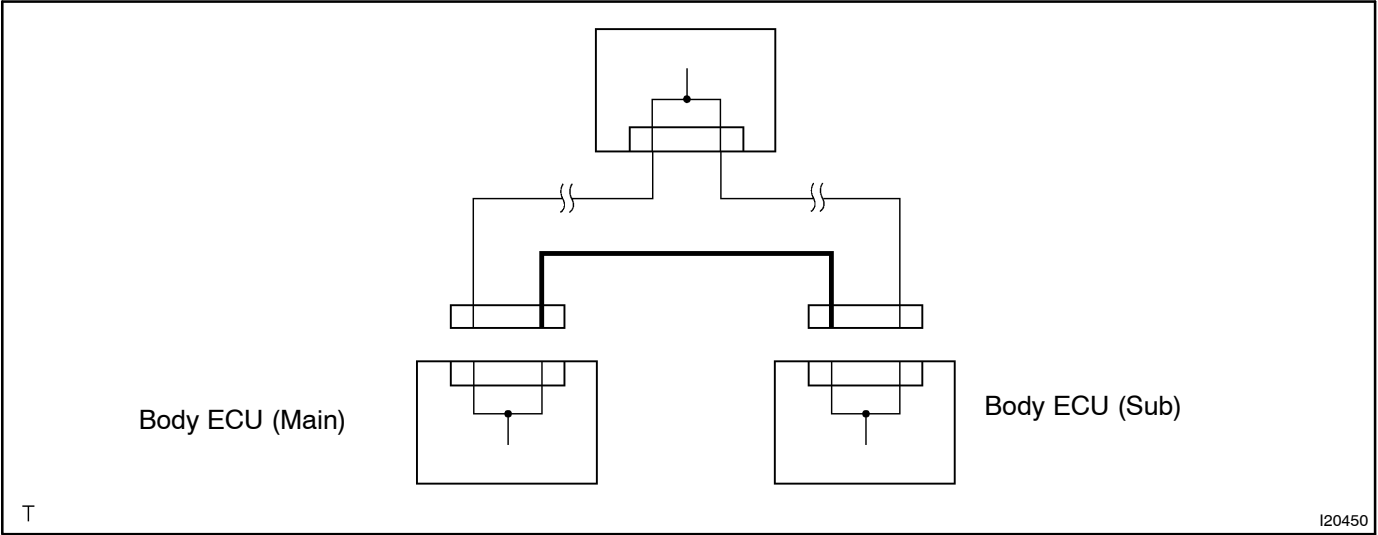
Pull out the ECU connectors below.

| Wire harness side connector of ECU | Terminal |
|---|---|
| Body ECU (Sub) – Body ECU (Main) | MPX+ (Z71-2) – MPX2 (B7-23) |

Check continuity of the wire harness between the connectors.

There is a continuity between the connectors.
