# SERVICE BULLETIN

| <b>SERVICE BULLETIN</b> | | No.: ESB-96E11-502 | |
| <b>Subject:</b> | OMISSION OF TIGHTENING TORQUE OF A/C COMPRESSOR TENSION PULLEY FIXING BOLT | CARISMA | 96-10 |

This Service Bulletin informs you that omission has been rectified of the tightening torque of A/C compressor tension pulley fixing bolt under Service DRIVE BELT TENSION CHECK AND ADJUSTMENT in Group 11A of the Workshop Manual.

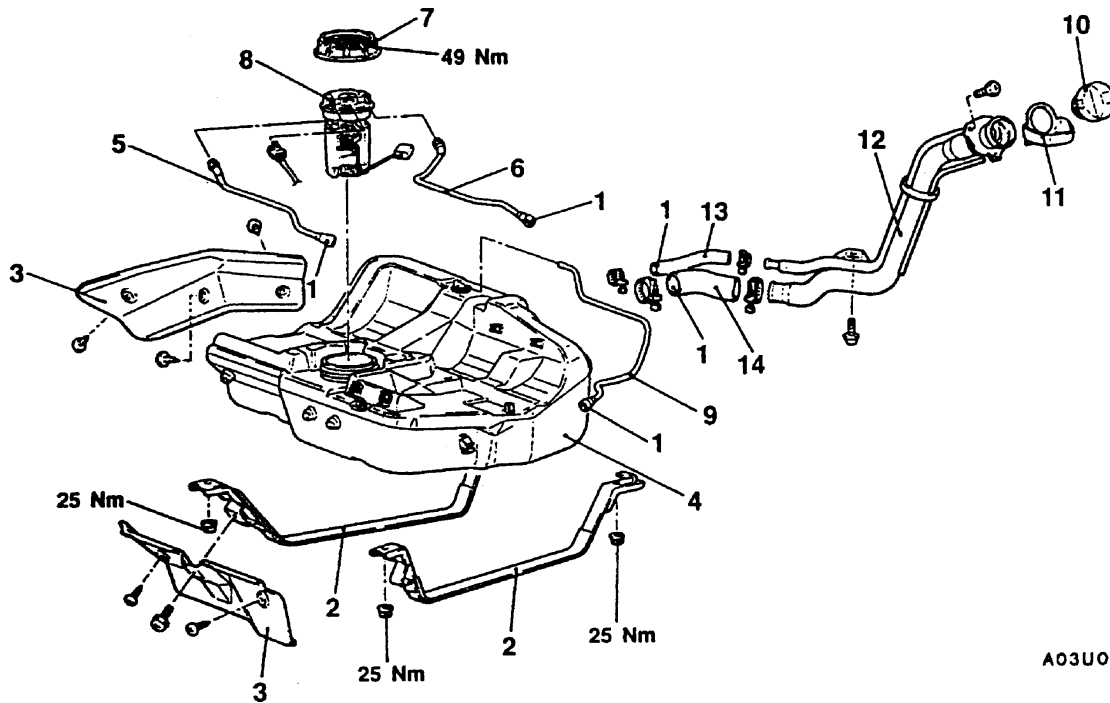
A03U0015

#### Removal steps

1. Hoses Connection
2. Band
3. Protector
4. Fuel tank assembly
5. Fuel main hose
6. Fuel return hose
7. Cap

8. Fuel pump module
9. Fuel vapor hose
10. Fuel Filler cap
11. Fuel rubber drain
12. Filler neck assembly
13. Leveling hose
14. Filler hose

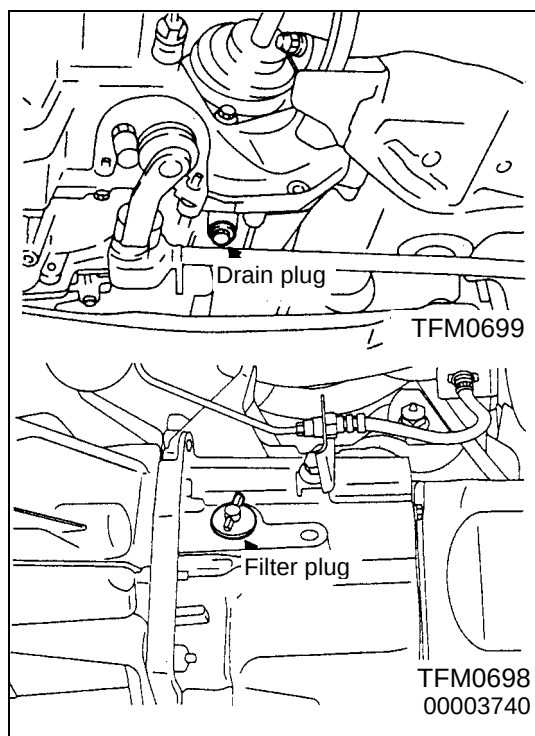
Tighten filler plug firmly by hand.  
(reference tighten torque: 2.25 Nm)

Inspect each component for evidence of leakage, and check the oil level by remaining the filler plug. If the oil is contaminated, it is necessary to replace it with new oil.

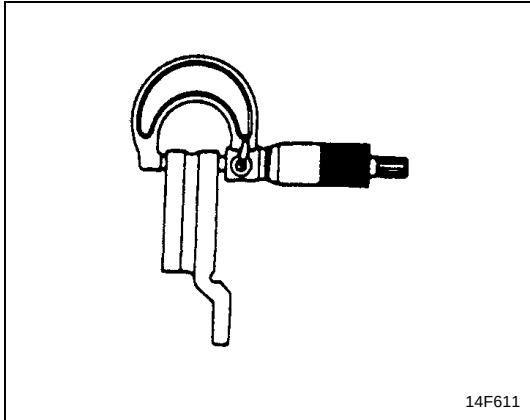
The difference between any thickness measurements should not be more than 0.015 mm.

2. If the disc is beyond the limits for thickness, remove it and install a new one. If thickness variation exceeds the specification, replace the brake disc or turn rotor with on the car type brake lathe ("MAD, DL-8700PF" or equivalent).

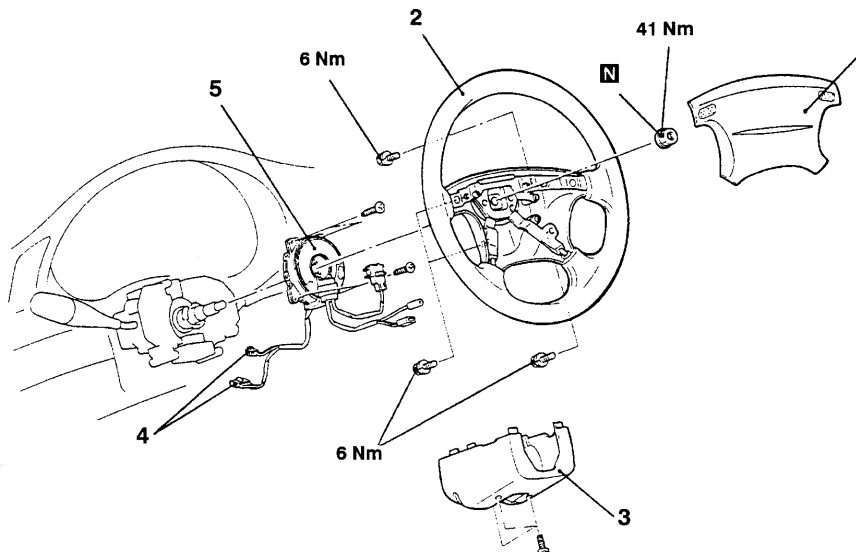
S19X0566

#### Clock spring removal steps
