# CHASSIS ELECTRICAL

# IMMOBILIZER SYSTEM

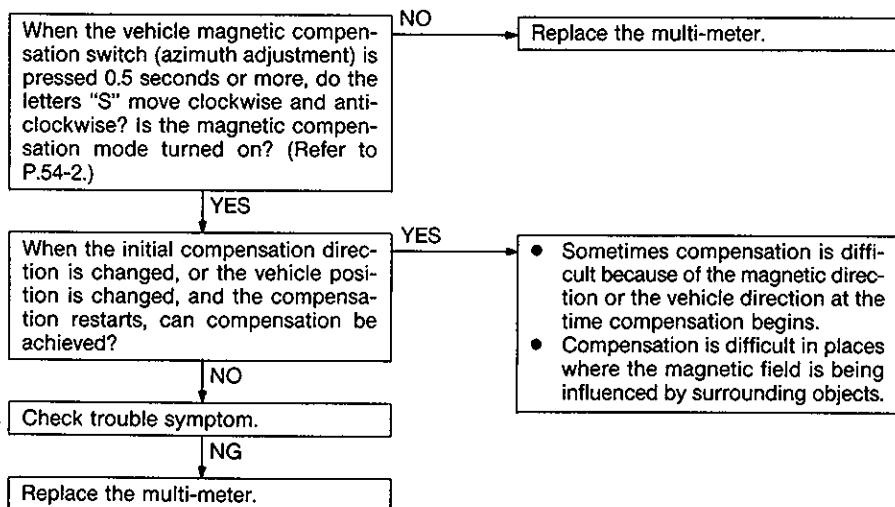
Vehicle magnetic compensation cannot be made.	Probable cause
The multi-meter may be defective.	<ul style="list-style-type: none"> <li>● Defective multi-meter</li> </ul>

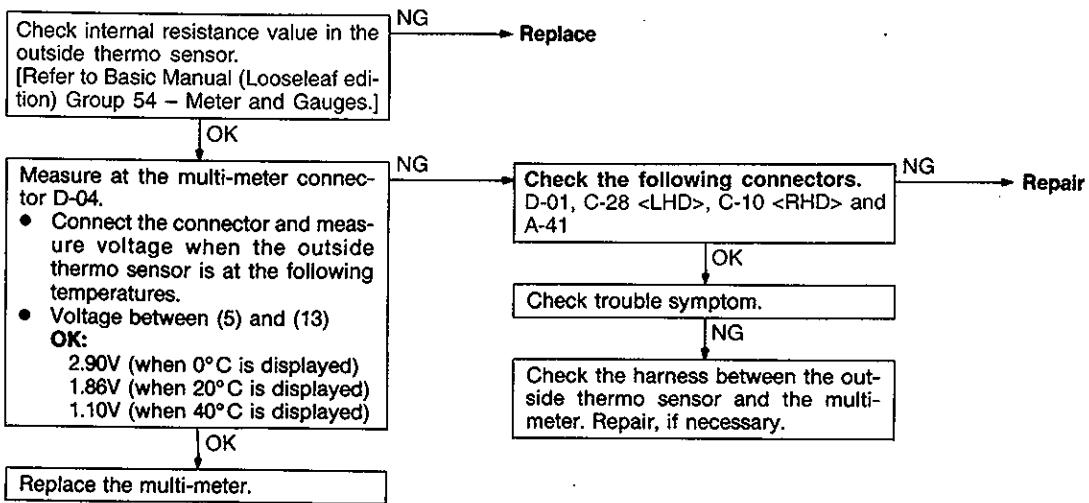
Discrepancy between the outside temperature and the display temperature	Probable cause
The outside thermo sensor, multi-meter, harness, or connector may be defective.	<ul style="list-style-type: none"> <li>● Defective outside thermo sensor</li> <li>● Defective multi-meter</li> <li>● Defective harness or connector</li> </ul>

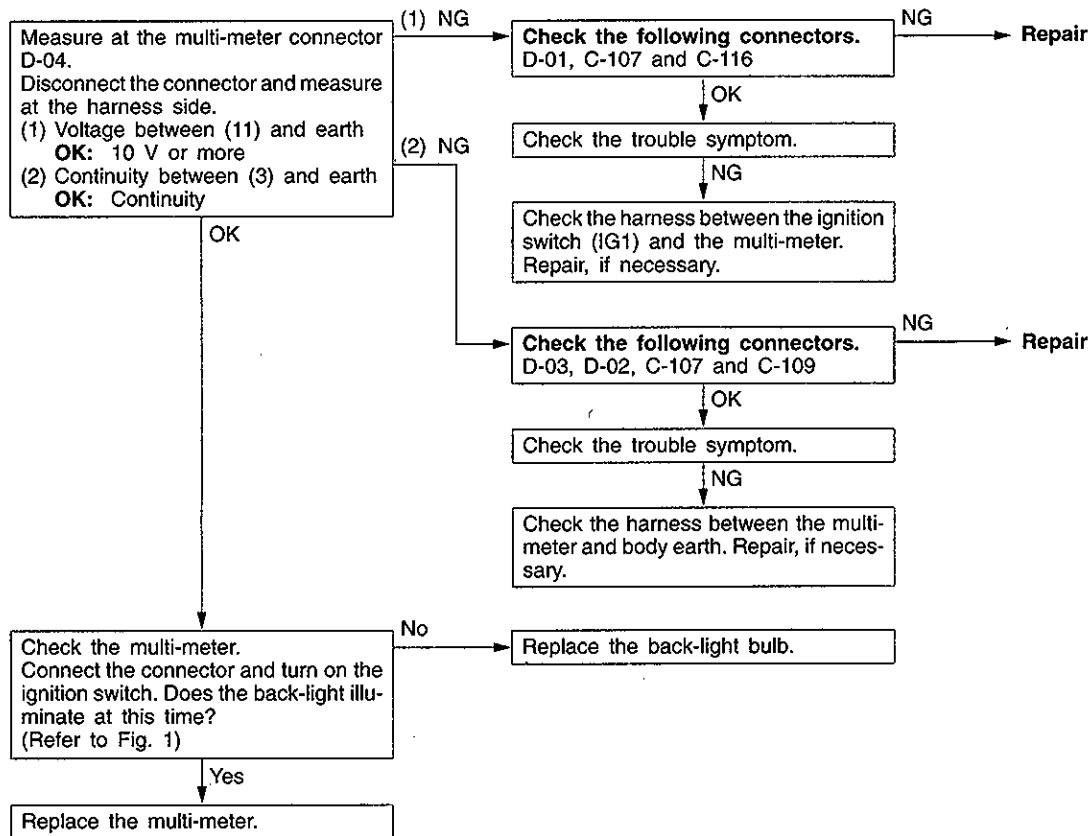
Display is hard to see or no display appears.	Probable cause
The multi-meter, harness, or connector may be defective.	<ul style="list-style-type: none"> <li>Defective multi-meter</li> <li>Defective harness or connector</li> </ul>

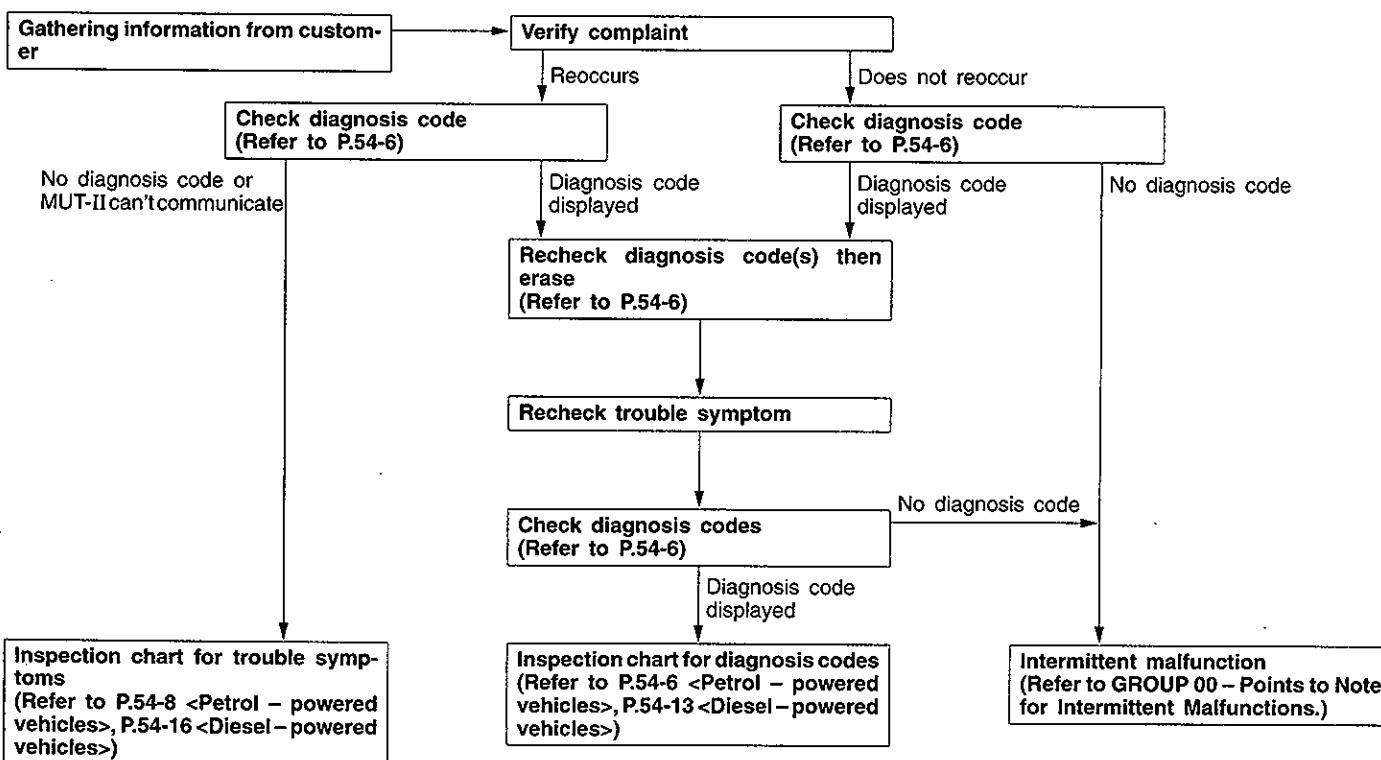
## TROUBLESHOOTING <PETROL-POWERED VEHICLES> STANDARD FLOW OF DIAGNOSTIC TROUBLESHOOTING

- The ID code should always be re-registered when replacing the immobilizer-ECU.

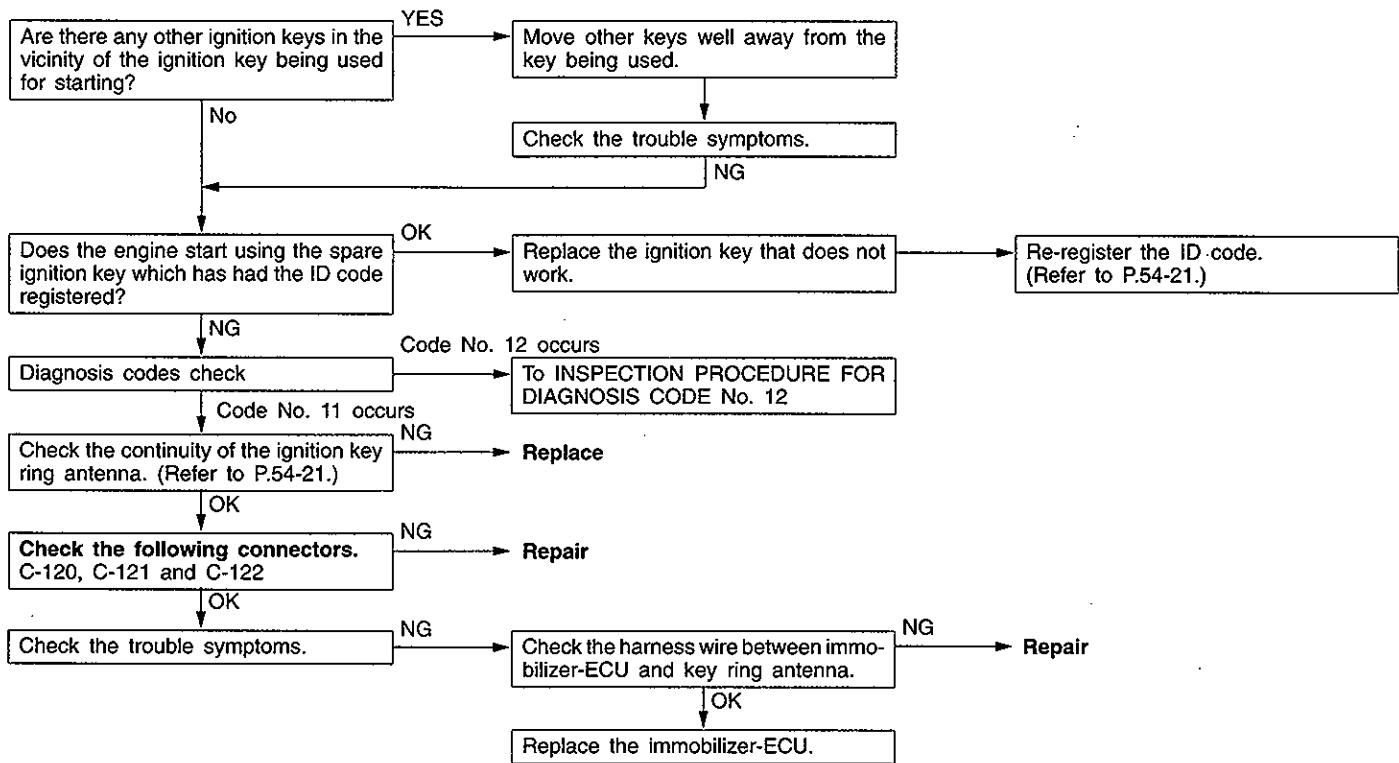
Code No. 11 Transponder communication system	Probable cause
<ul style="list-style-type: none"> <li>The ID code of the transponder is not sent to the immobilizer-ECU immediately after the ignition switch is turned to the ON position.</li> <li>If the engine is started while several ignition keys are in the vicinity, then interference between the different keys may occur, which will cause this code to be generated.</li> </ul>	<ul style="list-style-type: none"> <li>ID code interference</li> <li>Malfunction of the transponder</li> <li>Malfunction of the ignition key ring antenna</li> <li>Malfunction of harness or connector</li> <li>Malfunction of the immobilizer-ECU</li> </ul>

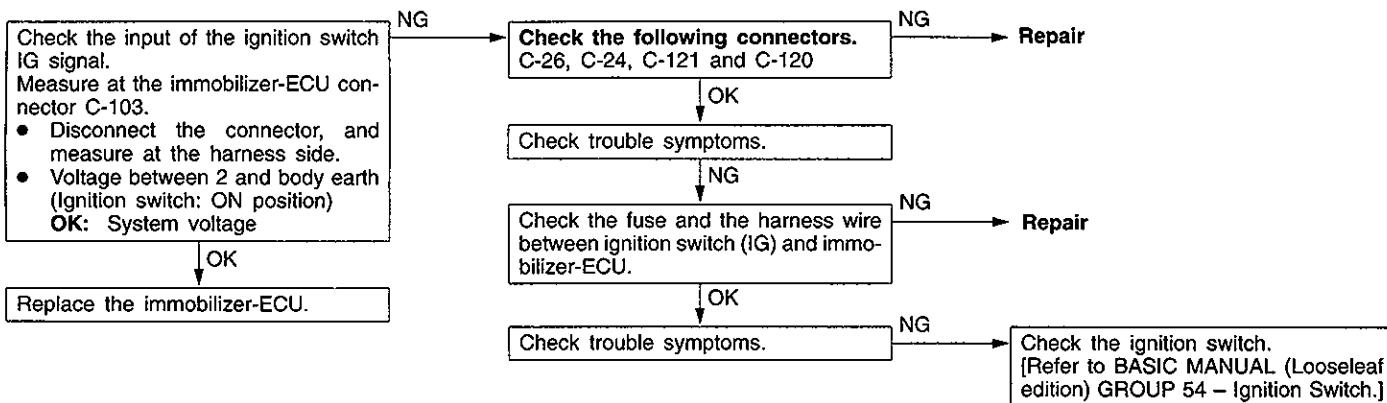
Code No. 32 Ignition switch IG signal circuit system	Probable cause
The ignition switch signal is not being input to the immobilizer-ECU.  Check the input of the ignition switch IG signal. Measure at the immobilizer-ECU connector C-103. <ul style="list-style-type: none"><li>• Disconnect the connector, and measure at the harness side.</li><li>• Voltage between 2 and body earth (Ignition switch: ON position) OK: System voltage</li></ul>	<ul style="list-style-type: none"> <li>• Malfunction of harness or connector</li> <li>• Malfunction of the ignition switch</li> <li>• Malfunction of the immobilizer-ECU</li> </ul>

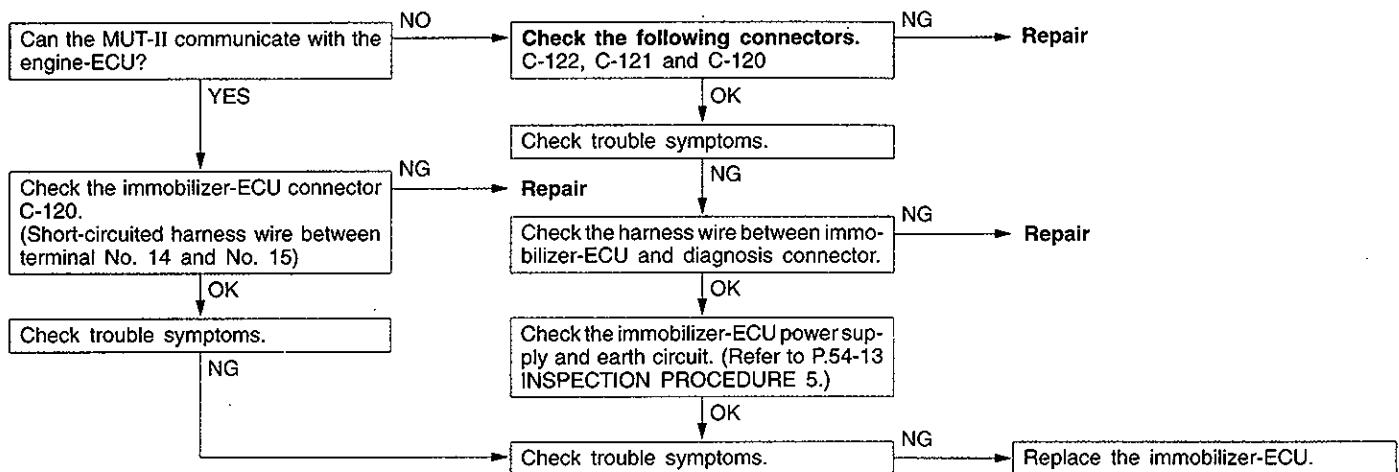
## Inspection Procedure 1

Communication with MUT-II is impossible.	Probable cause
The cause is probably that a malfunction of the diagnosis line or the immobilizer-ECU is not functioning.	<ul style="list-style-type: none"> <li>Malfunction of the diagnosis line</li> <li>Malfunction of harness or connector</li> <li>Malfunction of the immobilizer</li> </ul>

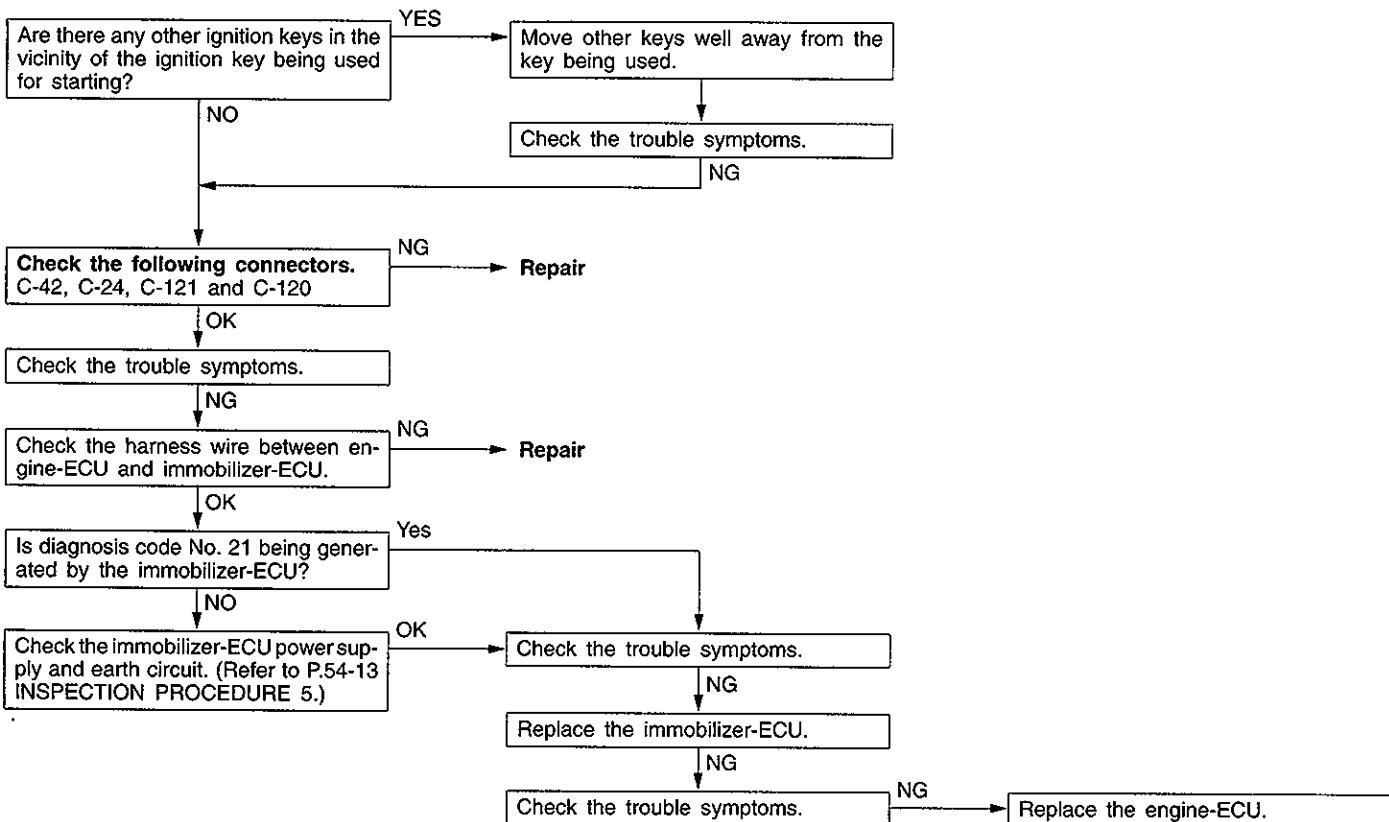
## Inspection Procedure 2

Diagnosis code No. 54 has been generated by the engine-ECU.	Probable cause
<ul style="list-style-type: none"> <li>There is a problem with communication between the engine-ECU and the immobilizer-ECU.</li> <li>If the engine is started while several ignition keys are in the vicinity, then interference between the different keys may occur, which will cause this code to be generated.</li> <li>This code may be generated when registering the ID code.</li> </ul>	<ul style="list-style-type: none"> <li>ID code interference</li> <li>Non-identical ID codes</li> <li>Malfunction of harness or connector</li> <li>Malfunction of the immobilizer-ECU</li> <li>Malfunction of the engine-ECU</li> </ul>

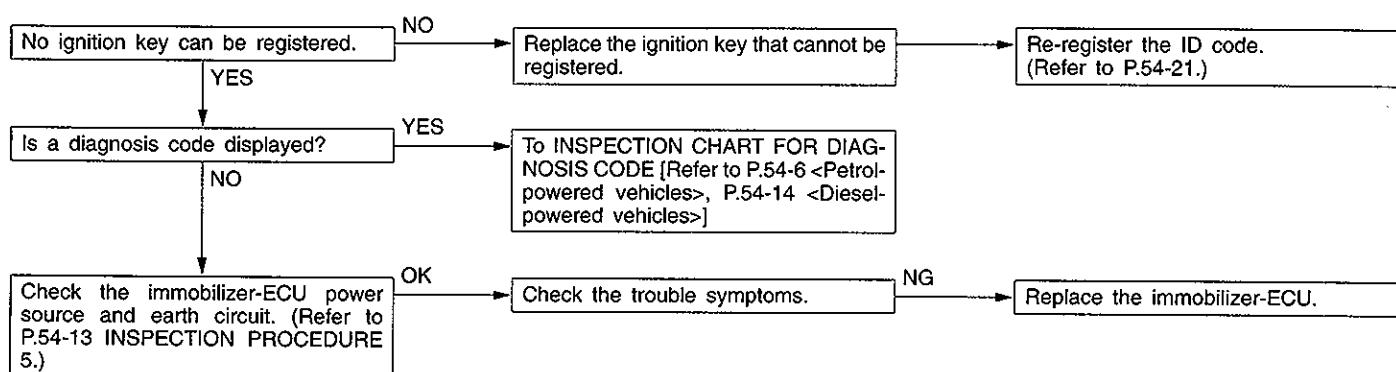
## Inspection Procedure 3

ID code cannot be registered using the MUT-II.	Probable cause
The cause is probably that there is no ID code registered in the immobilizer-ECU, or there is a malfunction of the immobilizer-ECU.	<ul style="list-style-type: none"> <li>Malfunction of the transponder</li> <li>Malfunction of the ignition key ring antenna</li> <li>Malfunction of the harness or connector</li> <li>Malfunction of the immobilizer-ECU</li> </ul>

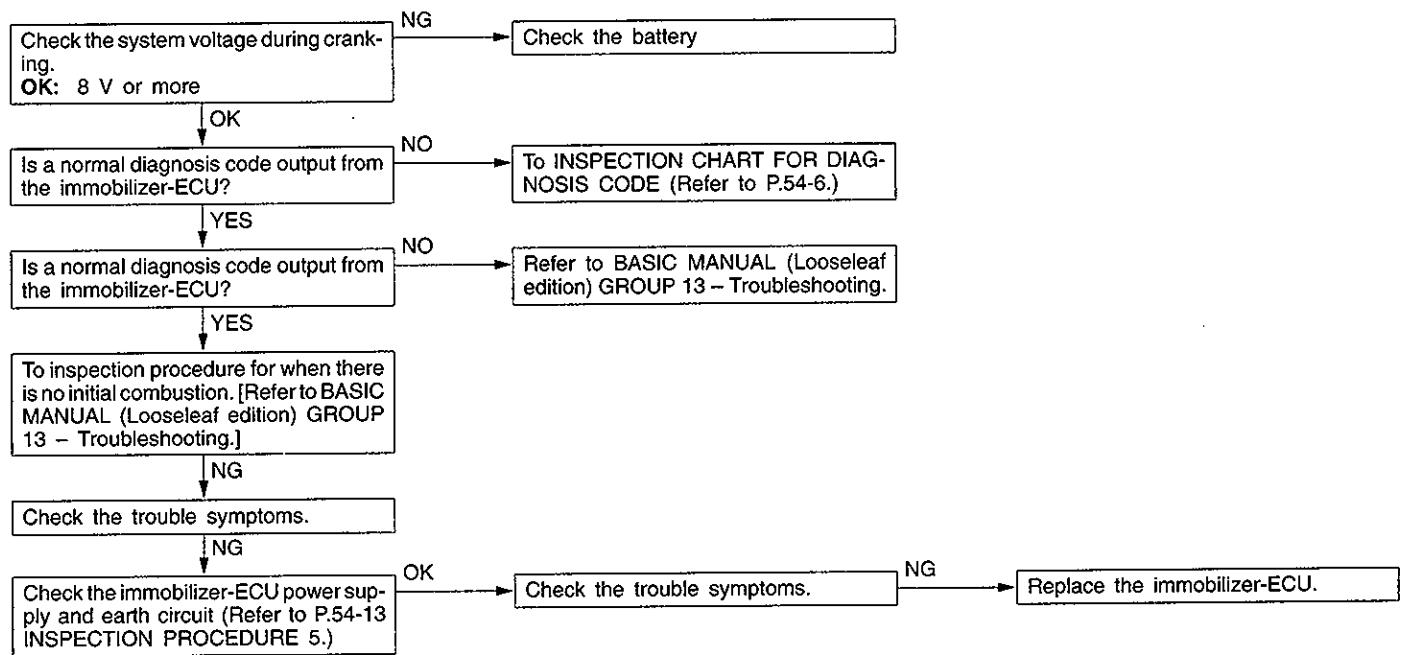
## Inspection Procedure 4

Engine does not start (cranking but no initial combustion).	Probable cause
<p>If the fuel injectors are not operating, there might be a problem with the MPI system in addition to a malfunction of the immobilizer system. It is normal for this to occur if an attempt is made to start the engine using a key that has not been properly registered.</p>	<ul style="list-style-type: none"> <li>• Malfunction of the MPI system</li> <li>• Malfunction of the immobilizer-ECU</li> </ul>

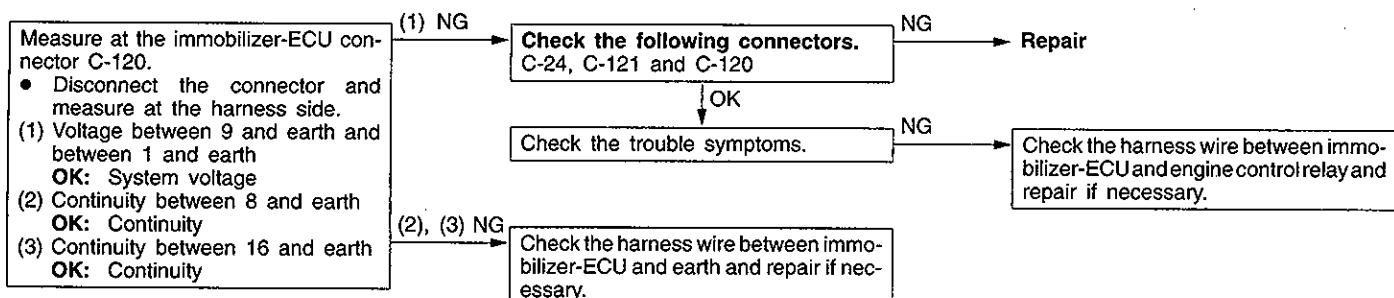
## Inspection Procedure 5

## Malfunction of the immobilizer-ECU power supply and earth circuit

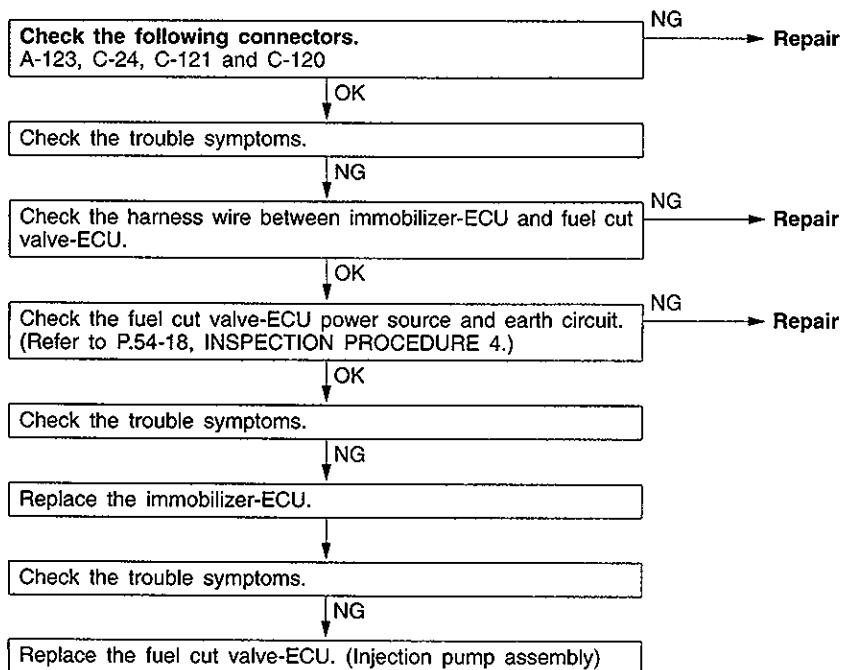
Code No. 21 Communication system between fuel cut valve-ECU and immobilizer-ECU	Probable cause
<p>The confirmation code is not sent from the fuel cut valve-ECU within the specified time after the ignition key is turned to ON, or an incorrect code is sent.</p>	<ul style="list-style-type: none"> <li>Open or short communication line, poor contact of connector</li> <li>Malfunction of fuel cut valve-ECU</li> <li>Malfunction of immobilizer-ECU</li> </ul>

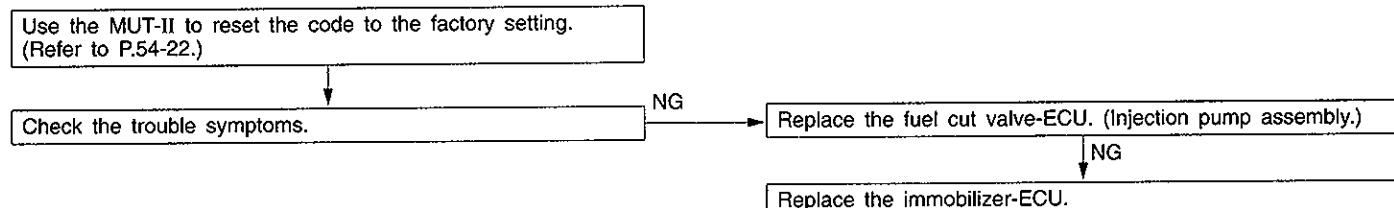
No. 23 Starting permission codes are not identical	Probable cause
The starting permission code received from the immobilizer-ECU is not identical to the starting permission code that has been recorded in the fuel cut valve ECU.	<ul style="list-style-type: none"> <li>Resetting the code to the factory setting is not made using the MUT-II.</li> <li>Malfunction of fuel cut valve-ECU.</li> </ul>

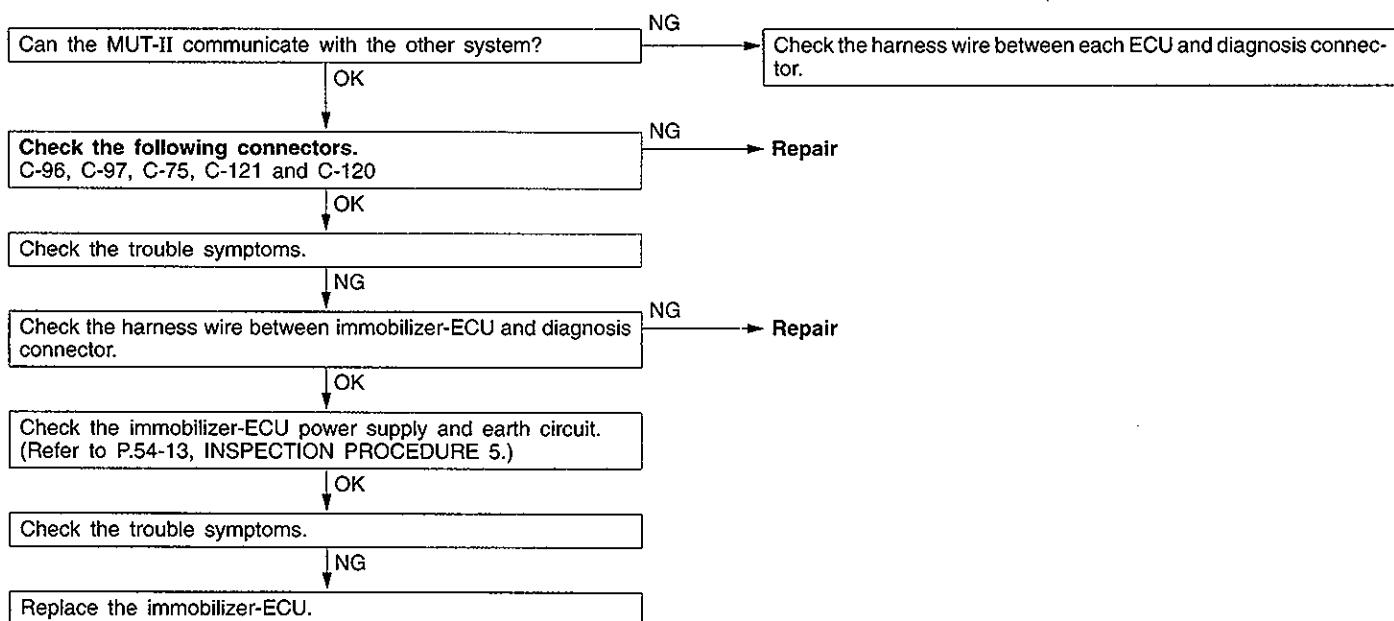
## Inspection procedure 1

Communication with MUT-II is impossible.	Probable cause
The cause is probably that a malfunction of the diagnosis line or the immobilizer-ECU is not functioning.	<ul style="list-style-type: none"> <li>• Malfunction of connector</li> <li>• Malfunction of diagnosis line</li> <li>• Malfunction of immobilizer-ECU power source</li> <li>• Malfunction of immobilizer-ECU</li> </ul>

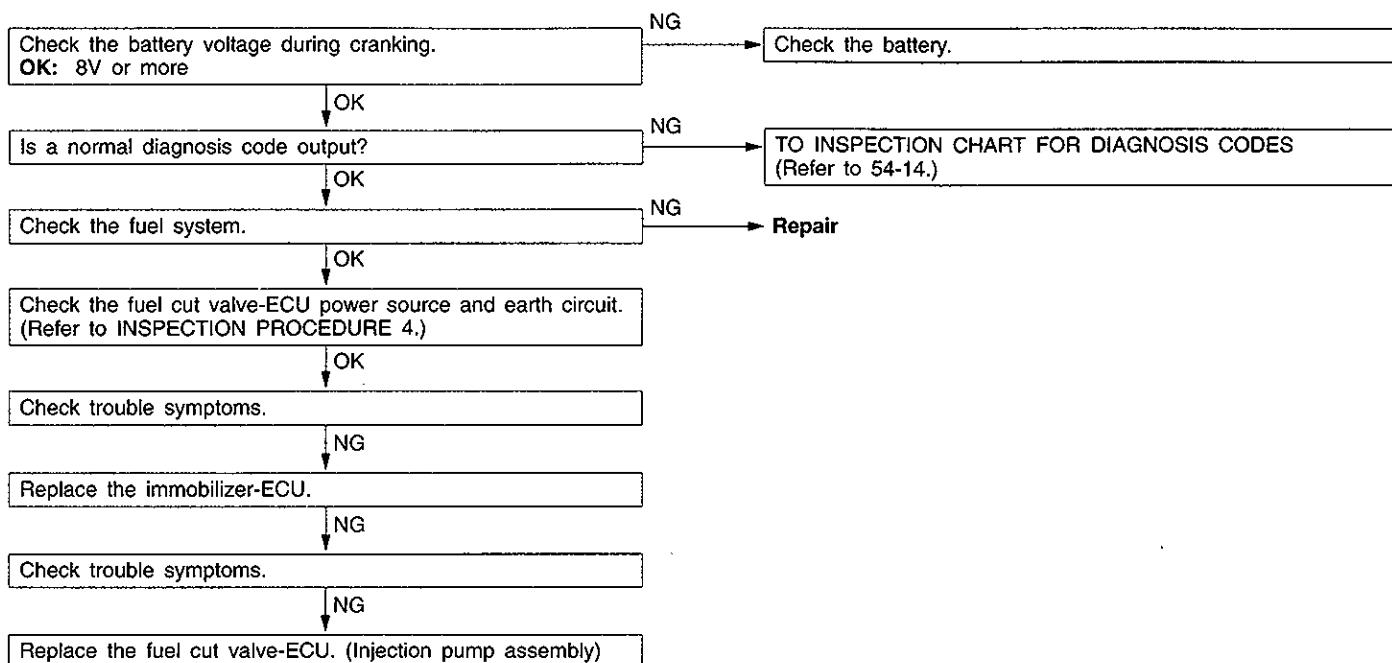
## Inspection procedure 2

Engine does not start. (Engine stops after firing momentarily Cranking but no initial combustion.)	Probable cause
If the fuel injectors are not operating, there might be a problem with the fuel system in addition to a malfunction of the immobilizer system. It is normal for this to occur if an attempt is made to start the engine using the key that has not been properly registered.	<ul style="list-style-type: none"> <li>Malfunction of fuel system</li> <li>Malfunction of immobilizer system</li> </ul>

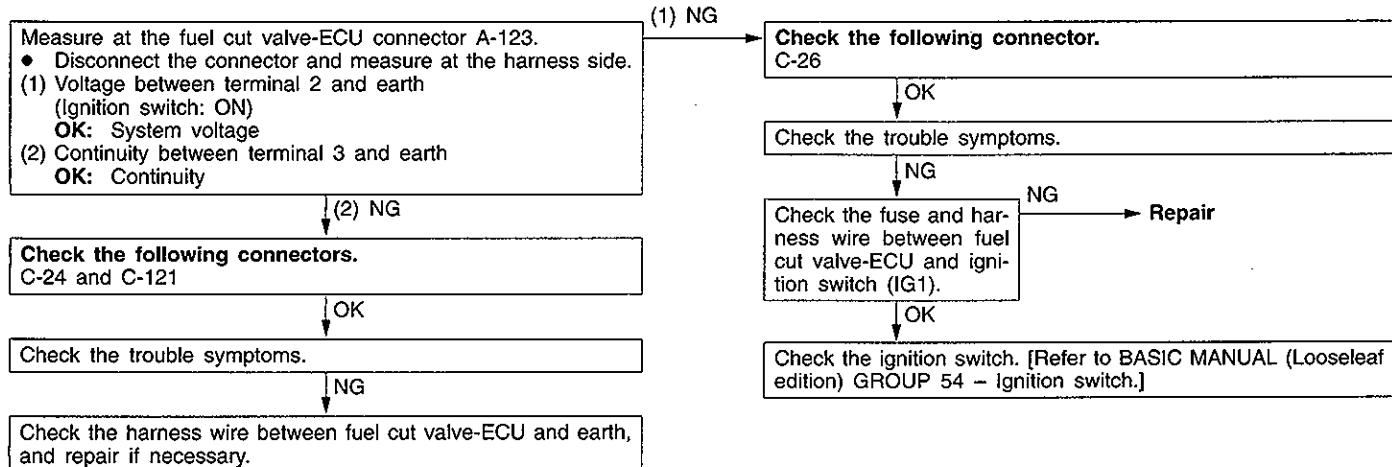
## Inspection procedure 4

## Fuel cut valve-ECU power supply and earth circuit

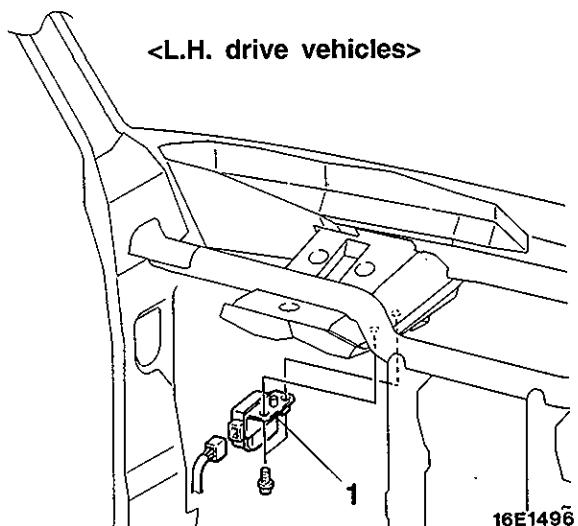
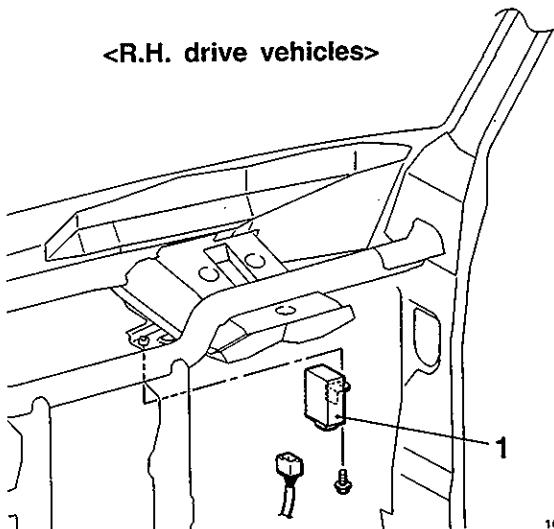
**Immobilizer-ECU removal steps**

- Instrument panel [Refer to BASIC MANUAL (Looseleaf edition) GROUP 52A – Instrument Panel.]

1. Immobilizer-ECU

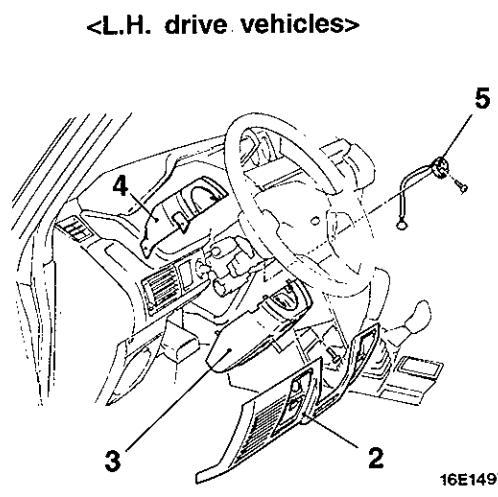
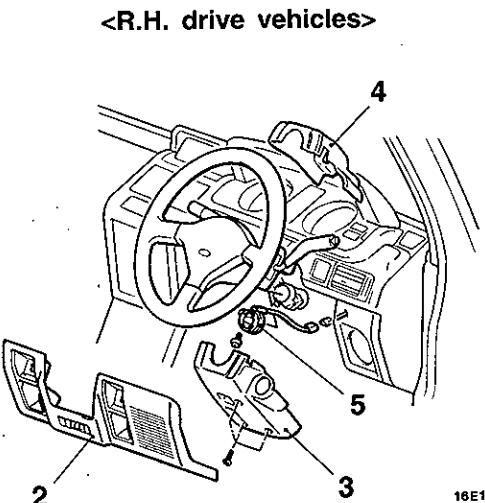
**Ignition key ring antenna removal steps**

2. Instrument under cover [Refer to BASIC MANUAL (Looseleaf edition) GROUP 52A – Instrument Panel.]
3. Column cover lower
4. Column cover upper
5. Ignition key ring antenna
