2.5 Liter Twin Cam Timing Belt Replacement

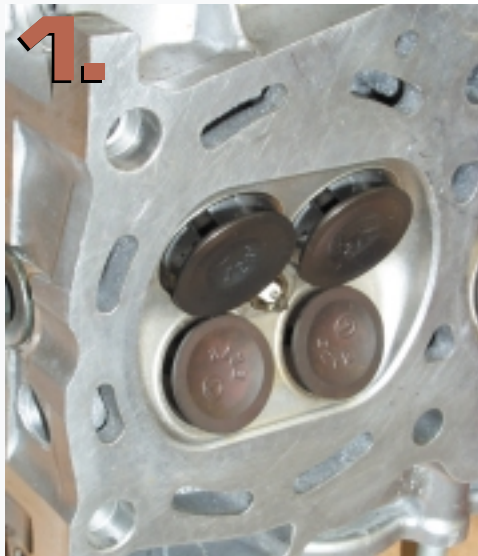
We've removed a 2.5 cylinder head to show just how crowded it is in the combustion chamber area. Each intake valve has its own cam lobe. The intake valve timing is slightly staggered, so one intake valve begins to open and close slightly ahead of its partner. If the intake and exhaust cams are allowed to get out of time in relation to one another, intake and exhaust valves will collide in the combustion chamber area. Intake valves in four-valve heads are necessarily small, and more easily damaged than similar components on two-valve engines. A collision between valves, even when the engine is not running (during a timing belt replacement for example), can cause valve damage. The object is to finish the job with the engine running at least as well as it was before you started, which is why it's so important to approach this job with the necessary caution and the proper tools.

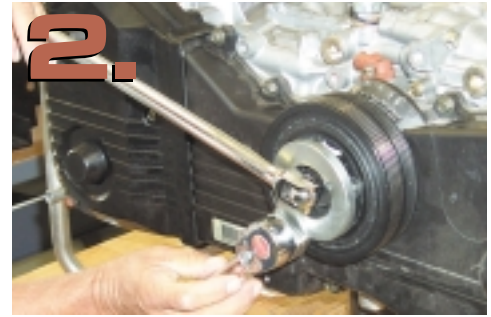
A special crankshaft pulley wrench (ST 499977100) is necessary to lock

the crankshaft while removing and installing the crankshaft pulley bolt. If you don't own this tool, you may be tempted to blast the pulley bolt with an impact wrench. While this method may *remove* the bolt, using an impact wrench to *reinstall* the bolt may cause serious engine damage. Over-tightening the bolt may cause the bolt to stretch and/or break. Over-tightening may also cause damage to the crankshaft snout. There have been reports of crankshaft snouts that have sheared off after incorrect pulley bolt installation. Use the proper tools and torque the bolt to the proper specification.

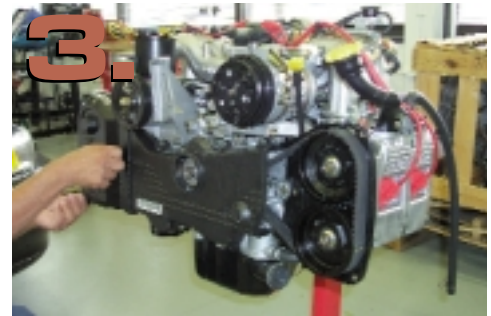
A three-piece outer belt cover set protects the timing belt. Fourteen bolts hold the covers in place. The left and right covers must be removed first, then the center section. Most of the bolts thread into captive nuts in the back sides of the cover set. Use a 1/4-inch drive socket set to remove the bolts and take your time. If the bolts feel tight, try tightening slightly before removing them. This will prevent damage to the captive nuts, which will make it easier to put the covers back in place and will make it easier for the next guy too.

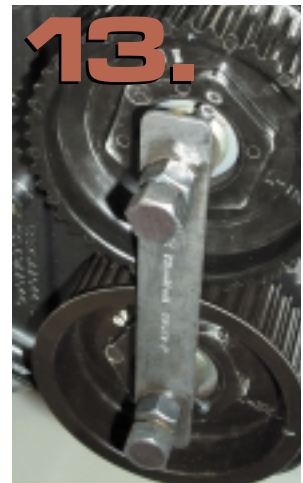
So do you put it all back together and close the hood? No. Not if you've got the proper tools. This tool fits over the large hexes on the upper and lower camshaft sprockets on the right side of the engine. The tool effectively locks the two sprockets together, keeping them from turning as long as it's in place.

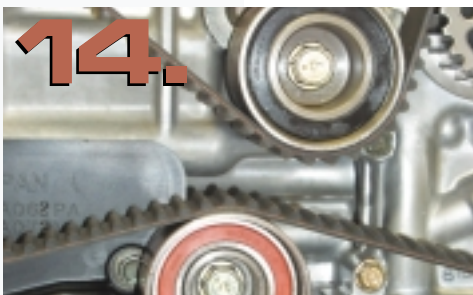
Things are even more interesting on the left side of the engine. This is the side of the engine where things really want to move when the timing belt is removed. This tool locks onto the upper and lower sprocket bolts using small set screws. Jam nuts at the top and bottom of the tool are used to lock the cam pulleys in place, while loosening them allows the pulleys to be moved independently using a hex wrench. Everything should be locked down solidly to prevent pulley movement before removing the timing belt.

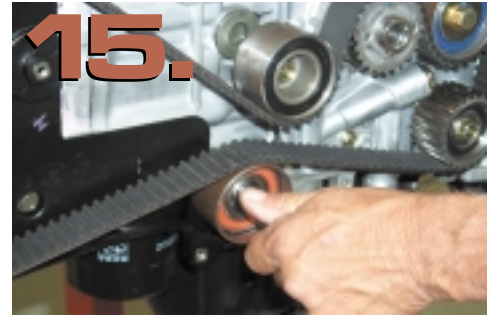
The 2.5 engine's timing belt must negotiate a combination of three idler pulleys, the water pump pulley and the tensioner pulley during each rotation. Pay particular attention to the position and appearance of the different idler pulleys, especially if you happen to remove more than one for any reason. They all look very similar to one another, but each pulley is designed for installation in a particular location. Different colors may or may not be used in different locations, but this isn't necessarily a reliable guide, as the pulleys can still be accidentally installed in the wrong location. Incorrectly installed pulleys can make unusual noises and fail prematurely. To avoid confusion, mark the pulleys with an indelible marker with the letter 'T' for top or 'B' for bottom. It's a simple step that will buy you a lot of piece of mind.

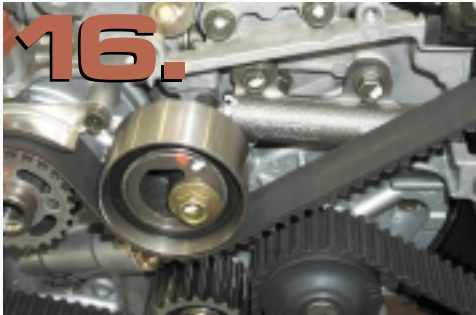
The idler pulley with the least amount of belt tension on it is the lower right idler pulley, which makes it the best candidate for removal when removing the timing belt. This is an all-aluminum engine, so it pays to be careful when removing and installing fasteners. Since the lower pulley isn't under a lot of stress, its mounting bolt can be removed and installed without risk of cross-threading or other damage.

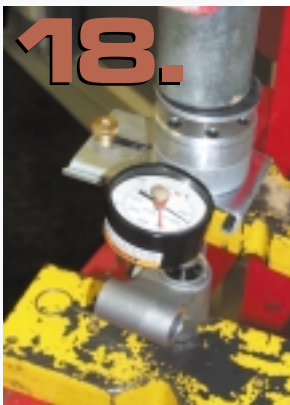
- Secure the tensioner in a press. This photo shows the recommended setup. An ABS brake pedal force gauge is inserted between the press rod and the adjuster piston. A small pin fits between the force gauge and the adjuster rod, assuring that all press force is directed to the adjuster rod. Use press plates to make sure the tensioner assembly is square and that no press force is directed to the tensioner pulley assembly.
- Slowly press the adjuster rod down to the end surface of the tensioner surface. Repeat this motion two or three times.
- Allow the adjuster rod to extend fully, then apply a pressure of 66 psi to the rod. Check the tensioner for resistance.
- If no resistance is felt and the adjuster rod moves down freely, replace the tensioner with a new one.
- Release the press and allow the adjuster rod to move up.

The tensioner rod must be compressed using a hydraulic press. The pressure exerted on the rod must not exceed 66 pounds. Exceeding this pressure may bend the tensioner rod. This will keep the rod from extending fully when it is reinstalled on the engine. If the rod cannot extend fully, excessive slack may develop in the timing belt, causing it to jump teeth. Jumped teeth can mean bent valves or damaged pistons, something you'll certainly want to avoid.

- Measure the extension of the adjuster rod beyond the body. Replace the tensioner if it is beyond the specification of 6.0 mm \pm 0.5 mm.
- Check the condition of the tensioner and pulley contact surface, bearing operation and grease leakage. Replace the tensioner if any abnormality is found.
- If the tensioner passes inspection to this point, slowly move the rod down with a force of 66 pounds. Up to 10 minutes of slow pumps on the press lever may be necessary to fully retract the adjuster rod. Pump the lever until the pressure reaches 66 psi, then allow the pressure to drop before giving it another slow pump.
- Stop when the adjuster rod is fully retracted (flush with the tensioner body). Pushing beyond this point will damage the tensioner. A 2 mm retaining pin should fit easily through the holes in the tensioner housing and adjuster rod.

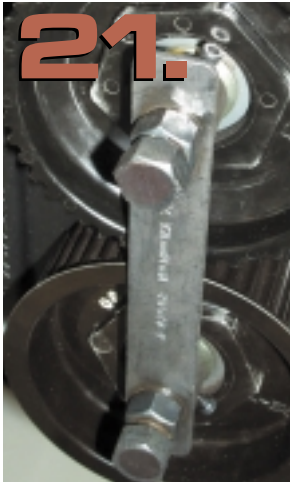
21. The holding tool on the left side of the engine is adjustable. Adjustment on this side of the engine is necessary because the tensioner is on the left side. Until the tensioner locking pin is removed, most of the belt slack will also be on this side of the engine. Counting the belt teeth and lining up the sprocket timing marks may produce what looks like a slightly 'wrong' lineup on the twin facing timing marks between the left cam sprockets. The problem is further aggravated by the fact that the holding tool blocks your view of the twin timing marks between the cam sprockets. If you've counted your teeth properly, all of the marks should come into alignment following the next couple of steps.

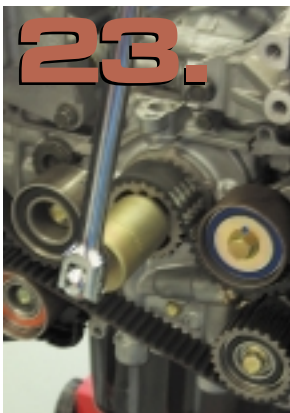
23. Remove both cam sprocket holding tools, then install the crankshaft turning socket. Turn the crankshaft 90 degrees counterclockwise, then 180 degrees clockwise, before returning the crankshaft sprocket to its alignment mark. This combination of movements allows the tensioner to take the slack out of the new belt and normalizes its position on the assortment of sprockets and idlers.

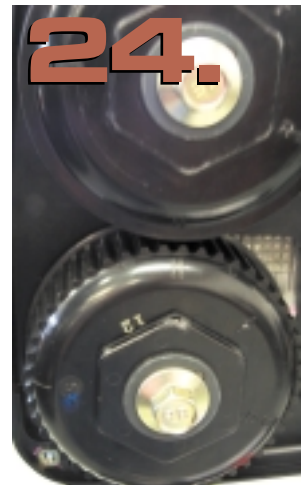
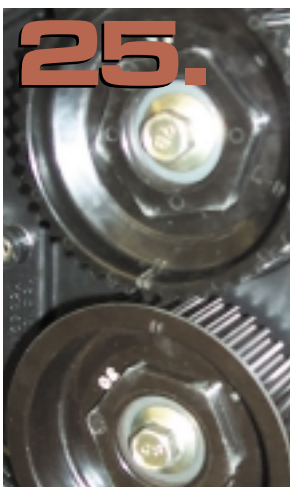
25. The timing marks on this engine lined up everywhere but here at the left cam sprocket match marks. After normalizing the belt by rotating it, the upper and lower pulley match marks didn't line up quite as precisely as we would have liked. The four marks didn't line up like four fingers pointing directly at each other. Rather, they lined up like four fingers pointing ever so slightly away from each other.

Subaru training instructor Joe Stoffa assured us that this was as close as we were going to get on this engine. Remember, four of the engine timing marks are simple notches in the inner timing cover plastic. Due to manufacturing tolerances and assembly variations, these notches may not end up in precisely the right spot. A slight variation here or there can add up to the slight misalignment we saw on our engine. Moving either of the pulleys a full tooth in either direction would not have corrected our perceived misalignment; it would only have made it worse.
