## COWL TOP SIDE INNER PANEL (ASSY)

### REPLACEMENT

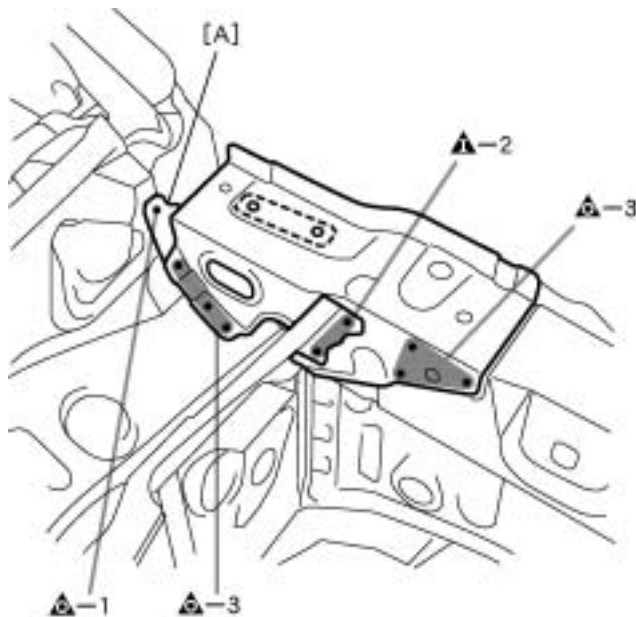
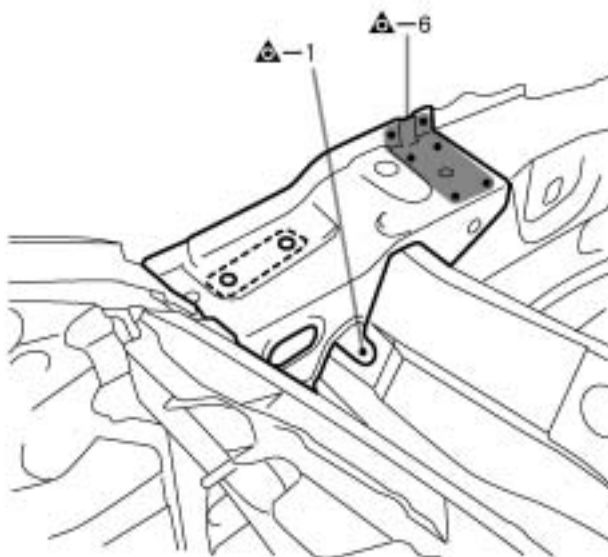
F20985

### REMOVAL

### POINT

- 1 Replace the [A] at the same time.

### PART NAME

[A] Cowl Top Side Reinforcement

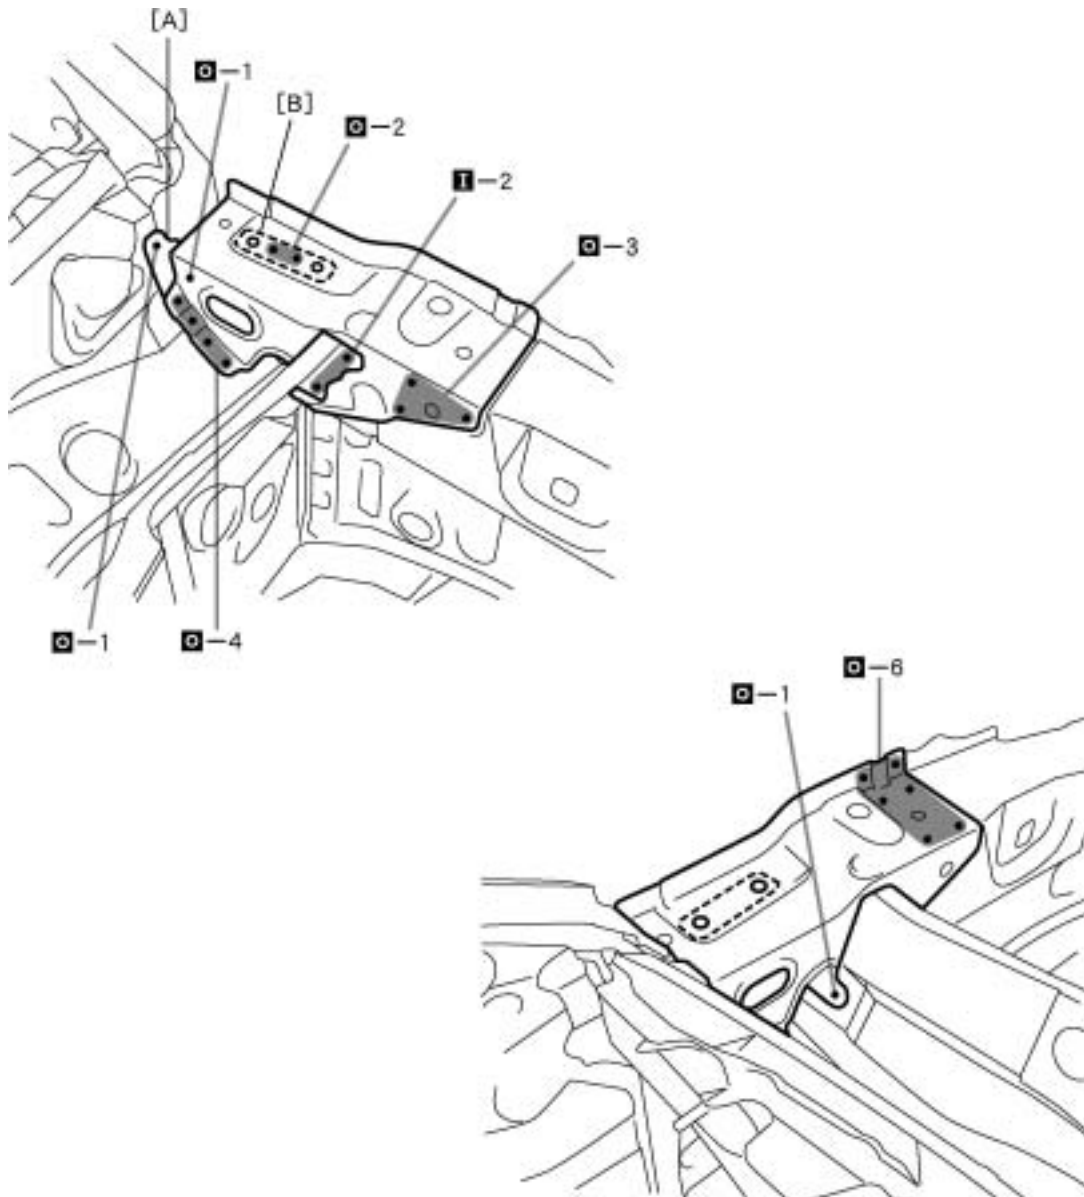
F20986

**INSTALLATION**

- Temporarily install the new parts and measure each part of the new parts in accordance with the body dimension diagram. (See the body dimension diagram)
- Inspect the fitting of the related parts around the new parts before welding. This affects the appearance of the finish.
- After welding, apply the polyurethane foam to the corresponding parts.
- After welding, apply body sealer and under-coating to the corresponding parts.
- After applying the top coat layer, apply anti-rust agent to the inside of the necked section structural weld spots.

**POINT**

- 1 Inspect the fitting of the front fender and hood, etc., before welding, since affects the appearance of the finish.

**PART NAME**

- [A] Cowl Top Side Reinforcement      [B] Hood Hinge Mounting Reinforcement
