## INSPECTION

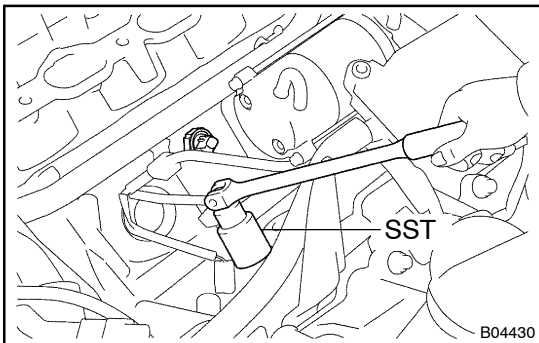
### 5. INSPECT KNOCK SENSOR

- (a) Disconnect the knock sensor connectors.
- (b) Using an ohmmeter, check that there is no continuity between the terminal and body.

If there is continuity, replace the sensor with SST.

SST 09816-30010

**Torque: 45 N·m (450 kgf·cm, 33 ft·lbf)**
