## INSPECTION

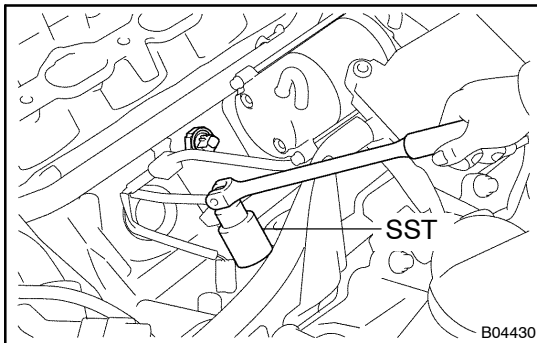
5. **INSPECT KNOCK SENSOR 1, 2**

- (a) Disconnect the knock sensor connectors.
- (b) Using an ohmmeter, check that there is no continuity between the terminal and body.

If there is continuity, replace the sensor with SST.

SST 09816-30010

**Torque: 45 N·m (450 kgf·cm, 33 ft·lbf)**
