# POWER WINDOW CONTROL SYSTEM

## TROUBLESHOOTING

BE19F-01

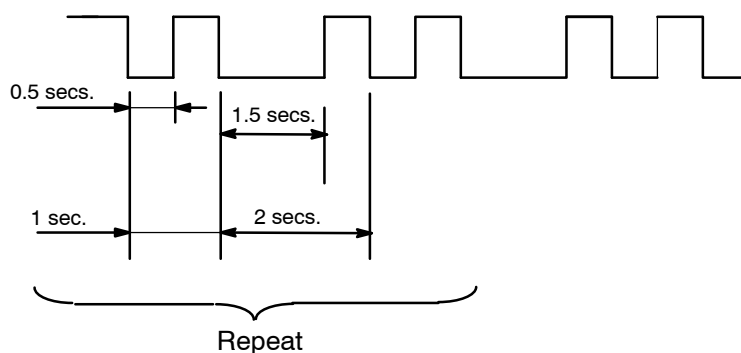
- Error is classified into the following 3 types according to the way of blinking.

#### ① Limit switch error

#### ② Pulse sensor error

#### ③ Limit switch/Pulse sensor synchronize error

- < Reference >
- When 30 seconds elapsed since blinking started, blinking finishes. (AUTO light remains ON)
  - When turning the ignition key OFF, blinking finishes.

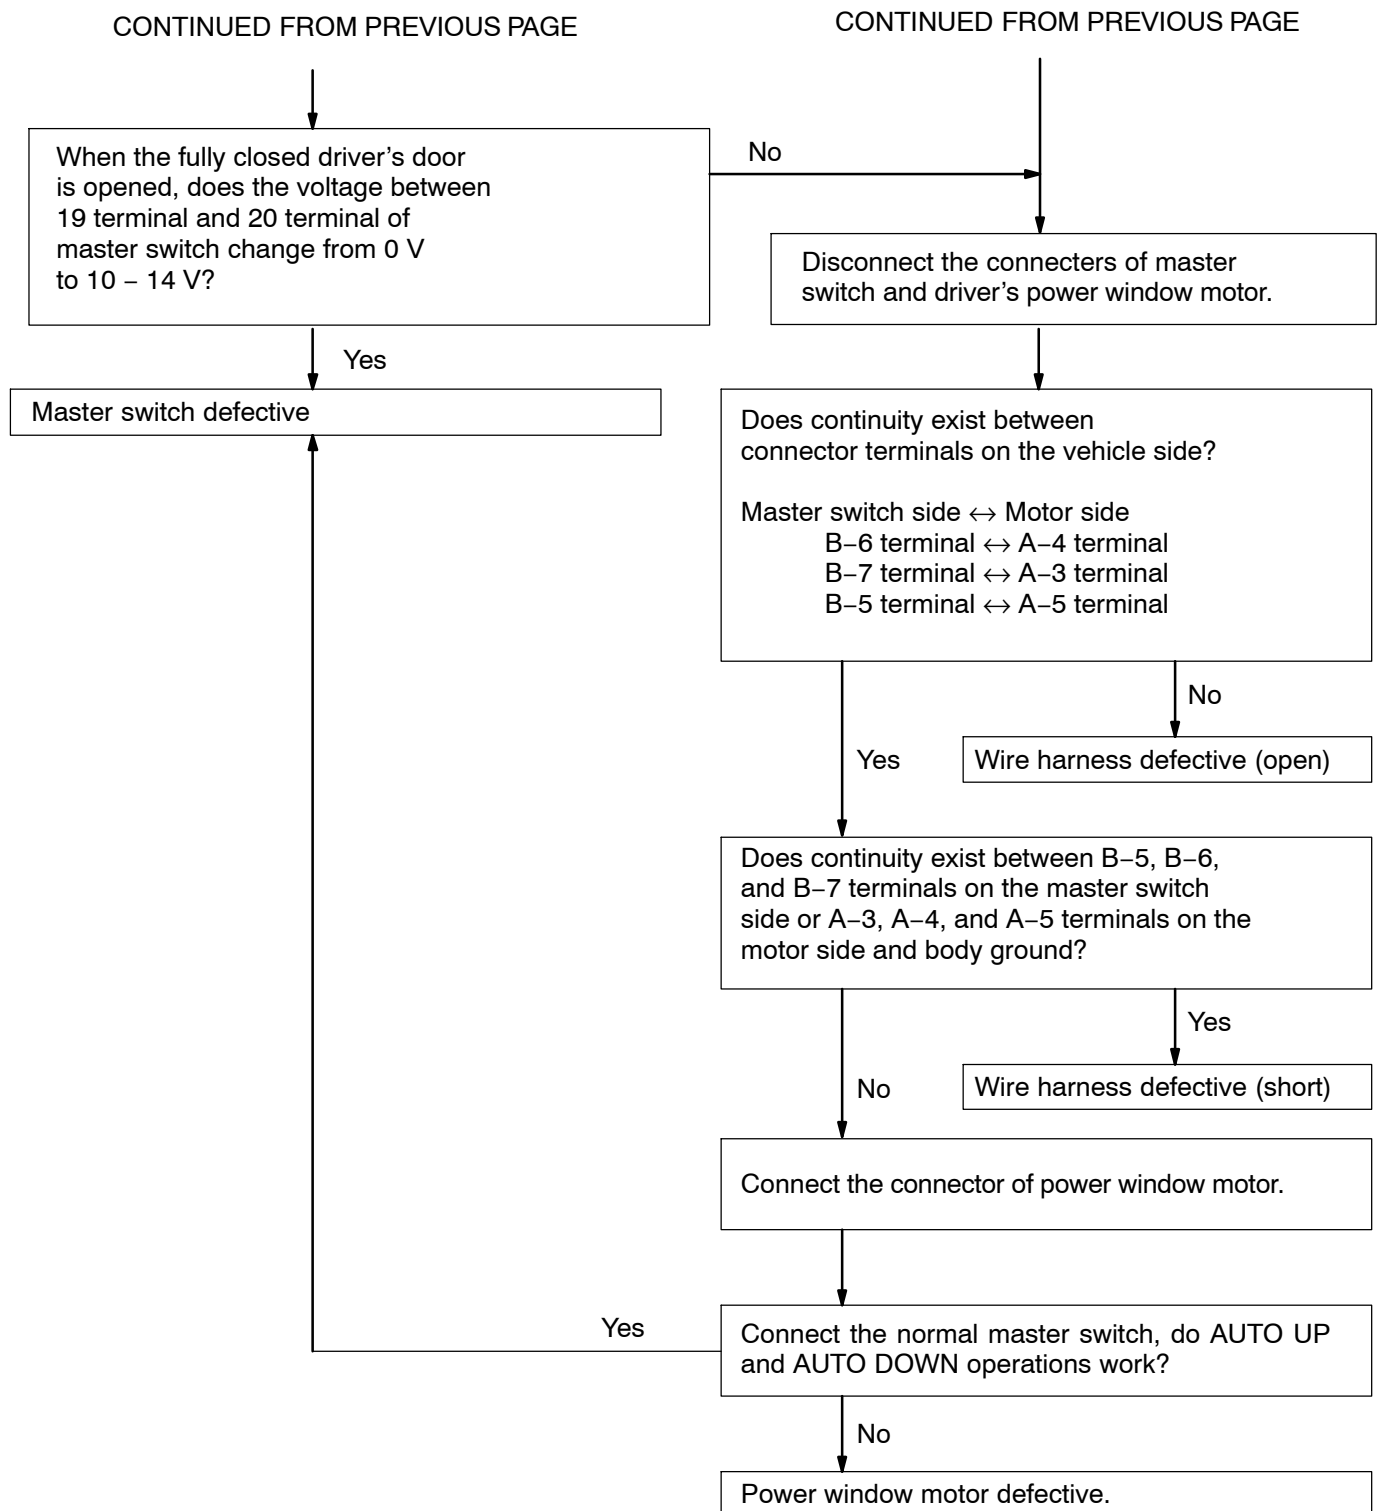
Blinks in the ① way

Remove the master switch.  
(Connector connection condition)

No

Master switch defective

Blinks in the ② or ③ way
