| <b>DTC</b> | <b>B2798</b> | <b>Communication malfunction No. 2</b> |

## CIRCUIT DESCRIPTION

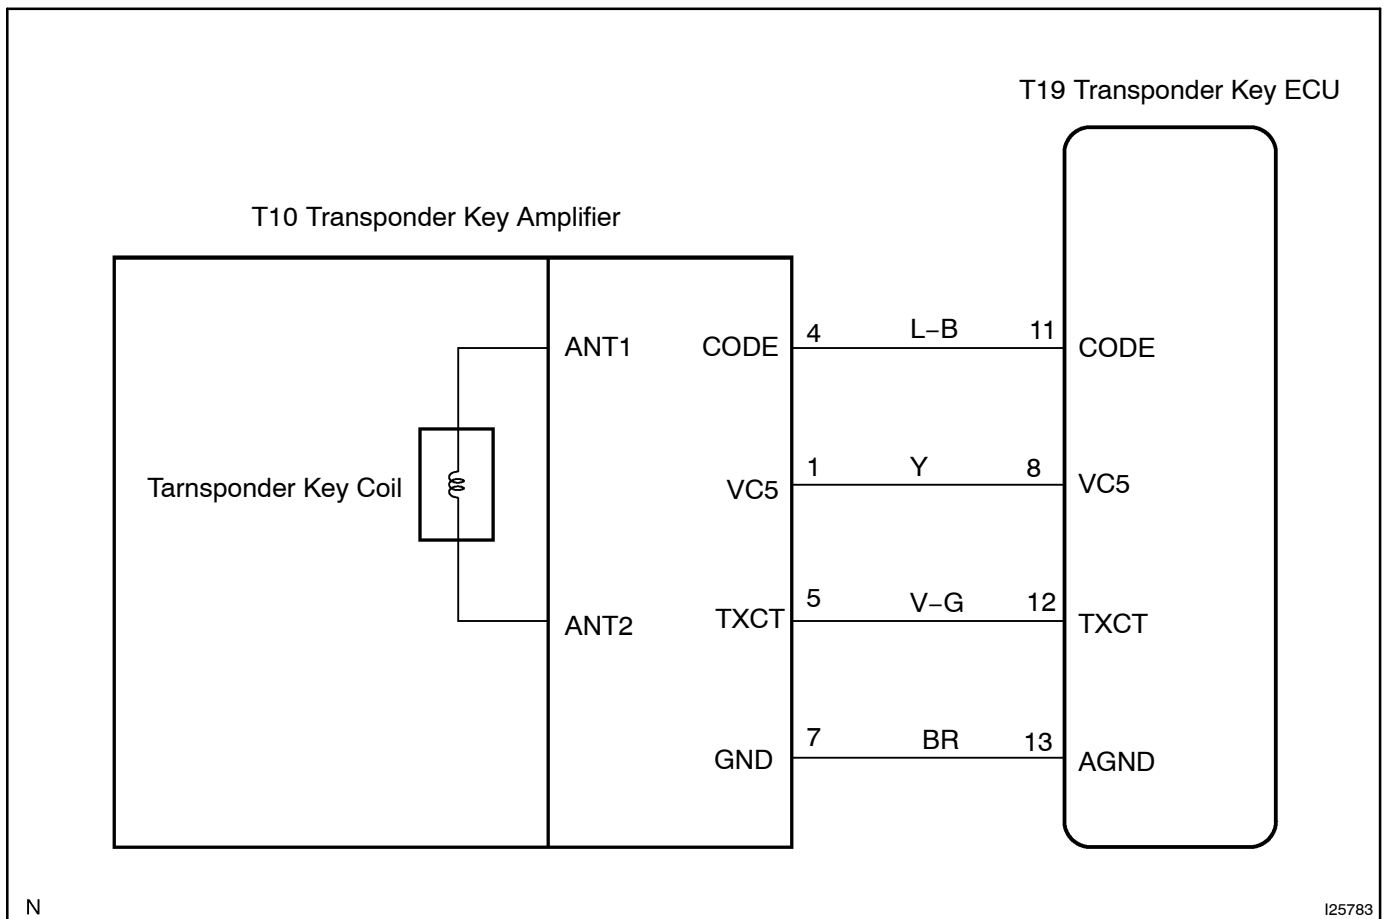
## WIRING DIAGRAM

| DTC No. | DTC Detecting Condition | Trouble Area |
|---|---|---|
| B2798 | Communication error | <ul style="list-style-type: none"> <li>• Key</li> <li>• Transponder Key Amplifier with coil</li> <li>• Wire harness</li> <li>• Transponder key ECU</li> </ul> |
