## INSPECTION

### 5. INSPECT KNOCK SENSOR 1, 2

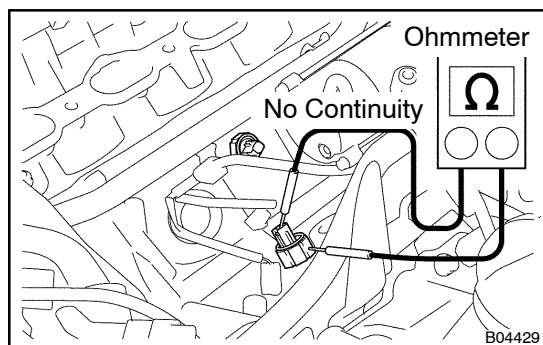
- (a) Disconnect the knock sensor connectors.
- (b) Using an ohmmeter, check that there is no continuity between the terminal and body.

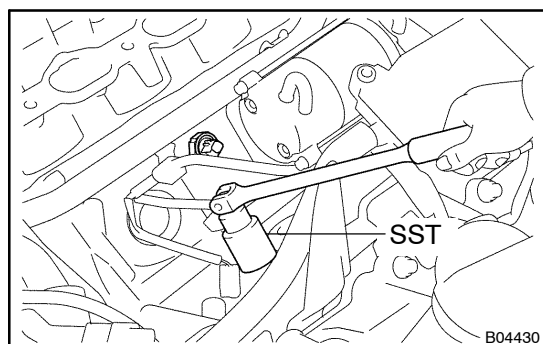
If there is a continuity, replace the sensor with SST.

SST 09816-30010

**Torque: 45 N·m (450 kgf·cm, 33 ft·lbf)**
