## INSPECTION

5. **INSPECT KNOCK SENSOR 1, 2**
  - (a) Disconnect the knock sensor connectors.
  - (b) Using an ohmmeter, check that there is no continuity between the terminal and body.

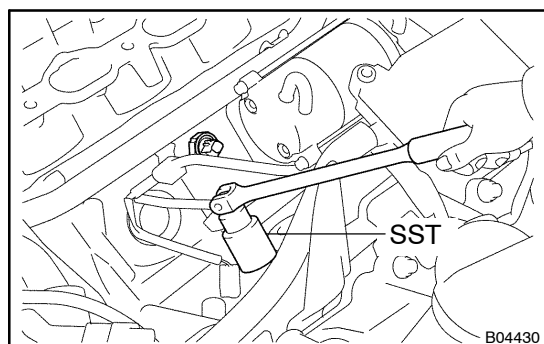
If there is a continuity, replace the sensor with SST.

SST 09816-30010

**Torque: 45 N·m (450 kgf·cm, 33 ft·lbf)**
