# 14. Rearview Camera System

## **B: REMOVAL**

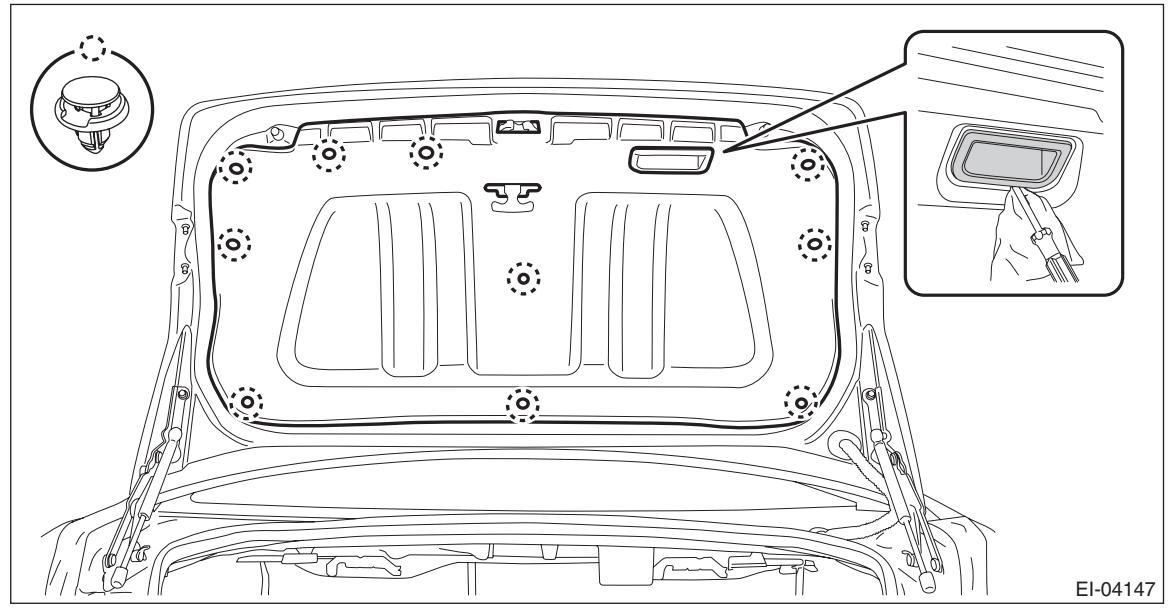
- 1) Disconnect the ground cable from battery.
- 2) Remove the trunk lid trim.
  - (1) Remove the trunk handle.
  - (2) Remove the clips and the trunk lid trim.

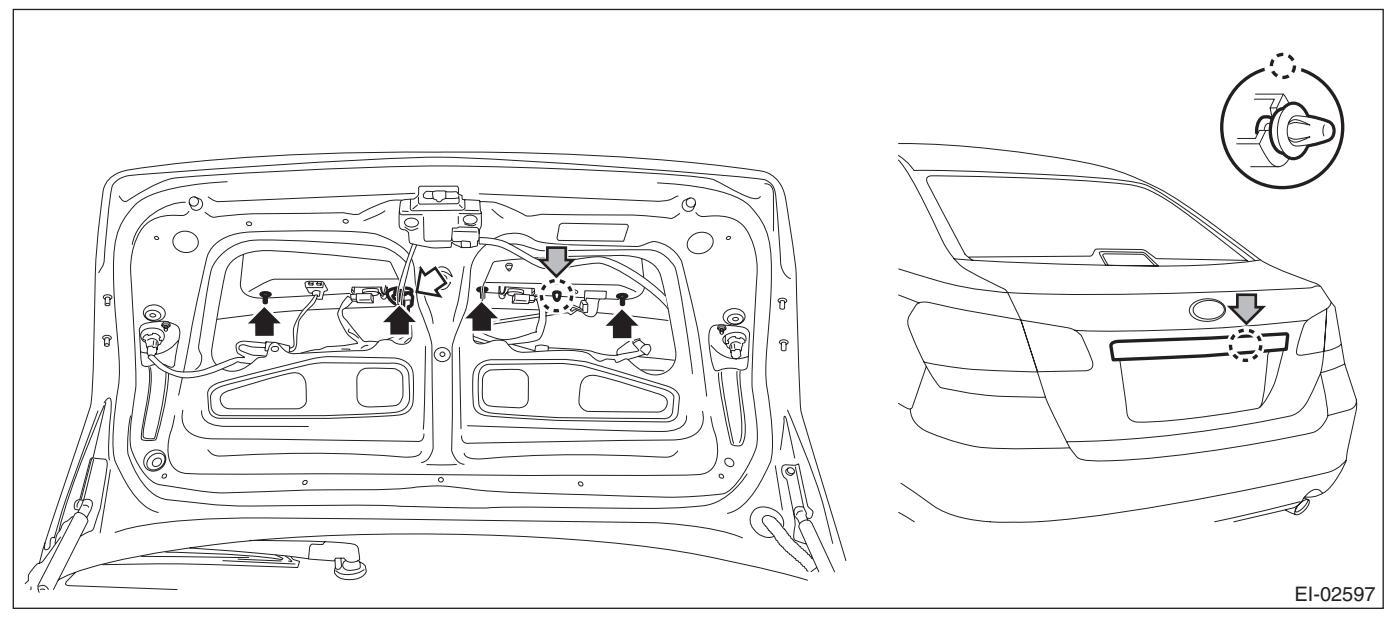
- 3) Remove the trunk lid garnish.
  - (1) Remove the nut.
  - (2) Remove the clips and the trunk lid garnish.

Sedan model Rearview camera (bracket): 7.5 N·m (0.76 kgf-m, 5.5 ft-lb) Trunk lid garnish: 4.5 N·m (0.46 kgf-m, 3.3 ft-lb)

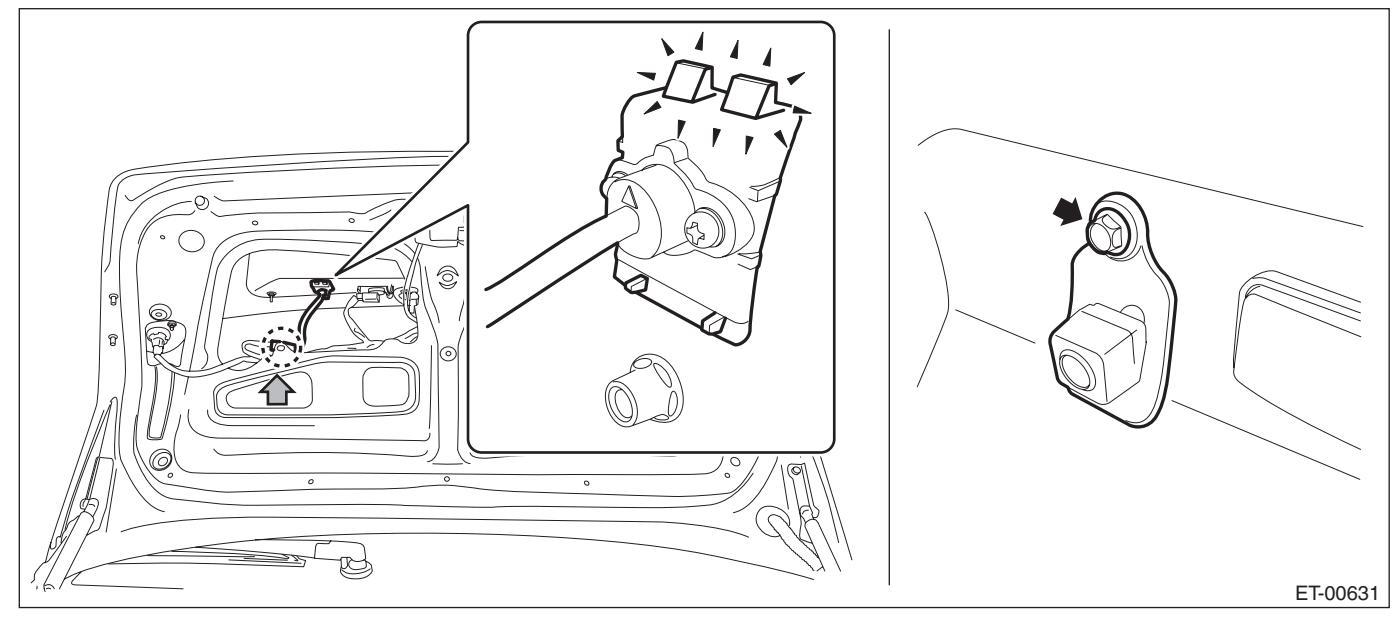
- (1) Disconnect the rearview camera connector.
- (2) Remove the bolt from the face of trunk.
- (3) Disconnect the claws and then remove the rearview camera assembly.

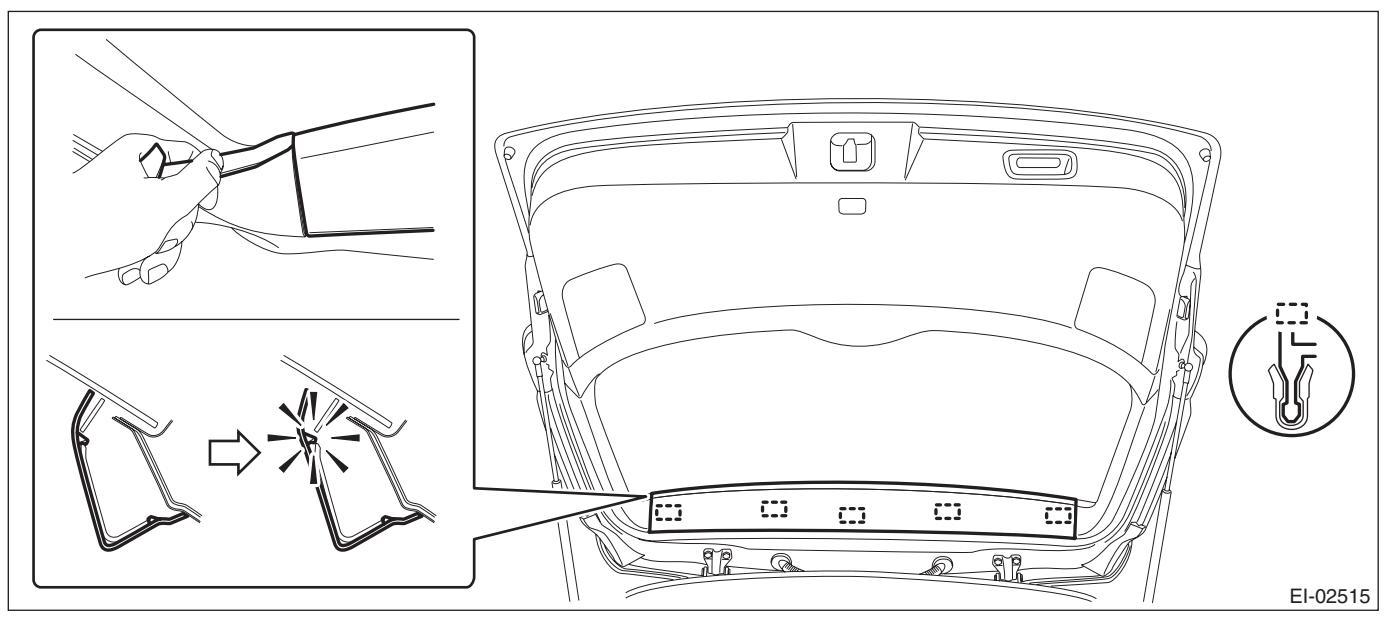
- 1) Disconnect the ground cable from battery.
- 2) Remove the rear gate trim.
  - (1) Remove the rear gate upper trim.
    - a) Remove the claws on the trim edge.
    - b) Disconnect the claws in the center of trim, and remove the rear gate upper trim.

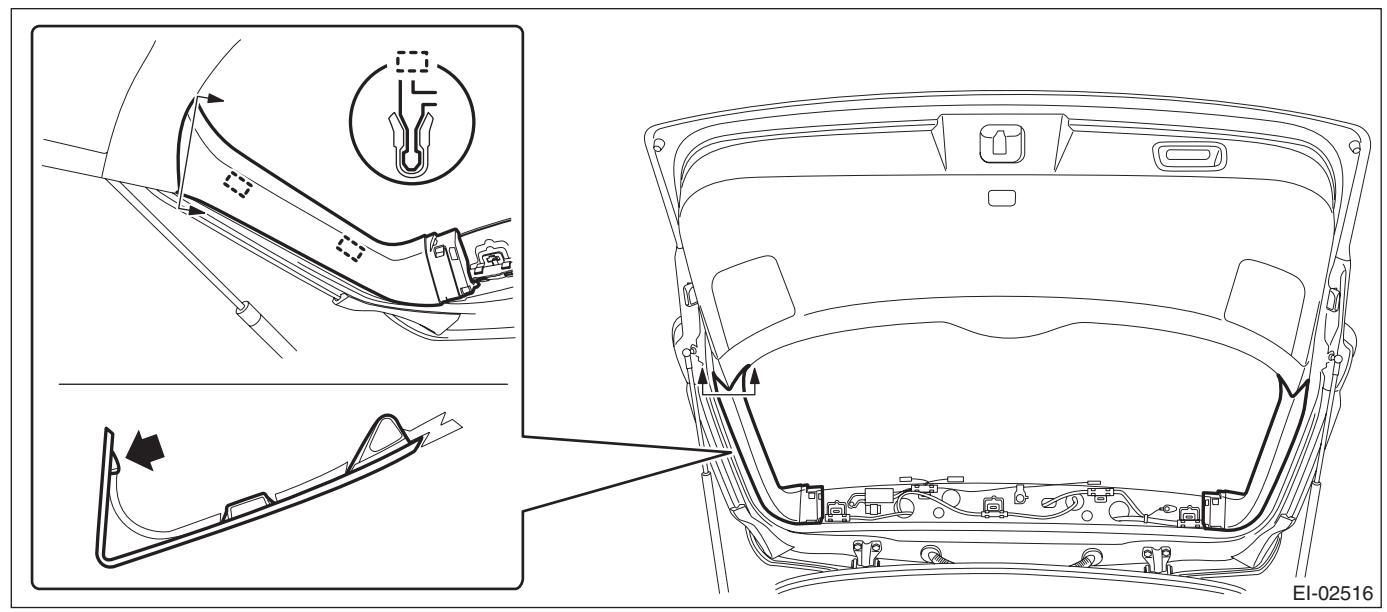
- (2) Remove the rear gate pillar trim.
  - a) Release the claws.
  - b) Remove the claws on the bottom of trim, and remove the rear gate pillar trim.

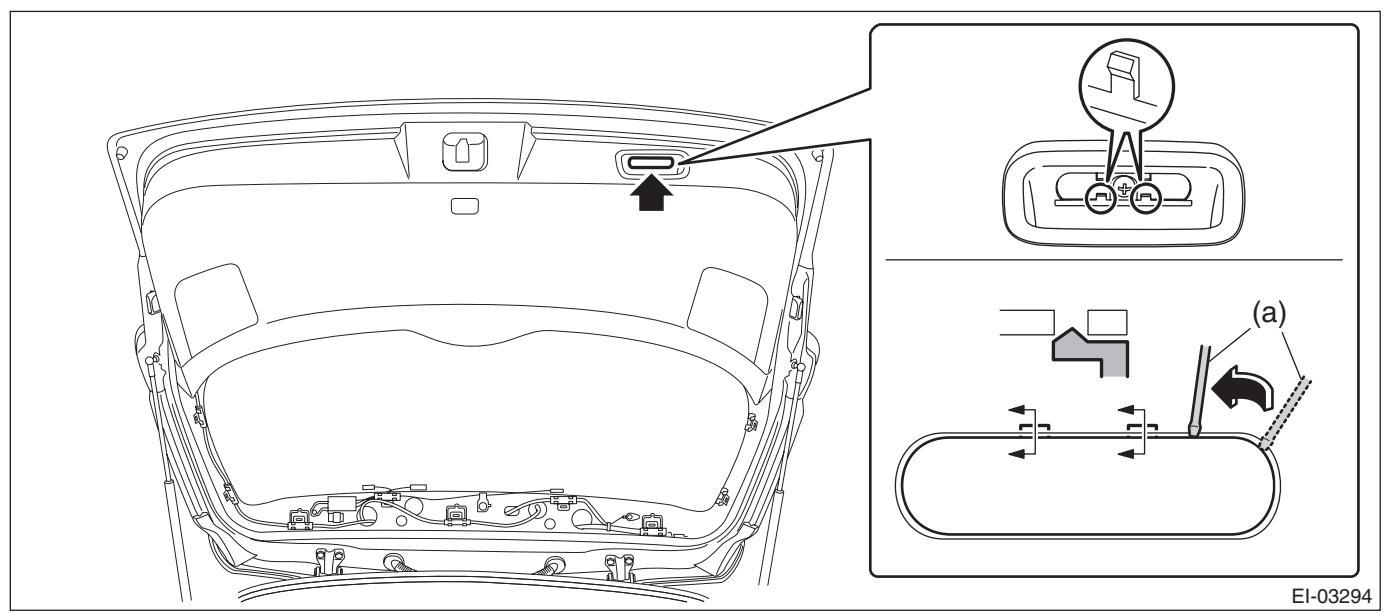
- Be careful not to scratch the trim.
- To protect the trim from damage, attach a protective tape to the tool in use.
  - a) Insert a precision screwdriver (a).
  - b) With the screwdriver inserted, move the precision screwdriver toward the claw and open the cap.
  - c) Remove the screws and detach the hand grip.

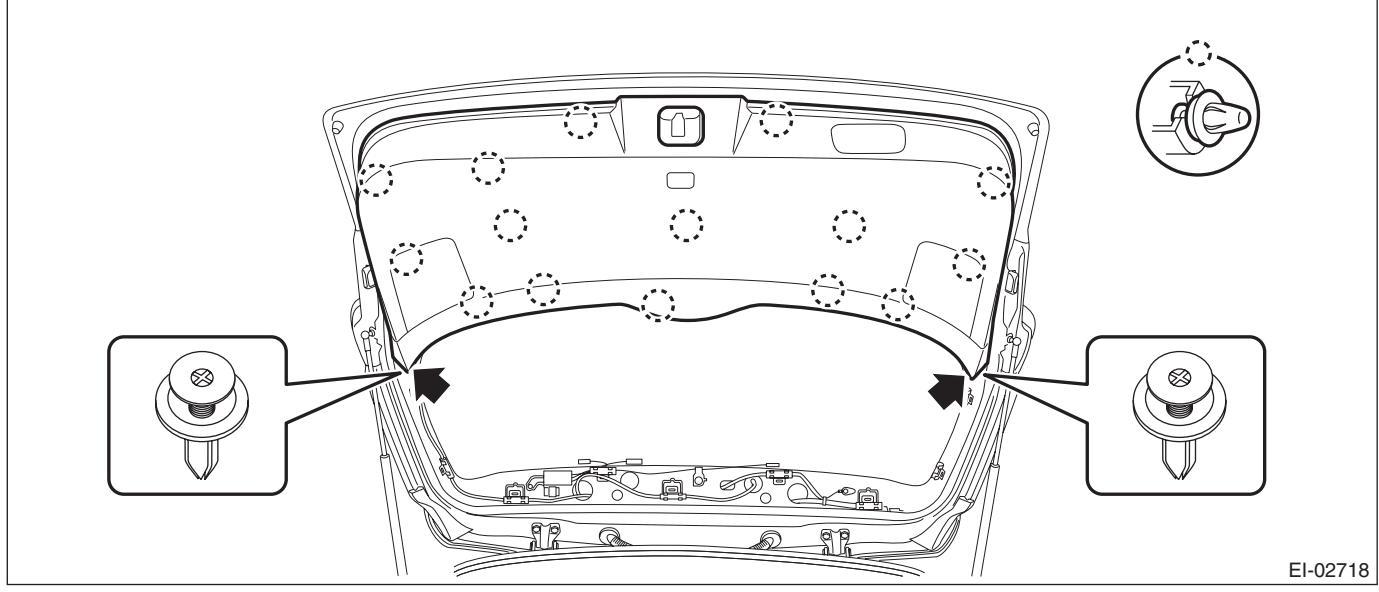
- (4) Remove the rear gate lower trim.
  - a) Remove the clips on both ends.
    - b) Release the clips and remove the rear gate lower trim.

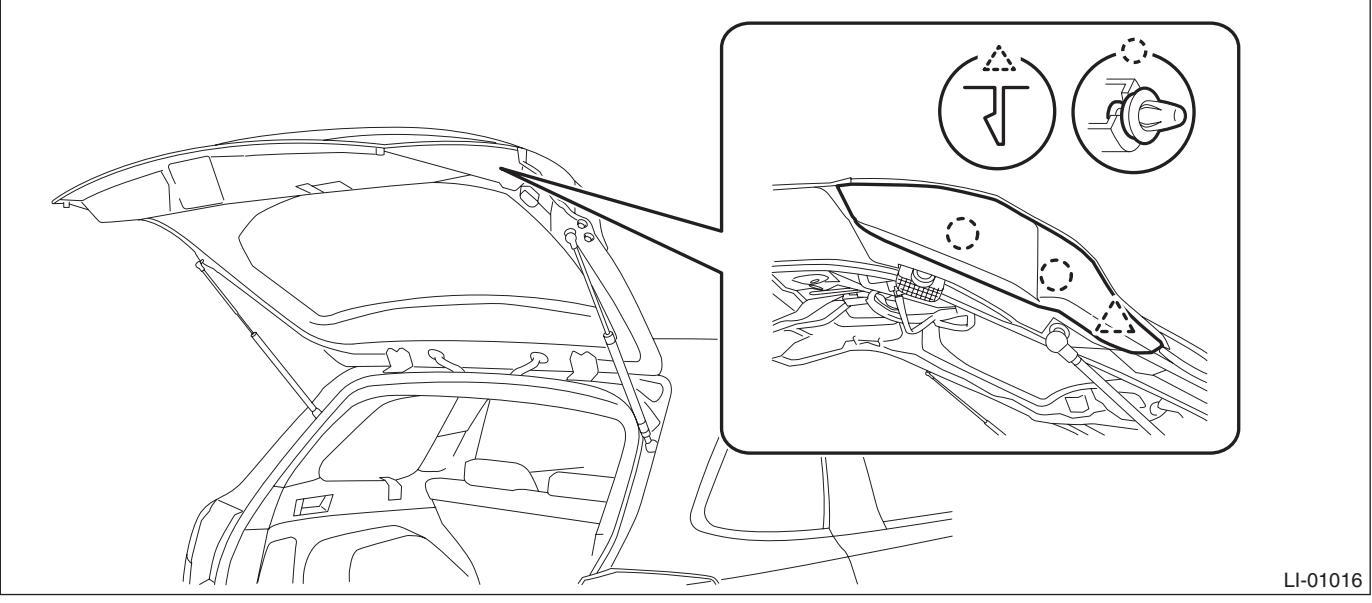
(1) Release the clips and claws, then detach the rear finisher light side cover.

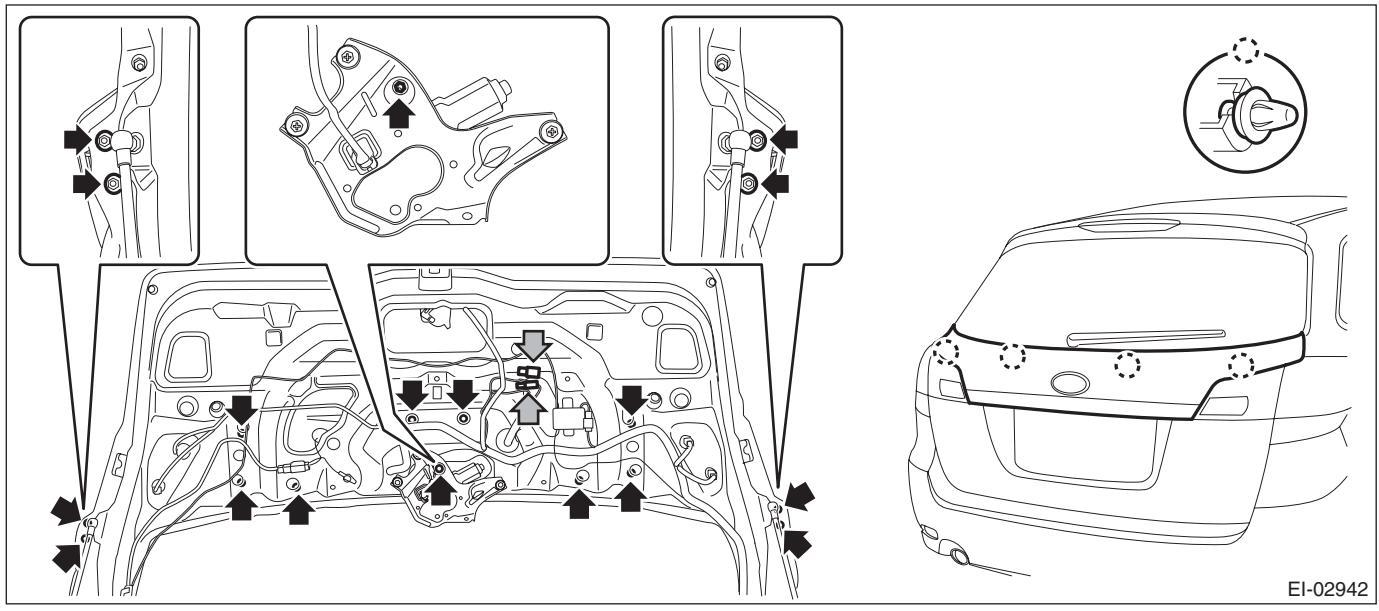
- (2) Disconnect the harness connector of license plate light assembly.
- (3) Remove the nuts.

(4) Remove the clips, and remove the rear gate garnish.

Rearview camera (bracket (nut)): 4.5 N·m (0.46 kgf-m, 3.3 ft-lb) Rear gate garnish: 4.5 N·m (0.46 kgf-m, 3.3 ft-lb) Rear wiper motor & wiper arm: <Ref. to WW-4, REAR WIPER, COMPONENT, General Description.>

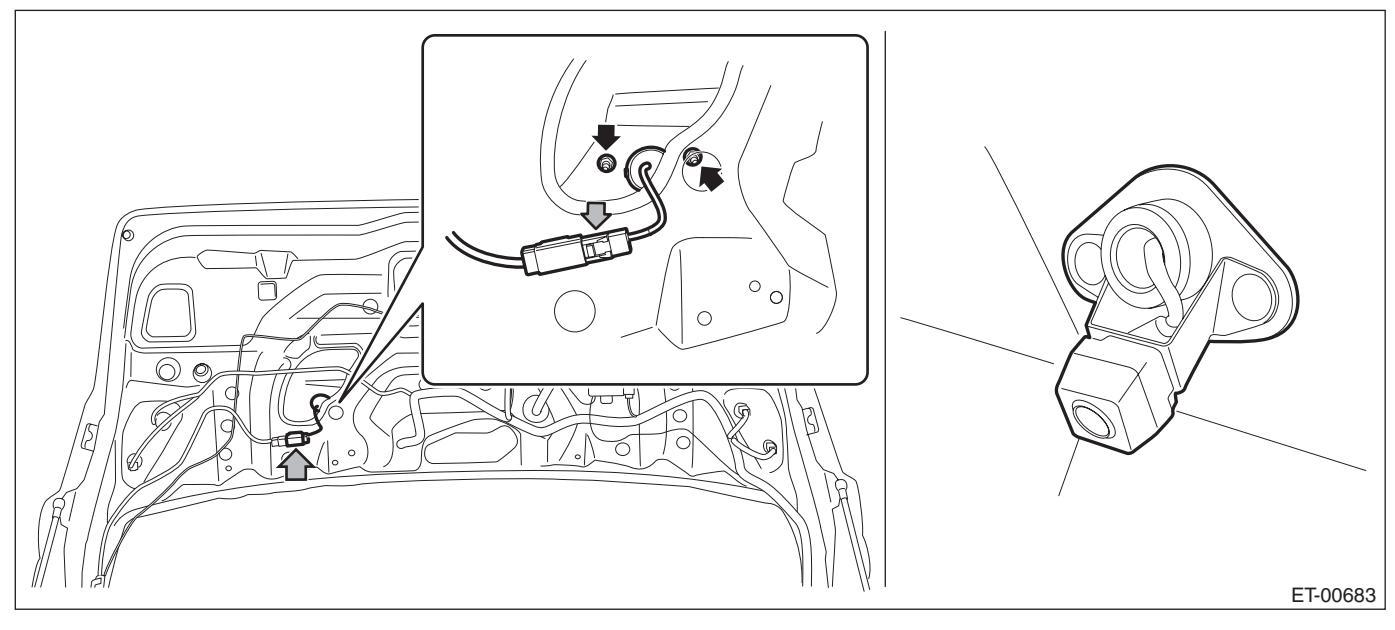
- (1) Disconnect the rearview camera connector.
- (2) Remove the nut and bolt on the back side of rear gate.
- (3) Disconnect the claws (for temporary fastening) and remove the rearview camera assembly.

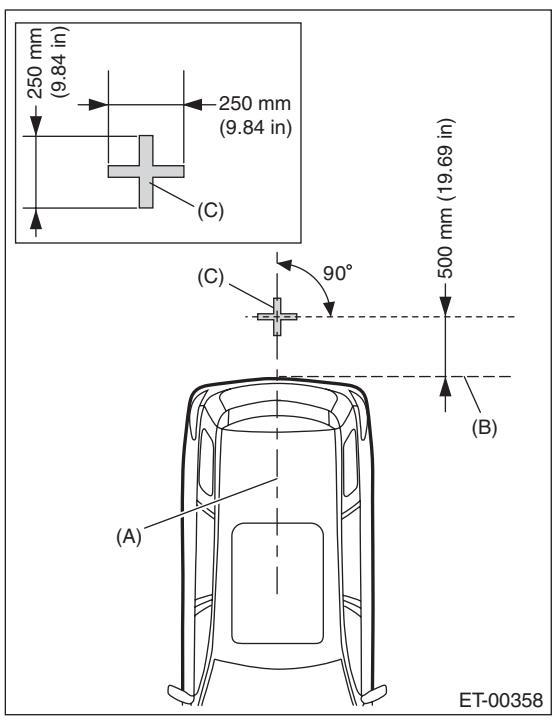
2) Attach the tape as the target point for standard at the floor rearward of the vehicle as shown in the figure below.

Standard tape width is about 30 - 50 mm (1.18 - 1.97 in) and brilliant color shall be used.

- (A) Vehicle body center line
- (B) Rear edge of bumper
- (C) Target point

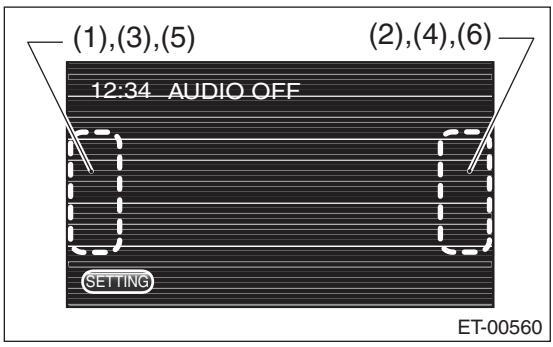
2) Display the audio OFF screen by turning the ignition switch to ON, then touch the screen in the order of (1) - (6).

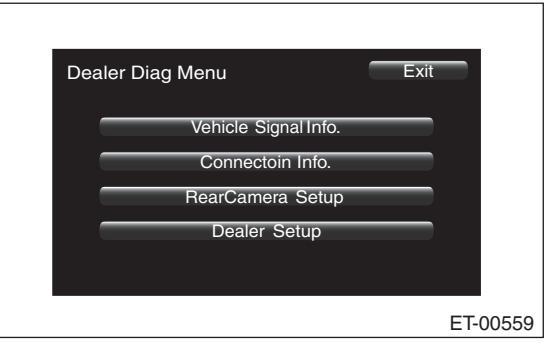
3) When the Dealer Diag menu screen is displayed, touch the "Rear Camera Setup" from the items.

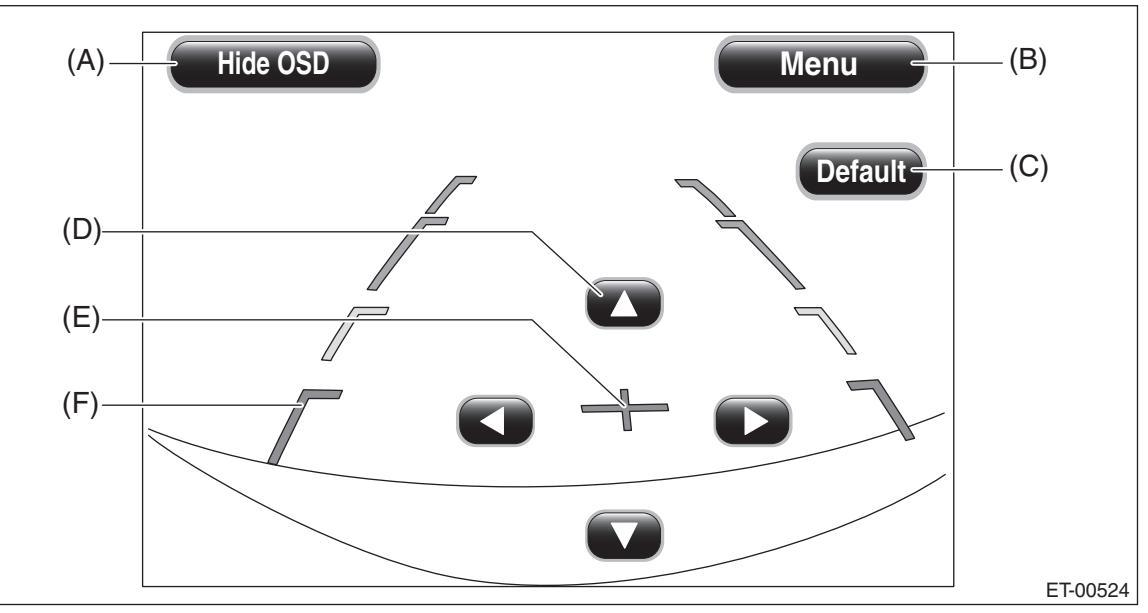
### • Sedan model

5) Touch the adjustment keys on the display screen to adjust the marker line.

(2) Adjust by touching the adjustment keys so that the cross line (E) and target point join together.
