B0118/46

Short in Side Squib (LH) Circuit (to B+)

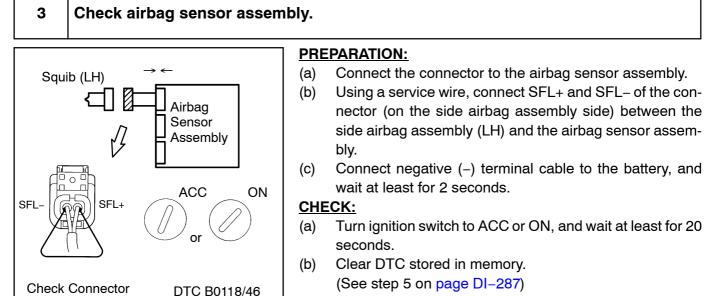
H01187

- (c) Turn ignition switch to LOCK, and wait at least for 20 seconds.
- (d) Turn ignition switch to ACC or ON, and wait at least for 20 seconds.
- (e) Check DTC. (See page DI-287)

DTC B0118/46 is not output.

Replace airbag sensor assembly.

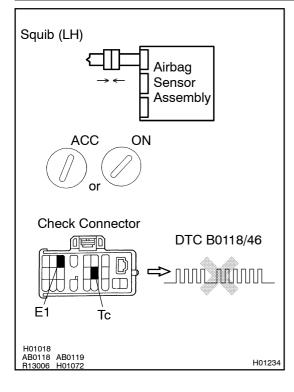
4 Check side squib (LH).

- (a) Turn ignition switch to LOCK.
- (b) Disconnect negative (–) terminal cable from the battery, and wait at least for 90 seconds.
- (c) Connect the side airbag assembly (LH) connector.
- (d) Connect negative (-) terminal cable to the battery, and wait at least for 2 seconds.

- (a) Turn ignition switch to ACC or ON, and wait at least for 20 seconds.
- (b) Clear DTC stored in memory. (See step 5 on page DI-287)
- (c) Turn ignition switch to LOCK, and wait at least for 20 seconds.
- (d) Turn ignition switch to ACC or ON, and wait at least for 20 seconds.
- (e) Check DTC. (See page DI–287)

DTC B0118/46 is not output.

\rangle Replace side airbag assembly (LH).
