DI16S-24

DTC	B0130/63	Short in P/T Squib (RH) Circuit
-----	----------	---------------------------------

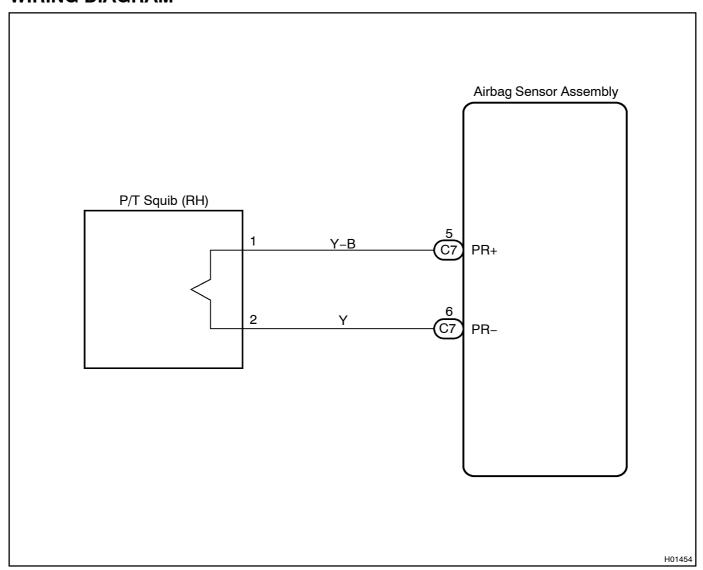
WIRING DIAGRAM

The P/T squib (RH) circuit consists of the airbag sensor assembly and seat belt pretensioner (RH). It causes the SRS to deploy when the SRS deployment conditions are satisfied. For details of the function of each component, see OPERATION on page RS-2. DTC B0130/63 is recorded when a short is detected in the P/T squib (RH) circuit.

DTC No.	DTC Detecting Condition	Trouble Area
B0130/63	Short circuit between PR+ wire harness and PR- wire harness of squib P/T squib (RH) malfunction Airbag sensor assembly malfunction	Seat belt pretensioner (RH) Airbag sensor assembly Wire harness

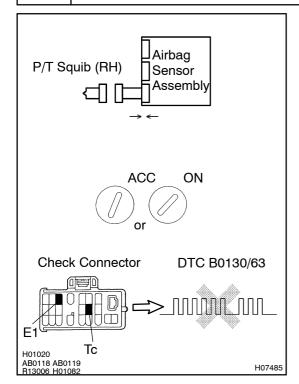
3 Check airbag sensor assembly.

PREPARATION:

- (a) Connect the connector to the airbag sensor assembly.
- (b) Connect negative (-) terminal cable to the battery, and wait at least for 2 seconds.

- (a) Turn ignition switch to ACC or ON, and wait at least for 20 seconds.
- (b) Clear DTC stored in memory. (See page DI-287)
- (c) Turn ignition switch to LOCK, and wait at least for 20 seconds.
- (d) Turn ignition switch to ACC or ON, and wait at least for 20 seconds.
- (e) Check DTC. (See page DI-287)

DTC B0130/63 is not output.

Replace airbag sensor assembly.

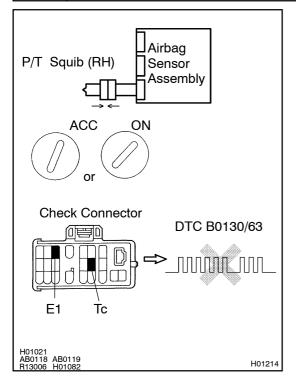
4 Check P/T squib (RH).

PREPARATION:

- (a) Turn ignition switch to LOCK.
- (b) Disconnect negative (–) terminal cable from the battery, and wait at least for 90 seconds.
- (c) Connect the seat belt pretensioner (RH) connector.
- (d) Connect negative (-) terminal cable to the battery, and wait at least for 2 seconds.

- (a) Turn ignition switch to LOOK, and wait at least for 20 second.
- (b) Turn ignition switch to ACC or ON, and wait at least for 20 seconds.
- (c) Clear DTC stored in memory. (See page DI-287)
- (d) Turn ignition switch to LOCK, and wait at least for 20 seconds.
- (e) Turn ignition switch to ACC or ON, and wait at least for 20 seconds.
- (f) Check DTC. (See page DI-287)

DTC B0130/63 is not output.

Replace seat belt pretensioner (RH).
