CIRCUIT INSPECTION

DTC	B0130/63	Short in P/T Squib (RH) Circuit
------------	-----------------	--

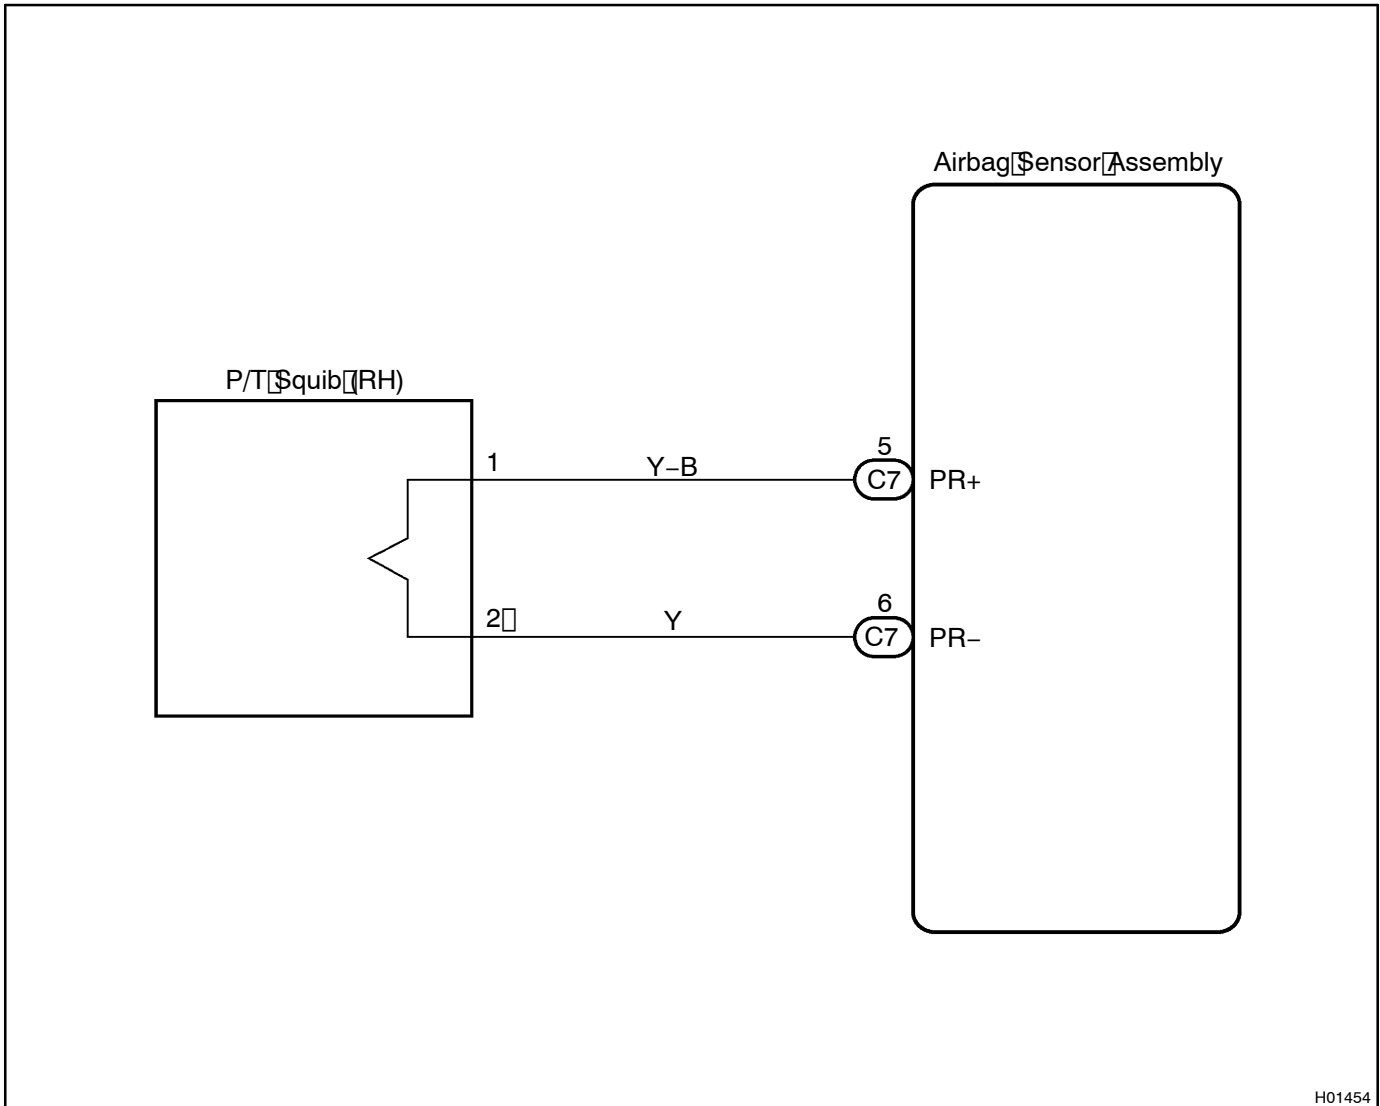
H01454

The P/T squib (RH) circuit consists of the airbag sensor assembly and seat belt pretensioner (RH). It causes the SRS to deploy when the SRS deployment conditions are satisfied.

WIRING DIAGRAM

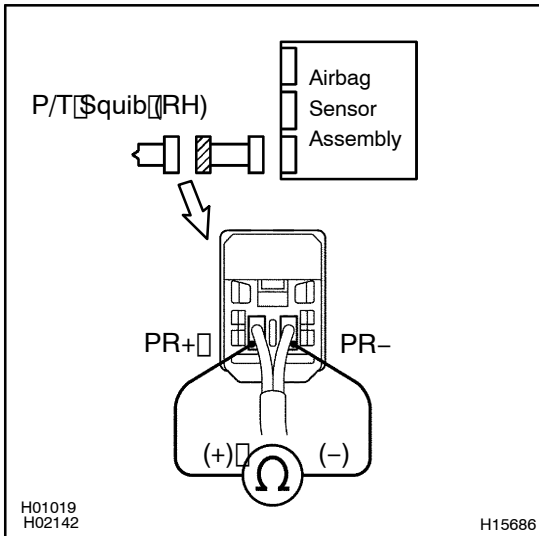
2 Check P/T squib (RH) circuit.

Release the airbag activation prevention mechanism of the connector (on the airbag sensor assembly side) between the airbag sensor assembly and the seat belt pretensioner (RH) (See page DI-3)

For the connector (on the seat belt pretensioner side) between the seat belt pretensioner (RH) and the airbag sensor assembly, measure the resistance between PR+ and PR-.

Resistance: 1 MΩ or Higher

Repair or replace harness or connector between seat belt pretensioner (RH) and airbag sensor assembly.

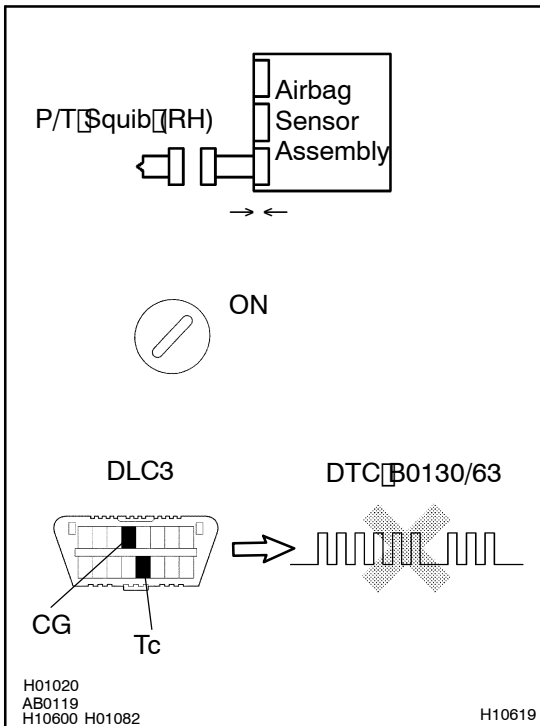
3 Check airbag sensor assembly.

- Connect the connector to the airbag sensor assembly.
- Connect negative (-) terminal cable to the battery, and wait at least for 2 seconds.

- Turn the ignition switch to ON, and wait at least for 20 seconds.
- Clear the DTC stored in memory (See page DI-3).
- Turn the ignition switch to LOCK, and wait at least for 20 seconds.
- Turn the ignition switch to ON, and wait at least for 20 seconds.
- Check the DTC (See page DI-3).

DTC B0130/63 is not output.

Replace airbag sensor assembly.

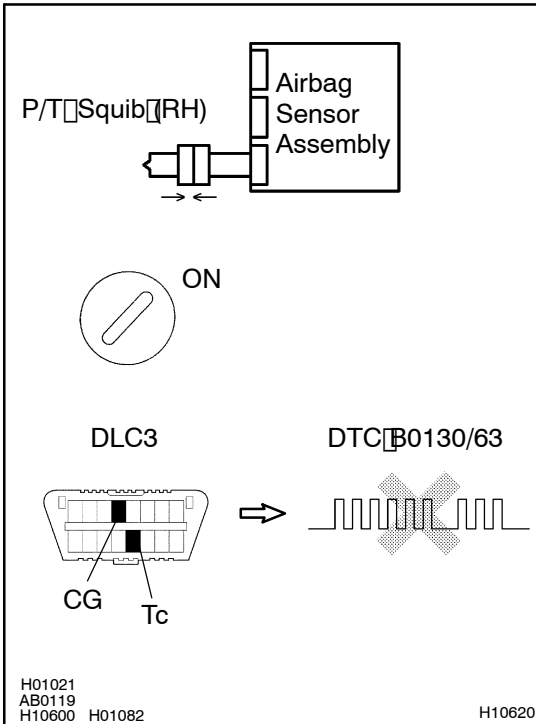
4 Check P/T squib (RH).

- Turn the ignition switch to LOCK.
- Disconnect negative (-) terminal cable from the battery, and wait at least for 90 seconds.
- Connect the seat belt pretensioner (RH) connector.
- Connect negative (-) terminal cable to the battery, and wait at least for 2 seconds.

- Turn the ignition switch to LOCK, and wait at least for 20 second.
- Turn the ignition switch to ON, and wait at least for 20 seconds.
- Clear the DTC stored in memory (See page DI-3)
- Turn the ignition switch to LOCK, and wait at least for 20 seconds.
- Turn the ignition switch to ON, and wait at least for 20 seconds.
- Check the DTC (See page DI-3)

DTC B0130/63 is not output.

Replace seat belt pretensioner (RH).
