DI1BH-23

DTC	B0132/61	Short in P/T Squib (RH) Circuit (to Ground)
-----	----------	---

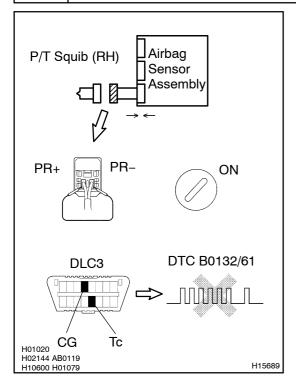
3

Check airbag sensor assembly.

- (a) Connect the connector to the airbag sensor assembly.
- (b) Using a service wire, connect PR+ and PR- of the connector (on the seat belt pretensioner side) between the seat belt pretensioner (RH) and the airbag sensor assembly.
- (c) Connect negative (-) terminal cable to the battery, and wait at least for 2 seconds.

- (a) Turn the ignition switch to ON, and wait at least for 20 seconds.
- (b) Clear the DTC stored in memory (See step 5 on page DI-3).
- (c) Turn the ignition switch to LOCK, and wait at least for 20 seconds.
- (d) Turn the ignition switch to ON, and wait at least for 20 seconds.
- (e) Check the DTC (See page DI-3).

DTC B0132/61 is not output.

Replace airbag sensor assembly.

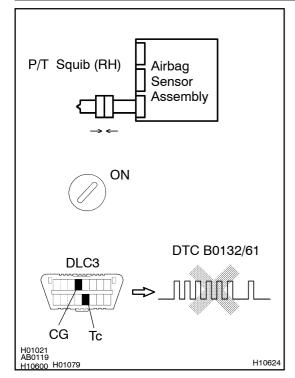
4 Check P/T squib (RH).

- (a) Turn the ignition switch to LOCK.
- (b) Disconnect negative (–) terminal cable from the battery, and wait at least for 90 seconds.
- (c) Connect the seat belt pretensioner (RH) connector.
- (d) Connect negative (–) terminal cable to the battery, and wait at least for 2 seconds.

- (a) Turn the ignition switch to ON, and wait at least for 20 seconds.
- (b) Clear the DTC stored in memory (See step 5 on page DI-3).
- (c) Turn the ignition switch to LOCK, and wait at least for 20 seconds.
- (d) Turn the ignition switch to ON, and wait at least for 20 seconds.
- (e) Check the DTC (See page DI-3).

DTC B0132/61 is not output.

NG Replace seat belt pretensioner (RH).
