DTC	B0137/71	Short in P/T Squib (LH) Circuit (to Ground)
------------	-----------------	--

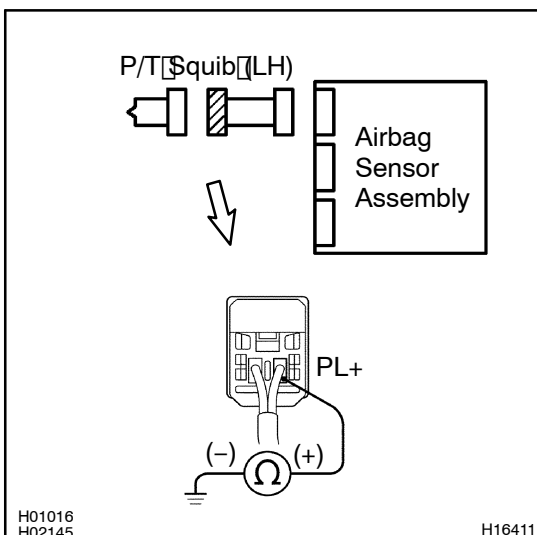
2	Check P/T squib (LH) circuit.
----------	--------------------------------------

For the connector (on the seat belt pretensioner side) between the seat belt pretensioner (LH) and the airbag sensor assembly, measure the resistance between PL+ and body ground.

Resistance: 1 MΩ or Higher

Repair or replace harness or connector between seat belt pretensioner (LH) and airbag sensor assembly.

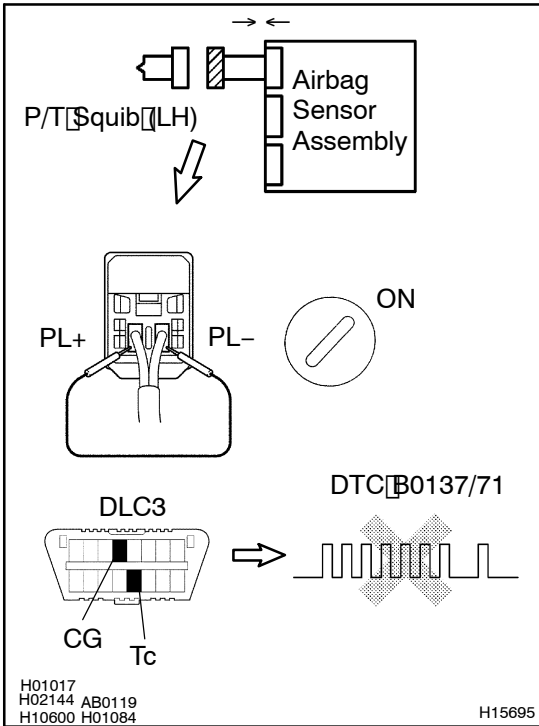
3 Check airbag sensor assembly.

- Connect the connector to the airbag sensor assembly.
- Using a service wire, connect PL+ and PL- of the connector (on the seat belt pretensioner side) between the seat belt pretensioner (LH) and the airbag sensor assembly.
- Connect negative (-) terminal cable to the battery, and wait at least for 2 seconds.

- Turn the ignition switch to ON, and wait at least for 20 seconds.
- Clear the DTC stored in memory (See step 5 on page DI-3)
- Turn the ignition switch to LOCK, and wait at least for 20 seconds.
- Turn the ignition switch to ON, and wait at least for 20 seconds.
- Check the DTC (See page DI-3)

DTC B0137/71 is not output.

Replace airbag sensor assembly.

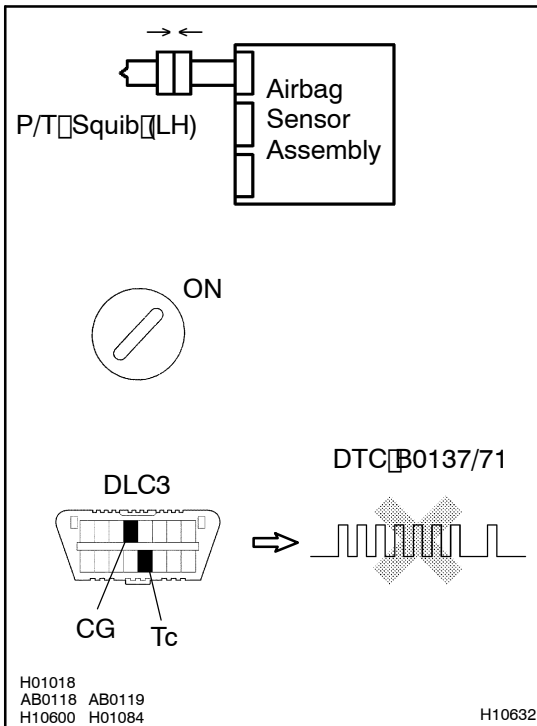
4 Check P/T squib (LH).

- Turn the ignition switch to LOCK.
- Disconnect negative (-) terminal cable from the battery, and wait at least for 90 seconds.
- Connect the seat belt pretensioner (LH) connector.
- Connect negative (-) terminal cable to the battery, and wait at least for 2 seconds.

- Turn the ignition switch to ON, and wait at least for 20 seconds.
- Clear the DTC stored in memory (See step 5 on page DI-3)
- Turn the ignition switch to LOCK, and wait at least for 20 seconds.
- Turn the ignition switch to ON, and wait at least for 20 seconds.
- Check the DTC (See page DI-3)

DTC B0137/71 is not output.

Replace seat belt pretensioner (LH).
