<b>SERVICE BULLETIN</b>		No.: MSB-97E37-001							
		Date: 1997-07-15

<Model>	<M/Y>	COLT(CJ0A)	96-10	LANCER(CK0A)	96-10
<Model>	<M/Y>								
COLT(CJ0A)	96-10								
LANCER(CK0A)	96-10								
Subject: CHANGE IN POWER STEERING HOSE PIPING									
Group: STEERING	Draftno: 96-TA-019								
INFORMATION	OVERSEAS SERVICE DEPT

This Service Bulletin informs you of changes in the power steering hose piping.

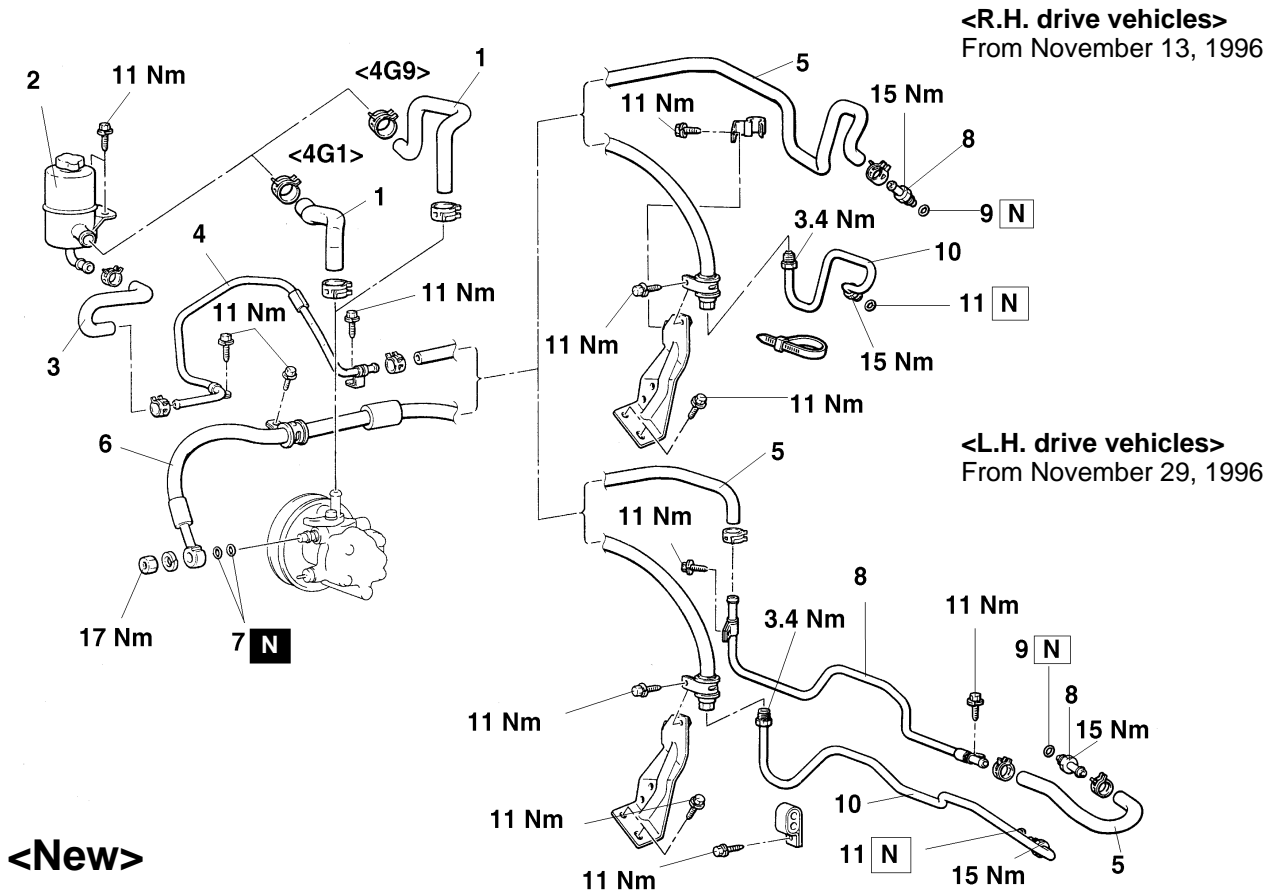
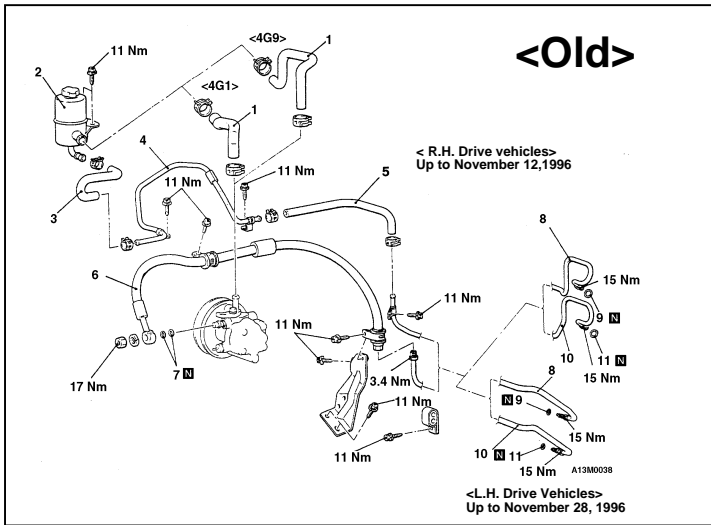
**POWER STEERING HOSES  
REMOVAL AND INSTALLATION**

| 1. Suction hose | 7. O-ring |
| 2. Oil reservoir | 8. Return tube |
| 3. Return hose | 9. O-ring |
| 4. Return tube | ▶ A ◀ 10. Pressure hose |
| 5. Return hose | 11. O-ring |
| ▶ A ◀ 6. Pressure hose | |

RH drive vehicles: From November 13, 1996

LH drive vehicles: From November 29, 1996
