# SERVICE BULLETIN

<b>SERVICE BULLETIN</b>		No.: MSB-97E52-001	
		Date: 1997-04-30	<Model> <M/Y>
<b>Subject:</b> ADDITION OF SRS AIR BAG MAINTENANCE PROCEDURE		ALL MODELS	91-10
<b>Group:</b> INTERIOR	<b>Draftno:</b> 96-AL-022		
<b>INFORMATION</b>	OVERSEAS SERVICE DEPT	  R. USAMI - MANAGER QUALITY INFORMATION ANALYSIS

In the SRS air bag troubleshooting, items of cause of trouble in the inspection procedure for each diagnostic trouble code, have been added.

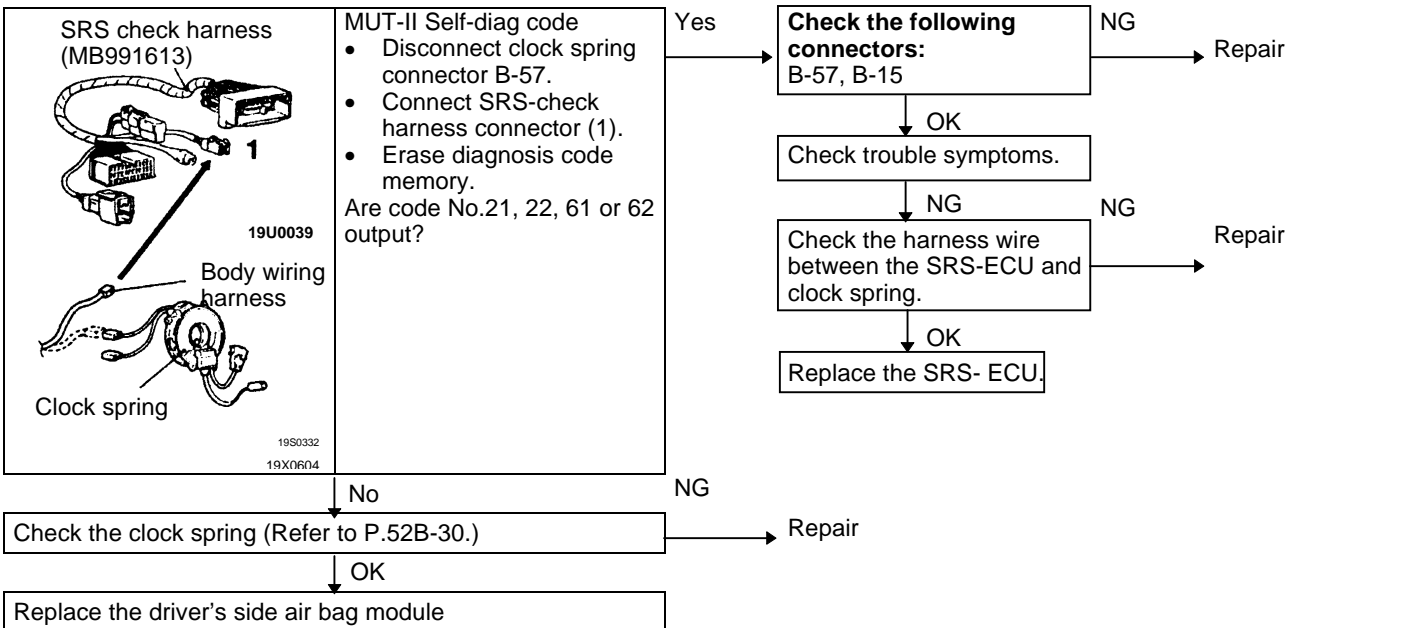
<b>Code No. 21, 22, 61 or 62 Driver's side air bag module (squib) system</b>	<b>Probable cause</b>
These diagnosis codes are output if there is abnormal resistance between the input terminals of the driver's side air bag module (squib). The trouble causes for each diagnosis code No. are as follows.	<ul style="list-style-type: none"> <li>Malfunction of clock spring</li> <li>Open-circuit in clock spring due to inappropriate neutral position</li> <li>Malfunction of wiring harness or connectors</li> <li>Malfunction of driver's side air bag module (squib)</li> <li>Malfunction of SRS-ECU</li> </ul>

Code No.	Trouble symptoms
21	<ul style="list-style-type: none"> <li>Short in driver's side air bag module (squib) or harness short</li> <li>Short in clock spring</li> </ul>
22	<ul style="list-style-type: none"> <li>Open circuit in driver's side air bag module (squib) or open harness</li> <li>Open circuit in clock spring</li> <li>Disconnected connector in the driver's side air bag module (squib).</li> <li>Open circuit in clock spring due to inappropriate neutral position.</li> <li>Malfunction of connector contact</li> </ul>
61	<ul style="list-style-type: none"> <li>Short in driver's side air bag module (squib) harness leading to the power supply</li> </ul>
62	<ul style="list-style-type: none"> <li>Short in driver's side air bag module (squib) harness leading to the earth</li> </ul>
