SECTION **BRM**
 BODY REPAIR

Body Exterior Paint Color

BODY COMPONENT PARTS

REPLACEMENT OPERATIONS

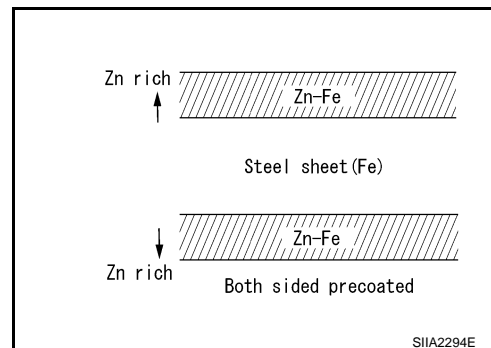
Anti-Corrosive Precoated Steel (Galvannealed Steel)

To improve repairability and corrosion resistance, a new type of anti-corrosive precoated steel sheet has been adopted replacing conventional zinc-coated steel sheet.

Galvannealed steel is electroplated and heated to form Zinc-iron alloy, which provides excellent and long term corrosion resistance with cationic electrodeposition primer.

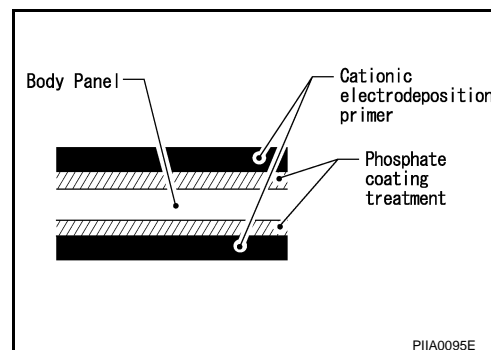
Phosphate Coating Treatment and Cationic Electrodeposition Primer

A phosphate coating treatment and a cationic electrodeposition primer, which provide excellent corrosion protection, are employed on all body components.

CAUTION:

Confine paint removal during welding operations to an absolute minimum.

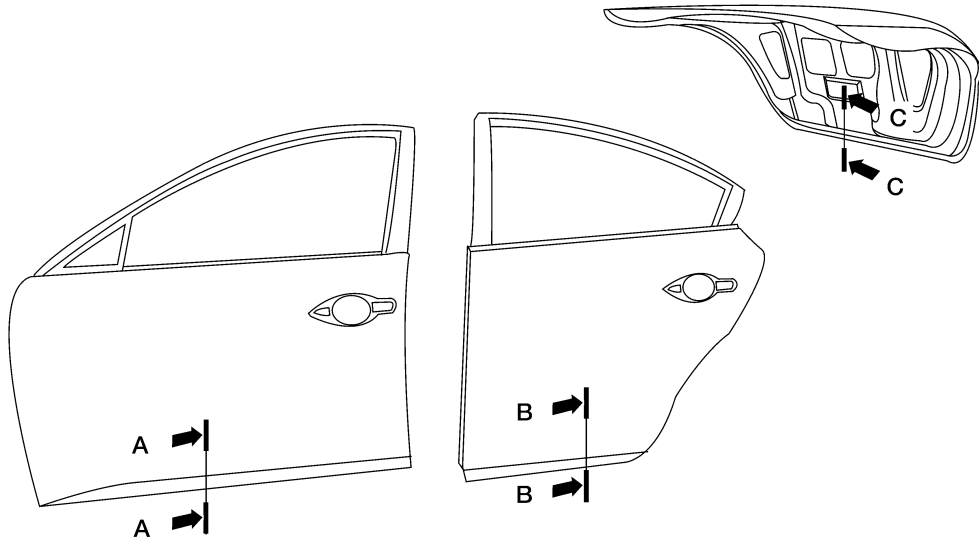
AWKIA1344GB

To improve corrosion resistance, anti-corrosive wax is applied inside the body sill and inside other closed sections. Accordingly, when replacing these parts, be sure to apply anti-corrosive wax to the appropriate areas of

the new parts. Select an excellent anti-corrosive wax which will penetrate after application and has a long shelf life.

: Indicates anti-corrosive wax coated portions

Section A-A	Section B-B	Section C-C

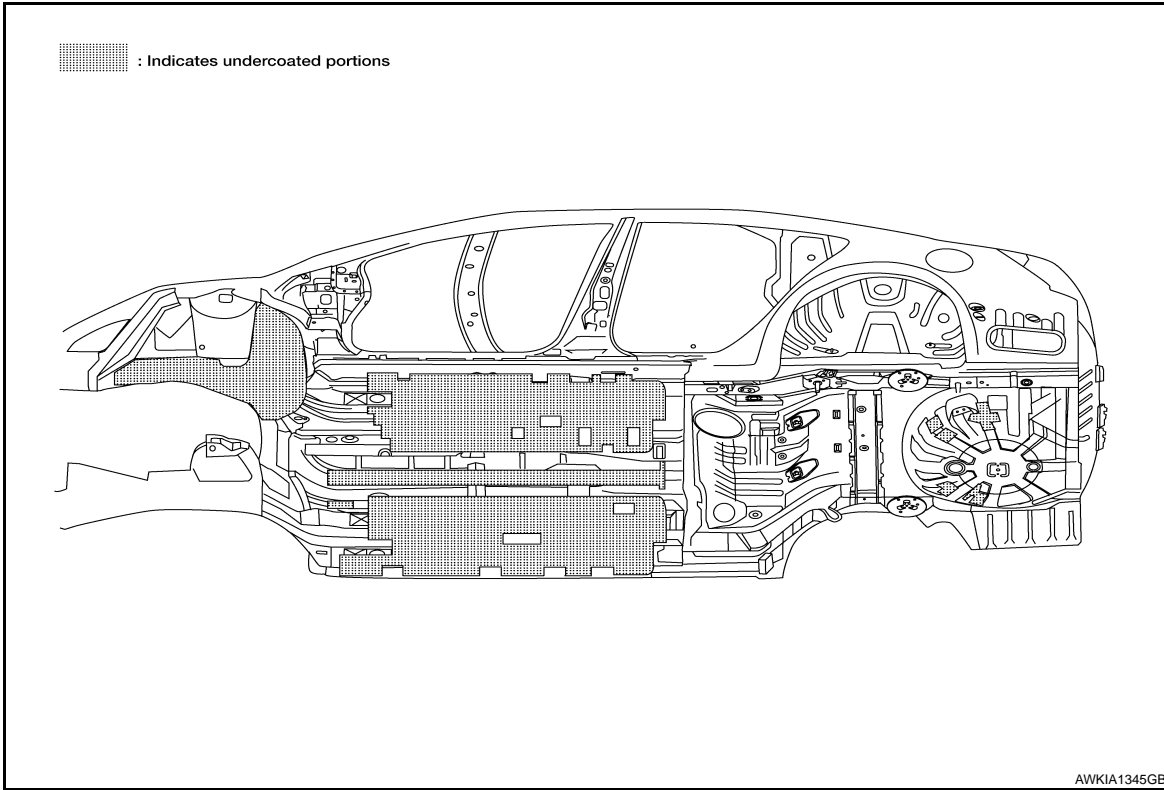
The underside of the floor and wheelhouse are undercoated to prevent rust, vibration, noise and stone chipping. Therefore, when such a panel is replaced or repaired, apply undercoating to that part. Use an undercoating which is rust preventive, soundproof, vibration-proof, shock-resistant, adhesive, and durable.

1. Do not apply undercoating to any place unless specified (such as the areas above the muffler and three way catalyst which are subjected to heat).
2. Do not undercoat the exhaust pipe or other parts which become hot.
3. Do not undercoat rotating parts.
4. Apply bitumen wax after applying undercoating.

5. After putting seal on the vehicle, put undercoating on it.

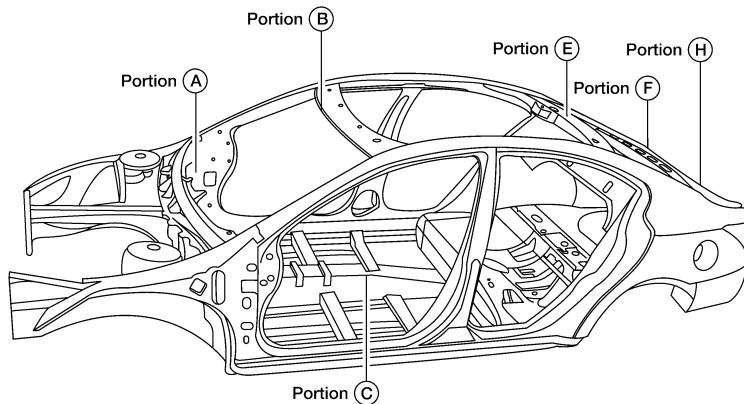
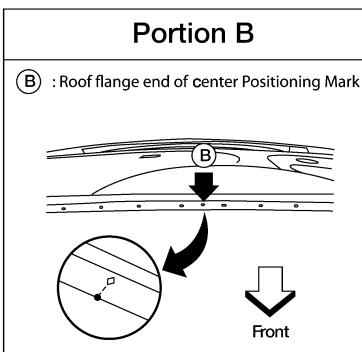
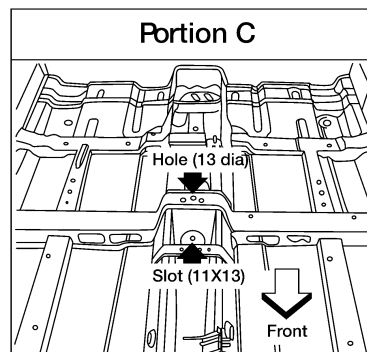
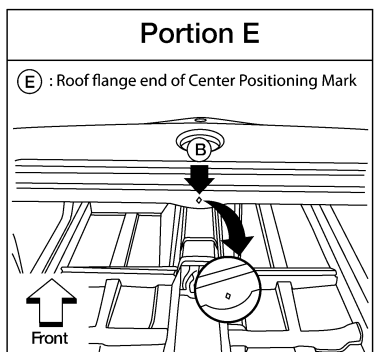
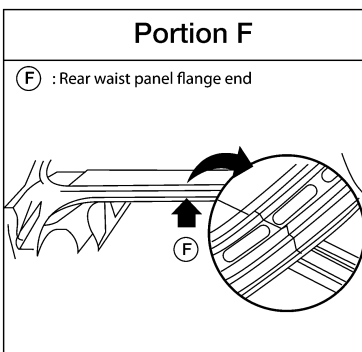
AWKIA1350GB

A mark has been placed on each part of the body to indicate the vehicle center. When repairing parts damaged by an accident which might affect the vehicle frame (members, pillars, etc.), more accurate and effective repair will be possible by using these marks together with body alignment specifications.

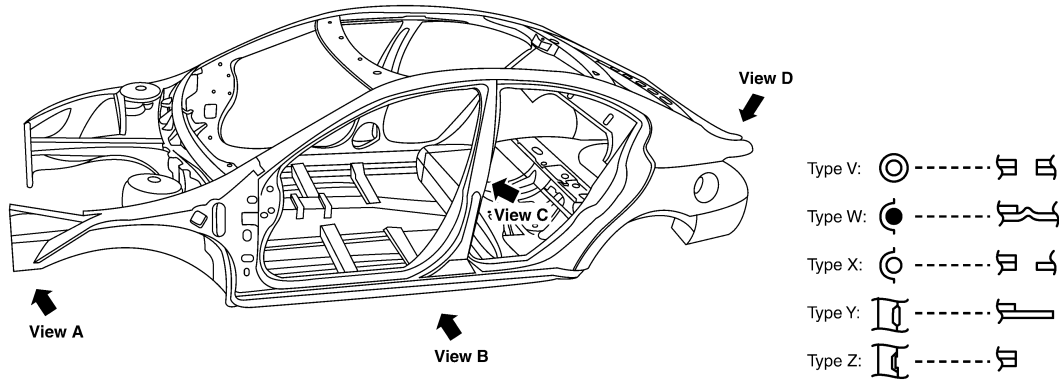
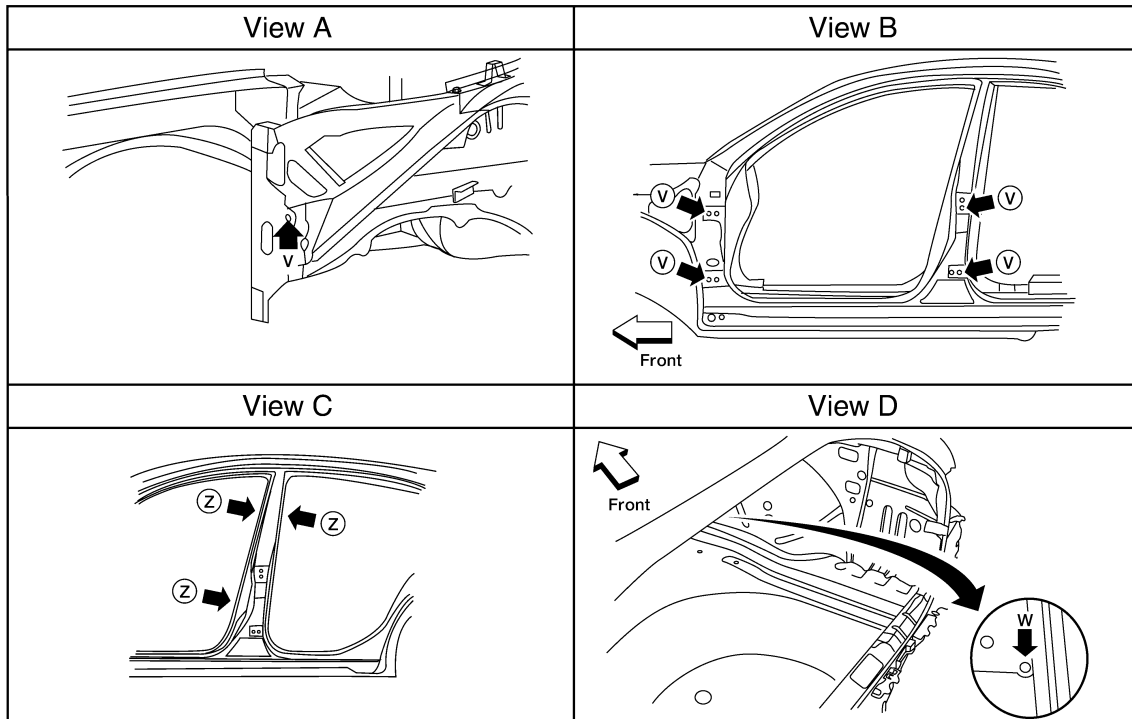
AWKIA1351GB

A mark has been placed on each body panel to indicate the parts matching positions. When repairing parts damaged by an accident which might affect the vehicle structure (members, pillars, etc.), more accurate and effective repair will be possible by using these marks together with body alignment specifications.

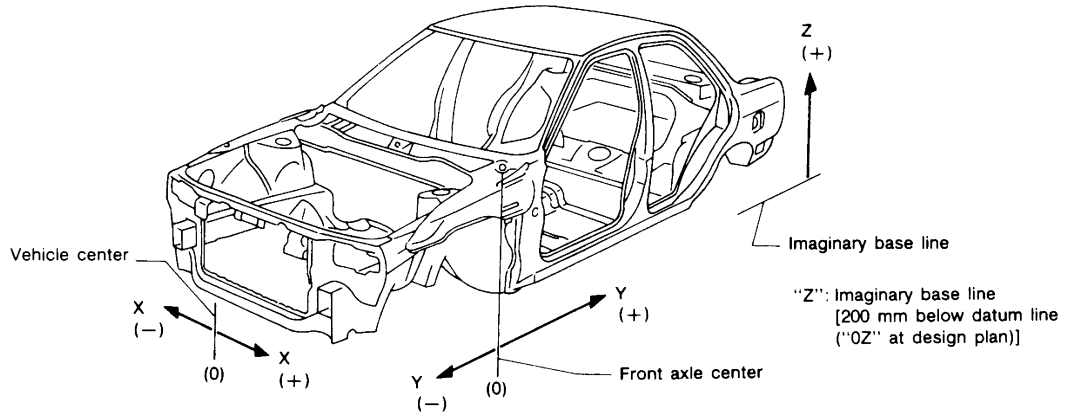
PIIA0104E

- All dimensions indicated in the figures are actual.
- When using a tracking gauge, adjust both pointers to equal length. Then check the pointers and gauge itself to make sure there is no free play.
- When a measuring tape is used, check to be sure there is no elongation, twisting or bending.
- Measurements should be taken at the center of the mounting holes.
- An asterisk (*) following the value at the measuring point indicates that the measuring point on the other side is symmetrically the same value.
- The coordinates of the measurement points are the distances measured from the standard line of "X", "Y" and "Z".

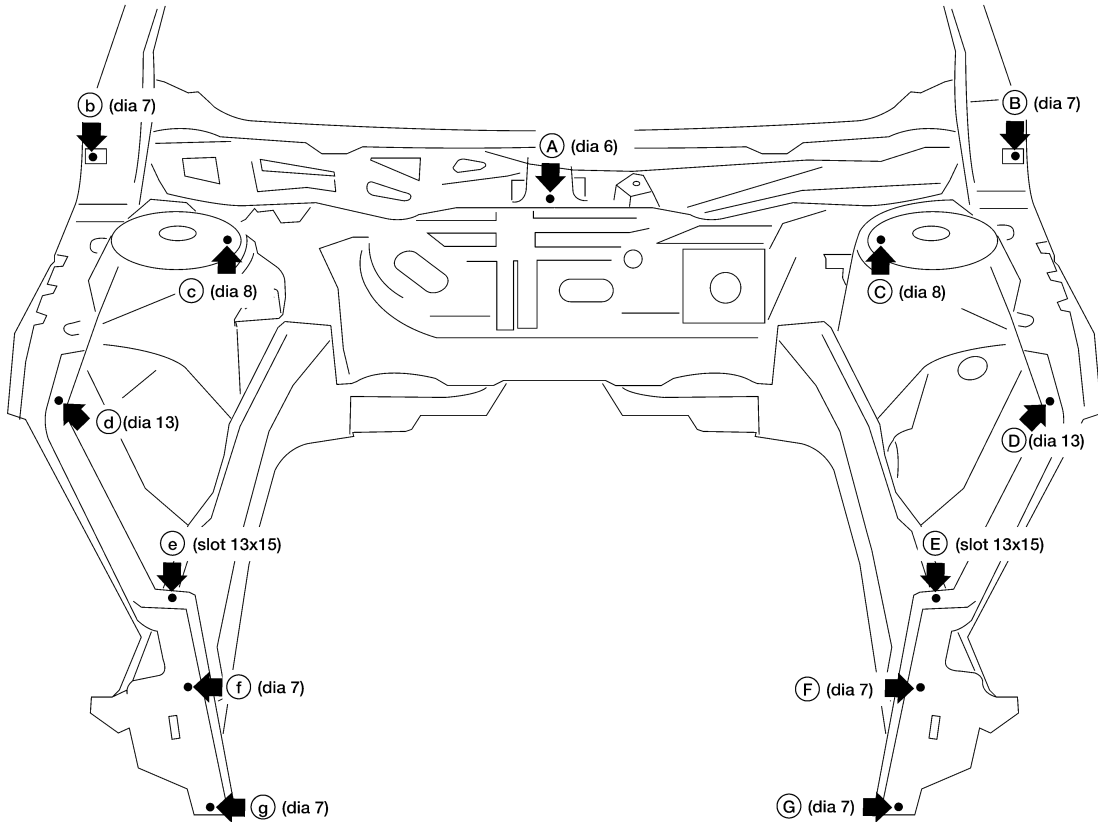
AWKIA1353GB

Figures marked with a (*) indicate symmetrically identical dimensions on both right and left sides of the vehicle.

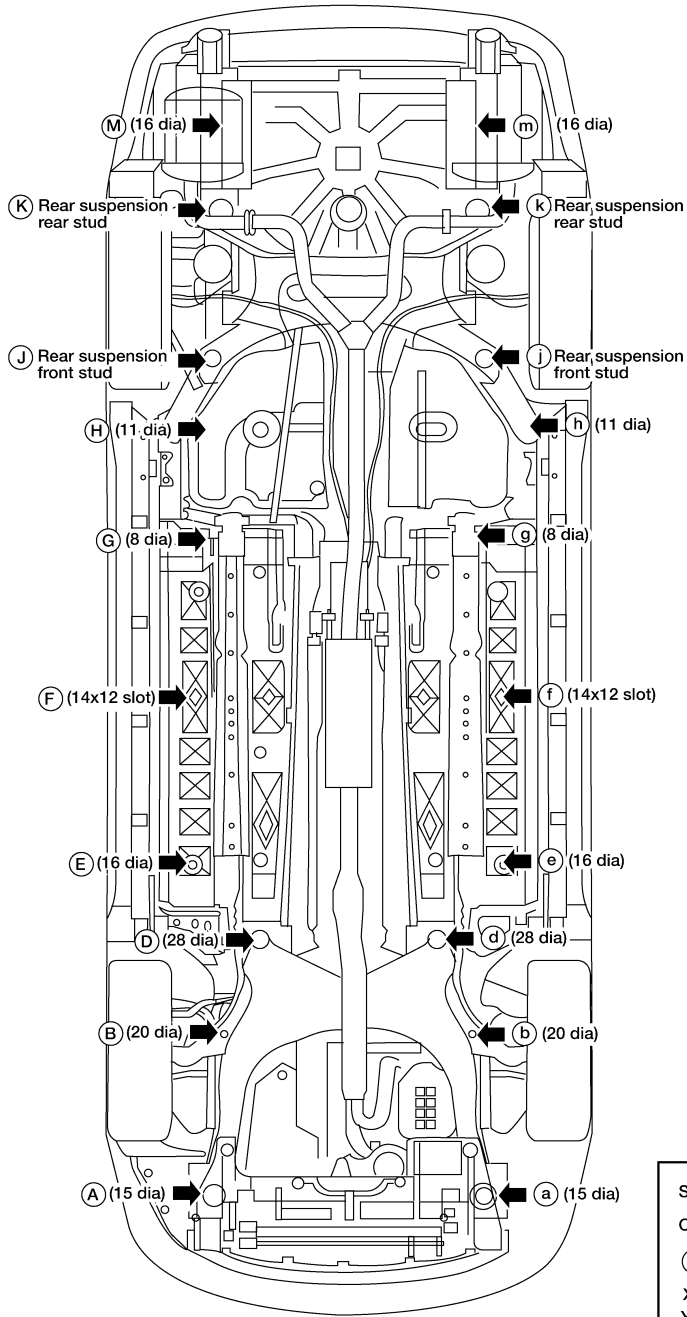
AWKIA1355GB

Figures marked with a (*) indicate symmetrically identical dimensions on both right and left hand sides of the vehicle.

As viewed from underside.

All dimensions indicated in this figure are actual.

(A) (a)
X: ± 497
Y: -556
Z: 332

(B) (b)
X: ± 446
Y: 151
Z: 297

(D) (d)
X: ± 327
Y: 395
Z: 168

(E) (e)
X: ± 424
Y: 624
Z: 91

(F) (f)
X: ± 431
Y: 1322
Z: 93

(G) (g)
X: ± 431
Y: 1938
Z: 79

(H) (h)
X: ± 643
Y: 2301
Z: 179

(J) (j)
X: ± 501
Y: 2558
Z: 161

(K) (k)
X: ± 466
Y: 3107
Z: 193

(M) (m)
X: ± 476
Y: 3525
Z: 338

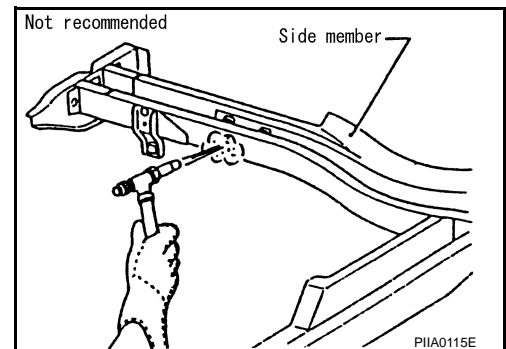
- The repair of reinforcements (such as side members) by heating is not recommended since it may weaken the component. When heating is unavoidable, do not heat HSS parts above 550°C (1,022°F). Verify heating temperature with a thermometer. (Crayon-type and other similar type thermometer are appropriate.)

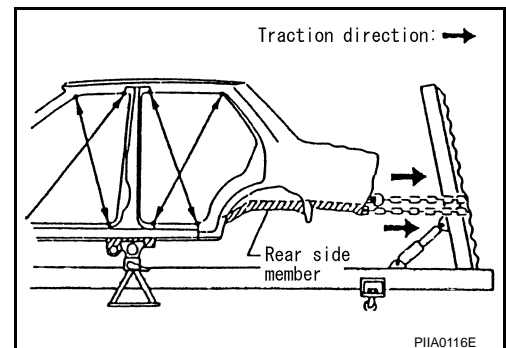
- When straightening body panels, use caution in pulling any HSS panel. Because HSS is very strong, pulling may cause deformation in adjacent portions of the body. In this case, increase the number of measuring points, and carefully pull the HSS panel.

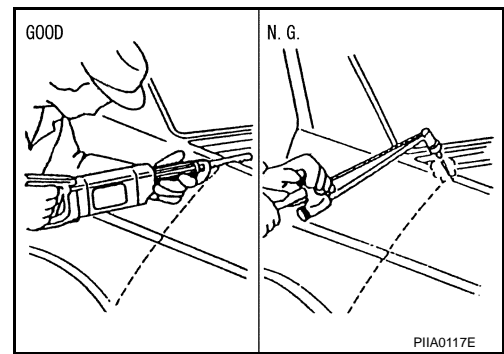
- When cutting HSS panels, avoid gas (torch) cutting if possible. Instead, use a saw to avoid weakening surrounding areas due to heat. If gas (torch) cutting is unavoidable, allow a minimum margin of 50 mm (1.97 in).

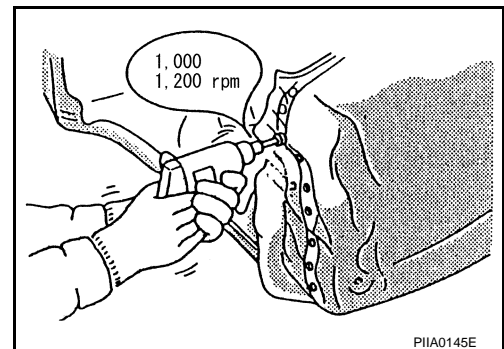
- The spot weld on HSS panels is harder than that of an ordinary steel panel. Therefore, when cutting spot welds on a HSS panel, use a low speed high torque drill (1,000 to 1,200 rpm) to increase drill bit durability and facilitate the operation.

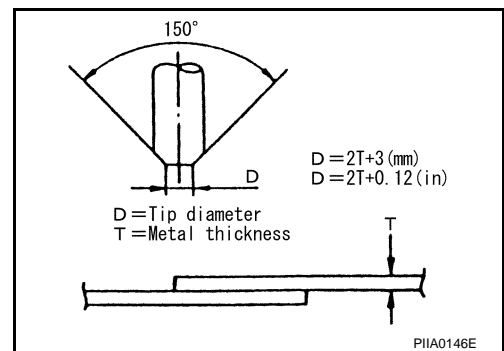
- Precautions in spot welding HSS
This work should be performed under standard working conditions. Always note the following when spot welding HSS:
 - The electrode tip diameter must be sized properly according to the metal thickness.

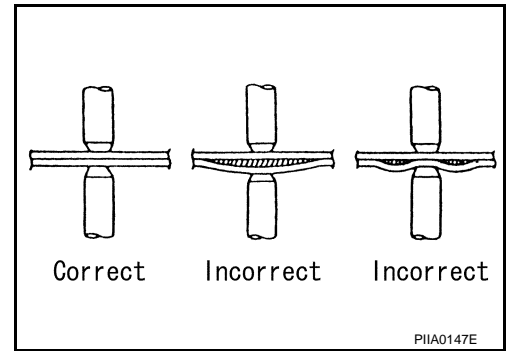
- The panel surfaces must fit flush to each other, leaving no gaps.

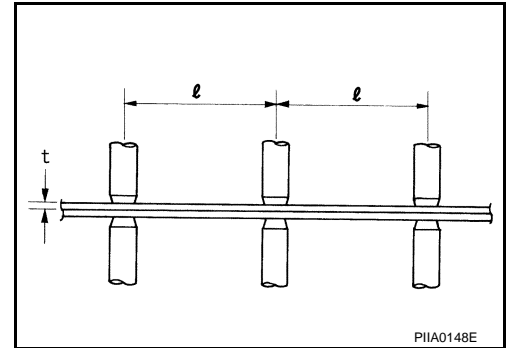
- Follow the specifications for the proper welding pitch.

Unit: mm (in)

Thickness (t)	Minimum pitch (l)
0.6 (0.024)	10 (0.39) or over
0.8 (0.031)	12 (0.47) or over
1.0 (0.039)	18 (0.71) or over
1.2 (0.047)	20 (0.79) or over
1.6 (0.063)	27 (1.06) or over
1.8 (0.071)	31 (1.22) or over

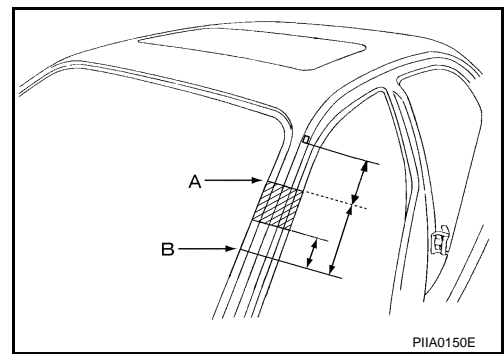
- Front pillar butt joint can be determined anywhere within shaded area as shown in the figure. The best location for the butt joint is at position A due to the construction of the vehicle. Refer to the front pillar section.

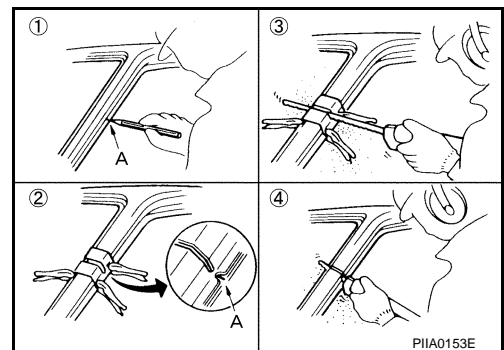
- An example of cutting operation using a cutting jig is as follows.

1. Mark cutting lines.
 - A: Cut position of outer pillar
 - B: Cut position of inner pillar
2. Align cutting line with notch on jig. Clamp jig to pillar.
3. Cut outer pillar along groove of jig. (At position A)
4. Remove jig and cut remaining portions.
5. Cut inner pillar at position B in same manner.

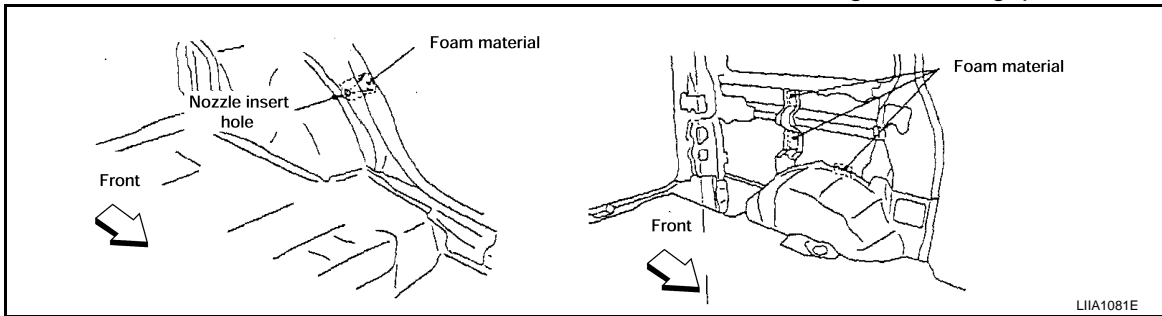
- Clean area in which foam was removed.
- Install service part.
- Insert nozzle into hole near fill area and fill foam material or fill in enough to close gap with service part.

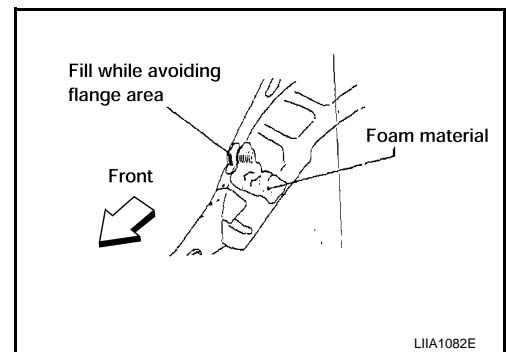
2. Fill procedures before installation service part

- Remove foam material remaining on vehicle side.
- Clean area in which foam material on wheelhouse outer side was removed.

Refer to label for information on working times.

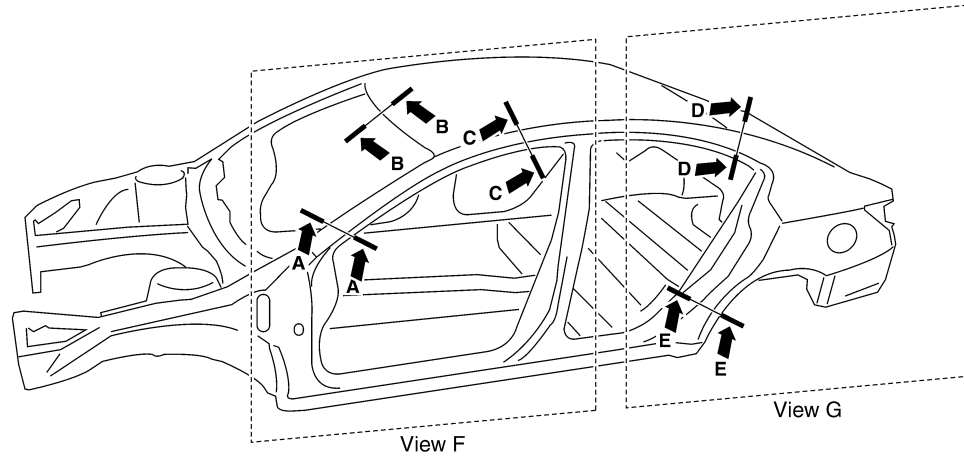
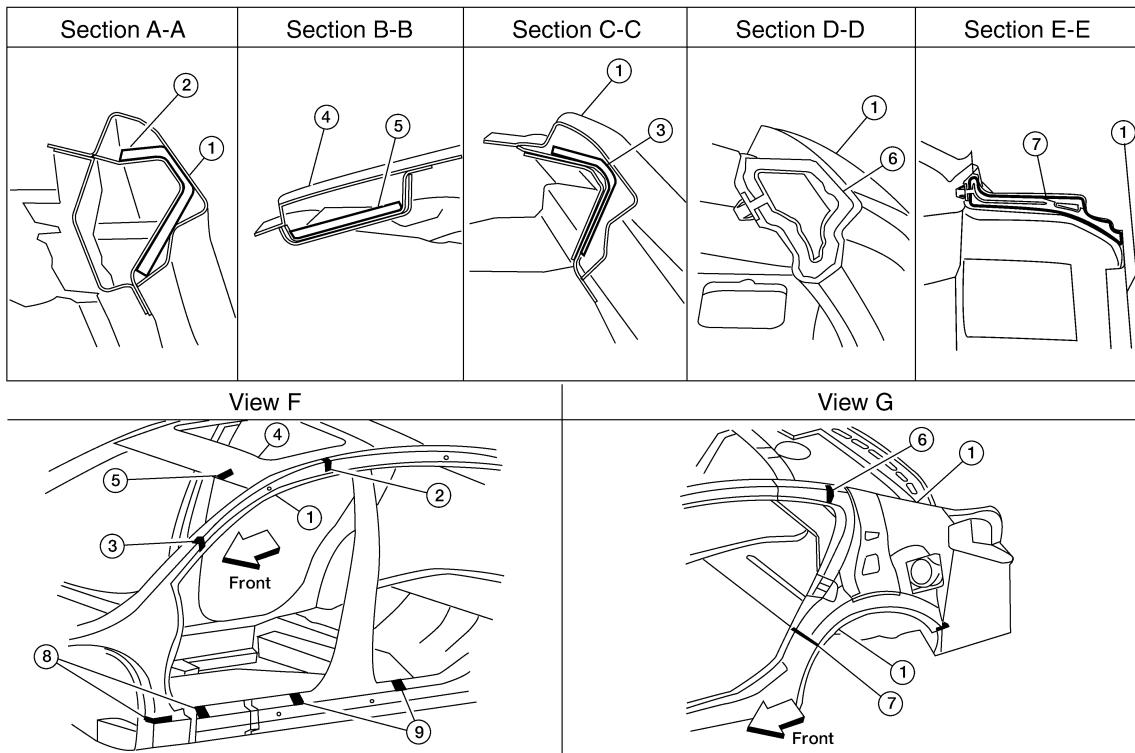
| 1. Body side outer | 2. Body side insulation (foam) upper front pillar | 3. Body side insulation (foam) front pillar |

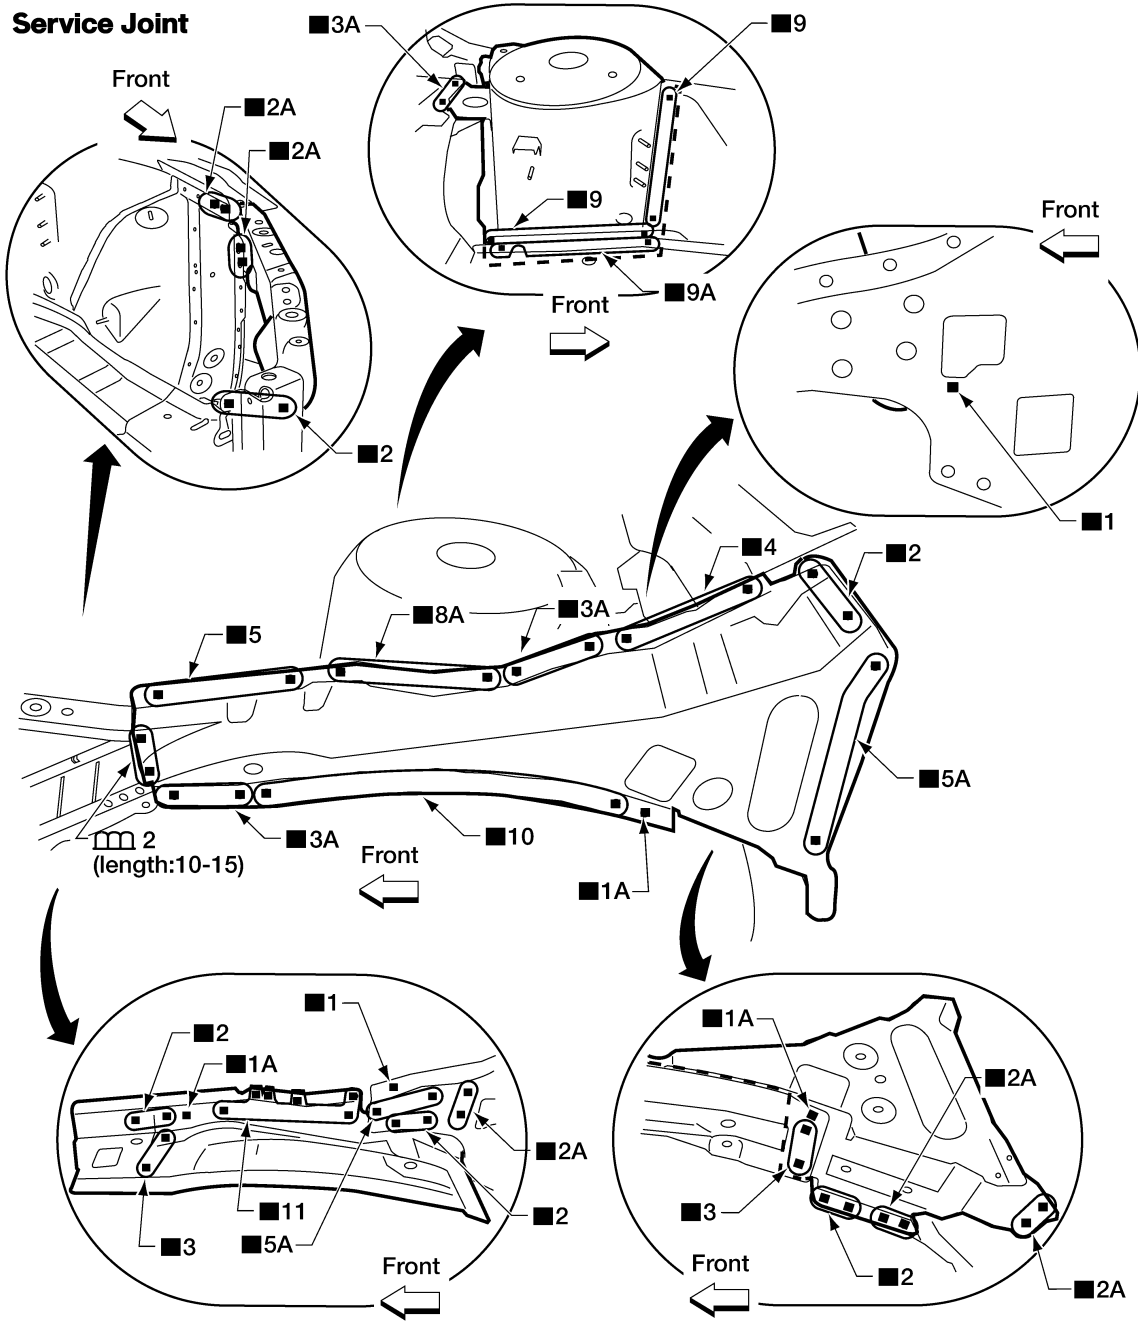
Hoodledge

Unit : mm

2-spot welds
