SECTION IP
INSTRUMENT PANEL

INSTRUMENT PANEL ASSEMBLY

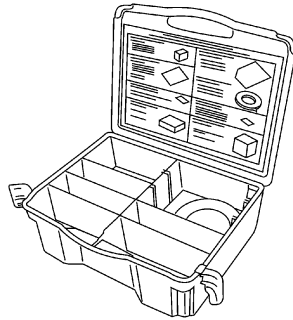
SBT839

Tool number (Kent-Moore No.) Tool name	Description
— (J-39570) Chassis ear	Locating the noise
— (J-43980) NISSAN Squeak and Rattle kit	Repairing the cause of noise

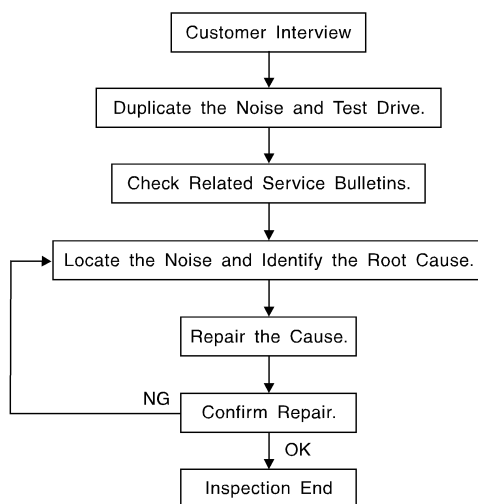
SBT842

Work Flow

CUSTOMER INTERVIEW

DUPLICATE THE NOISE AND TEST DRIVE

LOCATE THE NOISE AND IDENTIFY THE ROOT CAUSE

REPAIR THE CAUSE

CONFIRM THE REPAIR

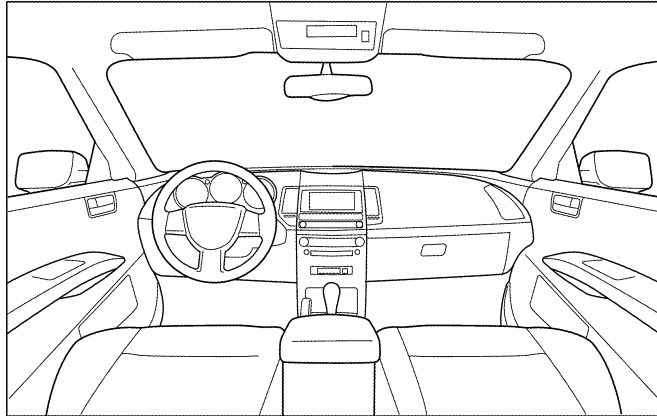
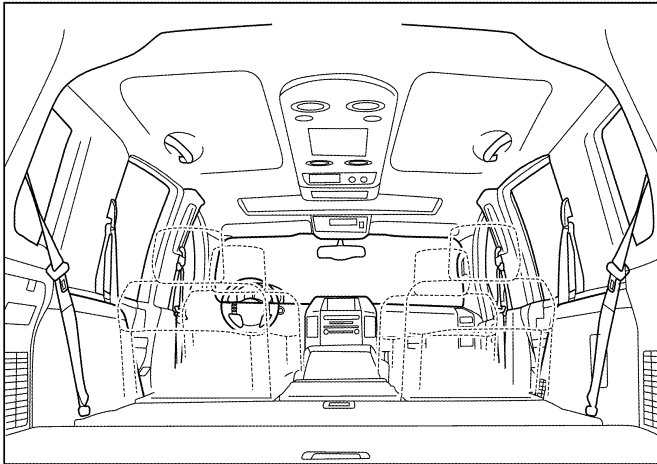
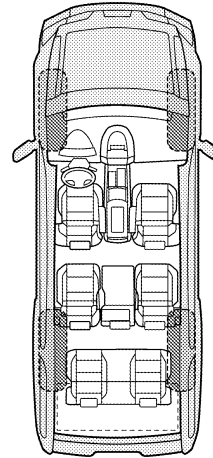
I. WHERE DOES THE NOISE COME FROM? (circle the area of the vehicle)

The illustrations are for reference only, and may not reflect the actual configuration of your vehicle.

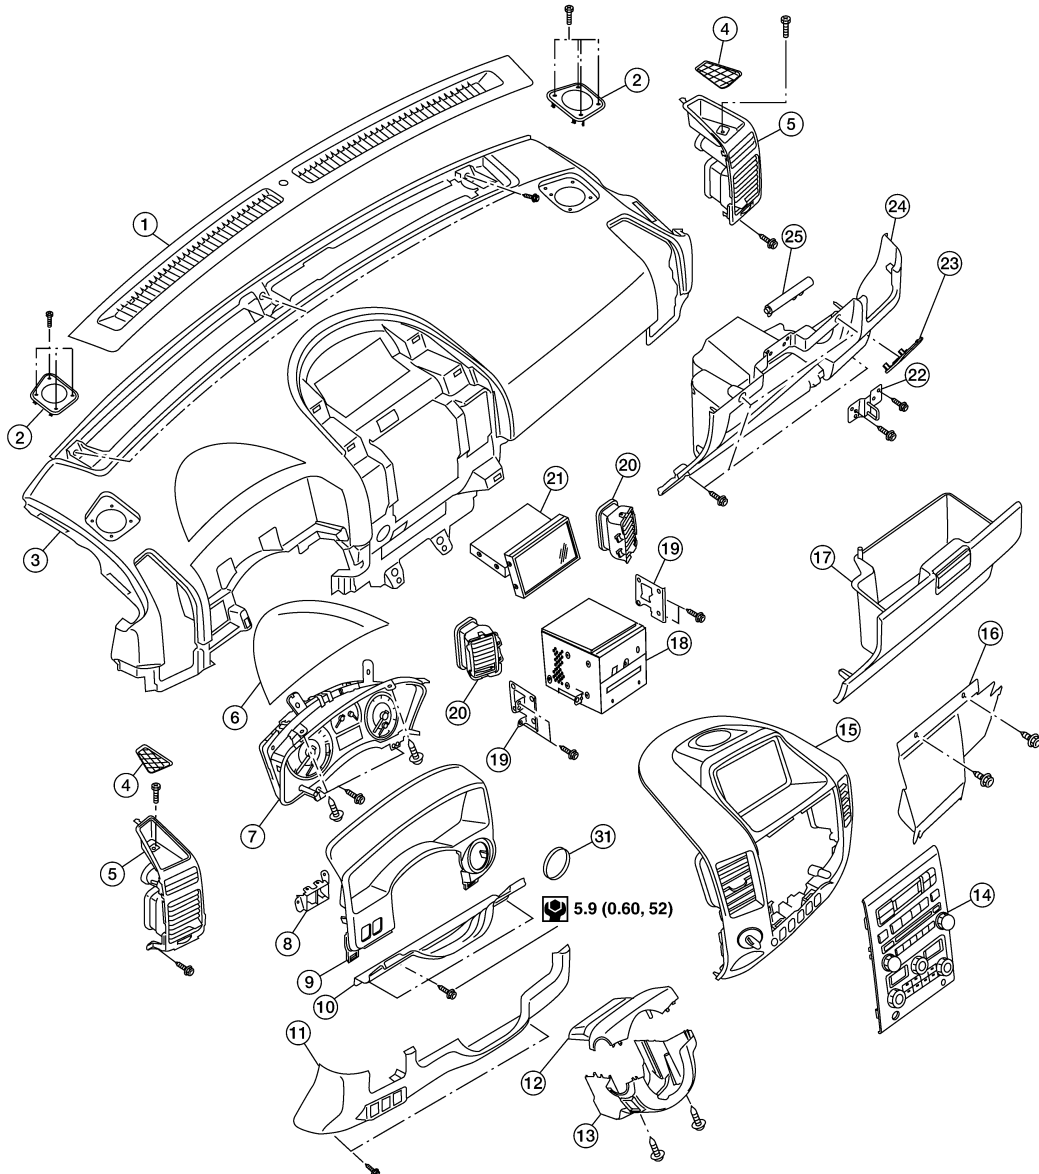
ALJIA0099GB

1. Defroster grille	2. Speaker grille RH/LH	3. Instrument panel and pad assembly	A
4. Deck pocket mat RH/LH	5. Side ventilator assembly RH/LH	6. Combination meter cover	
7. Combination meter	8. Switch assembly	9. Cluster lid A	
10. Lower knee protector	11. Lower instrument panel LH	12. Steering column cover upper	B
13. Steering column cover lower	14. Cluster lid D	15. Cluster lid C	
16. Instrument lower cover RH	17. Glove box	18. Audio unit	
19. Audio bracket RH/LH	20. Center ventilator assembly RH/LH	21. Display assembly (if equipped)	C
22. Glove box lid striker	23. Fuse block cover	24. Lower instrument panel RH	
25. Glove box damper (if equipped)			D

REMOVAL

1. Remove the center console. Refer to [IP-18, "Removal and Installation"](#).
2. Remove instrument lower cover LH. Refer to [IP-16, "Removal and Installation"](#).

3. Remove the steering column. Refer to [ST-12, "Removal and Installation"](#).
4. Remove the combination meter. Refer to [MWI-103, "Removal and Installation"](#).

5. Remove audio unit. Refer to [AV-34, "Removal and Installation"](#).
6. Remove display unit (if equipped). Refer to [AV-316, "Removal and Installation"](#).

7. Remove lower knee protector.
8. Remove defroster grille and disconnect the optical sensor harness.
9. Remove side ventilator assembly LH.
10. Remove the LH assist grip and windshield garnish.

11. Remove side ventilator assembly RH.
12. Remove the RH assist grip and windshield garnish.
13. Remove the passenger air bag module. Refer to [SR-8, "Removal and Installation"](#).

14. Remove instrument panel and pad assembly.
15. Disconnect remaining instrument panel assembly electrical connectors.

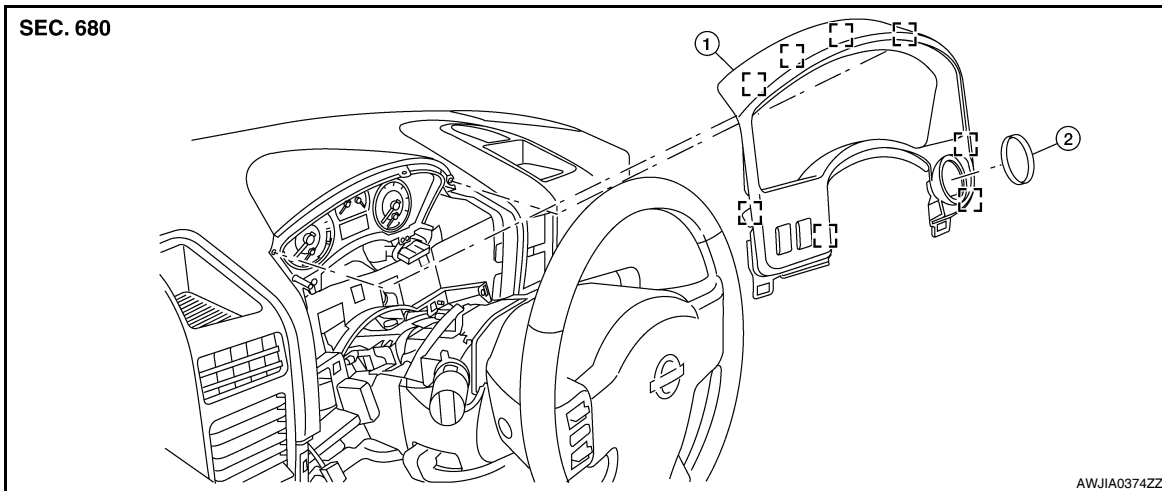
1. Cluster lid A

2. Ignition switch escutcheon

Metal Clip

1. Disconnect the battery negative terminal.
2. Remove the lower instrument panel LH. Refer to [IP-16, "Removal and Installation"](#).
3. Tilt the steering wheel to the lowest position, then remove steering column cover upper.
4. Remove ignition switch escutcheon.
5. Pull cluster lid A rearward in vehicle to release the clips.
6. Disconnect the electrical connector(s), then remove cluster lid A.

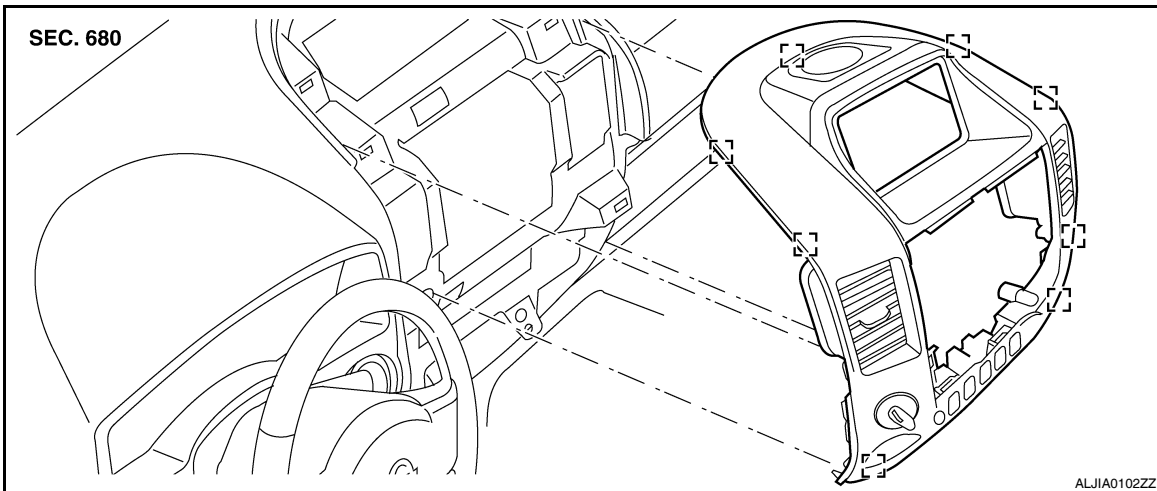
Metal clip

1. Disconnect the battery negative terminal.
2. Remove center console upper finisher and A/T finisher (if equipped). Refer to [IP-17, "Removal and Installation"](#).
3. Remove instrument lower panel RH and glove box. Refer to [IP-15, "Removal and Installation"](#).
4. Remove lower instrument panel LH. Refer to [IP-16, "Removal and Installation"](#).
5. Remove cluster lid D. Refer to [IP-14, "Removal and Installation"](#).
6. Remove center console (if equipped). Refer to [IP-18, "Removal and Installation"](#).
7. Disconnect the electrical connector(s), then remove cluster lid C.
8. Pull cluster lid C rearward in vehicle to release the clips.

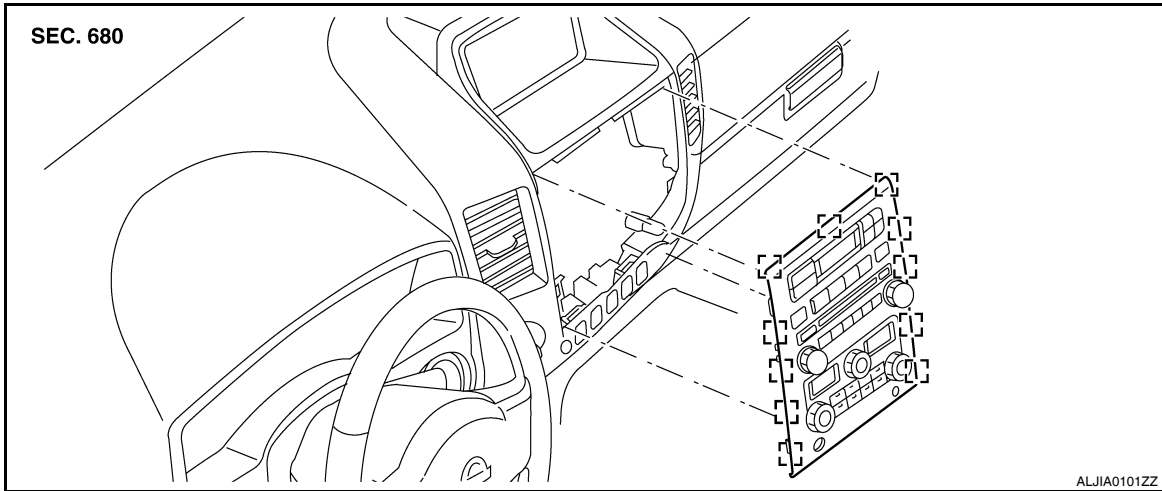
Metal clip

1. Disconnect the battery negative terminal.
2. Pull cluster lid D rearward in vehicle to release the clips.
3. Disconnect the electrical connector(s), then remove cluster lid D.

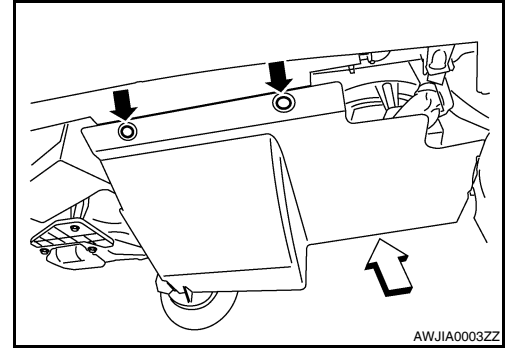
1. Disconnect the battery negative terminal.
2. Release the clips, then remove instrument lower cover RH.
← Vehicle front
3. Remove lower instrument panel RH and glove box screws.
Refer to [IP-19, "Exploded View"](#).
4. Disconnect the electrical connector, then remove the lower instrument panel RH and glove box.

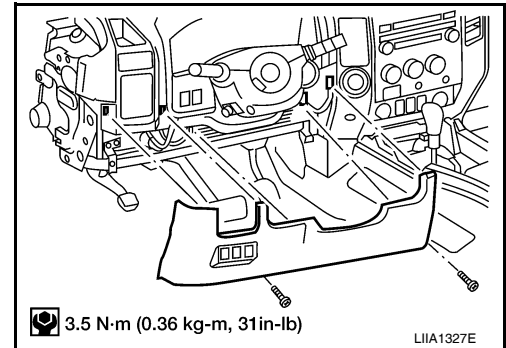
1. Remove lower instrument panel LH screws.
2. Pull lower instrument panel LH rearward in vehicle to release the clips.
3. Disconnect the electrical connector(s), then remove lower instrument panel LH.

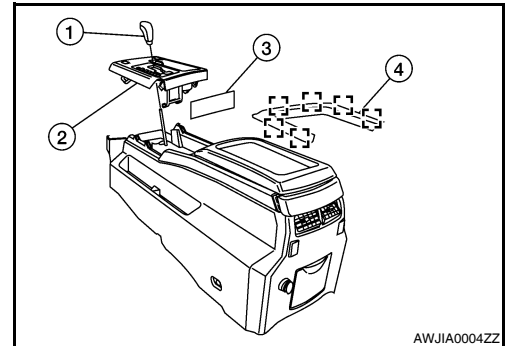
1. Remove the shift knob (1).
2. Remove the storage compartment mask (3) and console upper finisher (4).
3. Pull up on A/T finisher (2) to release clips, then tilt aside.
4. Disconnect A/T finisher electrical connectors and remove from front center console assembly.

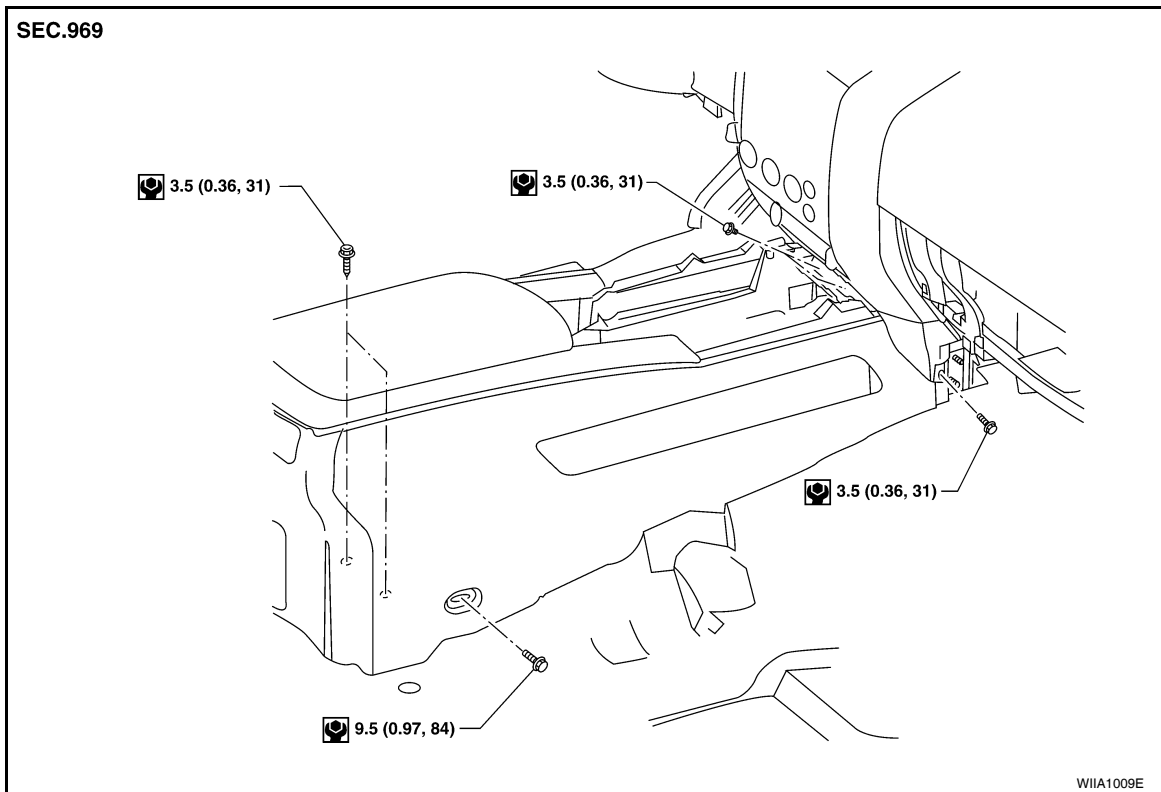
1. Disconnect the battery negative terminal.
2. Remove control device. Refer to [TM-217. "Control Device Removal and Installation"](#).
3. Remove lower instrument panel RH and glove box. Refer to [IP-15. "Removal and Installation"](#).
4. Remove center console lower cover RH/LH.
5. Remove front center console screws.
6. Move front seats (including seat back) to forward most position, then remove rear center console screws.
7. Lift rear of center console upward then rearward to disengage heat duct.
8. Remove center console through rear door opening.

When removing, two workers are required (one for each front and rear of center console). Cover seating and interior surfaces with a shop cloth to prevent damage.

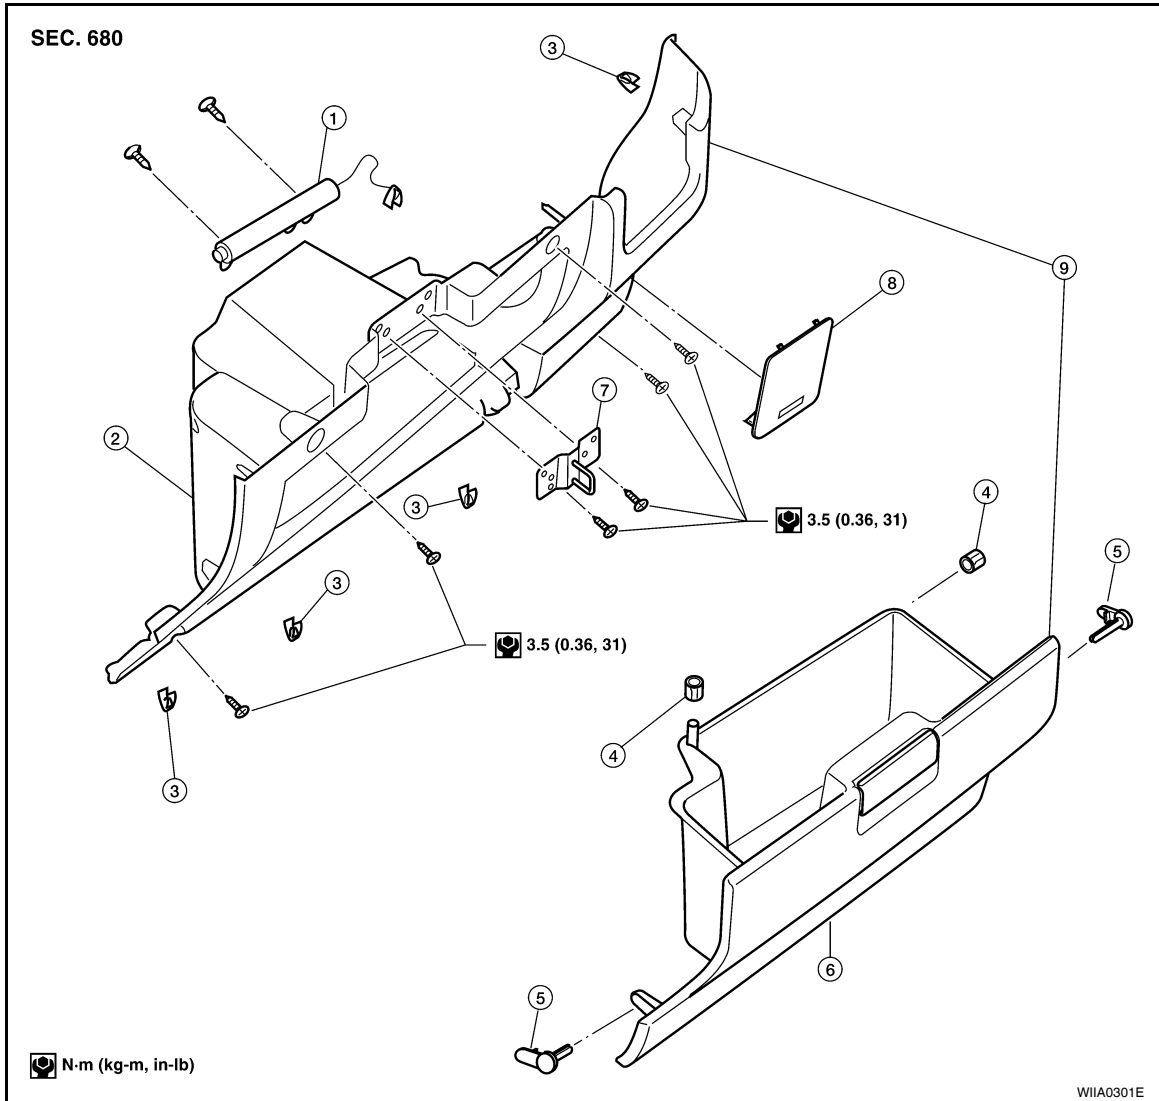
| 1. Glove box damper (if equipped) | 2. Glove box housing | 3. Clips |
| 4. Rubber stoppers | 5. Glove box pins | 6. Glove box |
| 7. Glove box striker | 8. Fuse block cover | 9. Instrument lower panel RH and glove box assembly |

1. Remove damper clip (if equipped) from glove box.
2. Remove glove box pins and glove box.
3. Remove glove box striker screws, using power tool and remove glove box striker.
4. Remove fuse block cover.
5. Remove glove box damper screws and remove glove box damper (if equipped).

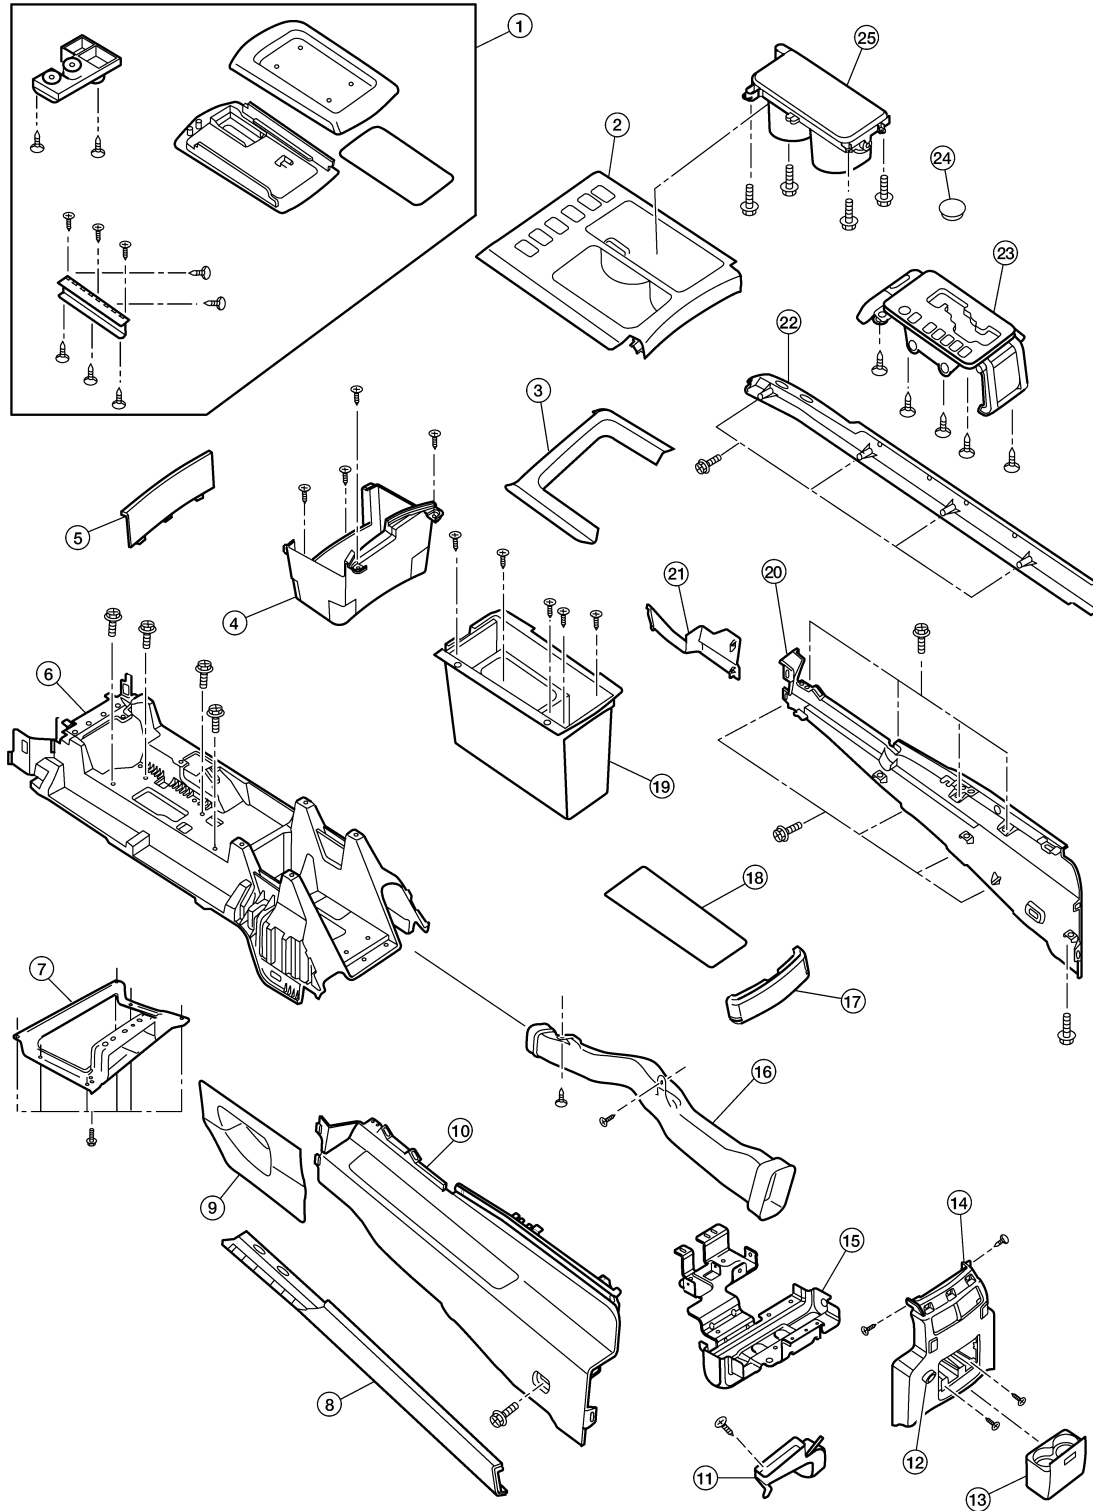
ALJIA0103ZZ

| 1. Console lid assembly | 2. A/T finisher | 3. Console upper finisher |
| 4. Storage compartment | 5. Storage compartment mask | 6. Console reinforcement assembly |
| 7. Console front bracket | 8. Lower side finisher LH | 9. Center console lower cover LH |
