SECTION **IP**
INSTRUMENT PANEL

INSTRUMENT PANEL ASSEMBLY

Component Parts Drawing

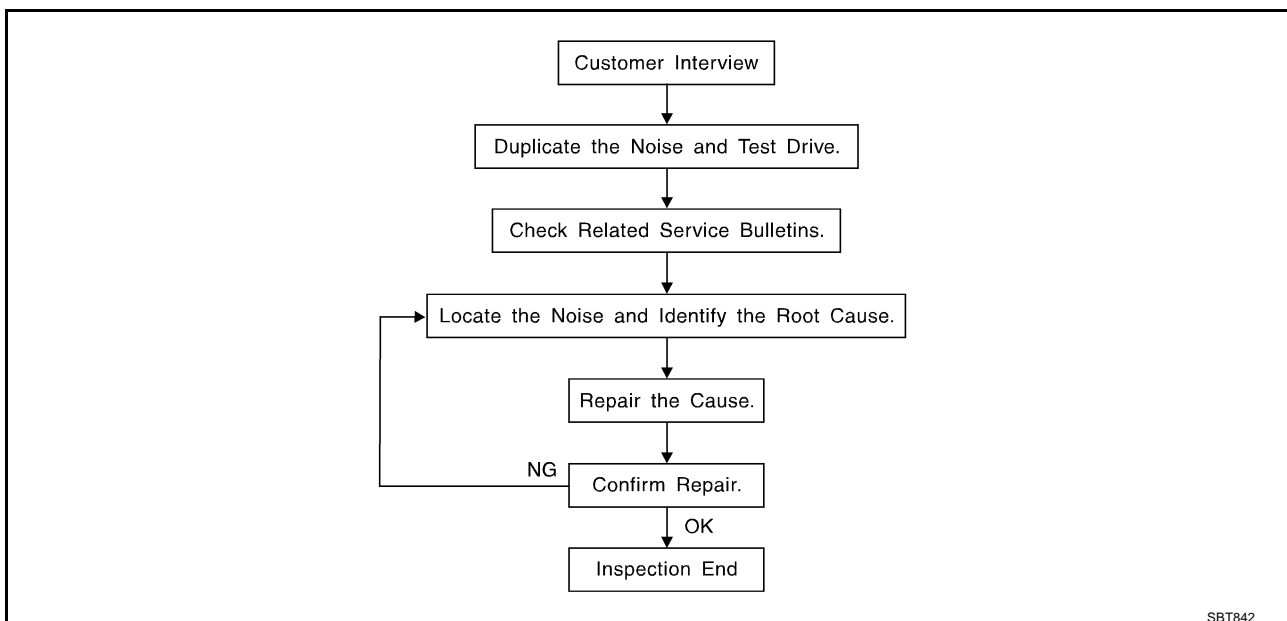
Work Flow

CUSTOMER INTERVIEW

Interview the customer if possible, to determine the conditions that exist when the noise occurs. Use the Diagnostic Worksheet during the interview to document the facts and conditions when the noise occurs and any customer's comments; refer to [IP-8, "Diagnostic Worksheet"](#). This information is necessary to duplicate the conditions that exist when the noise occurs.

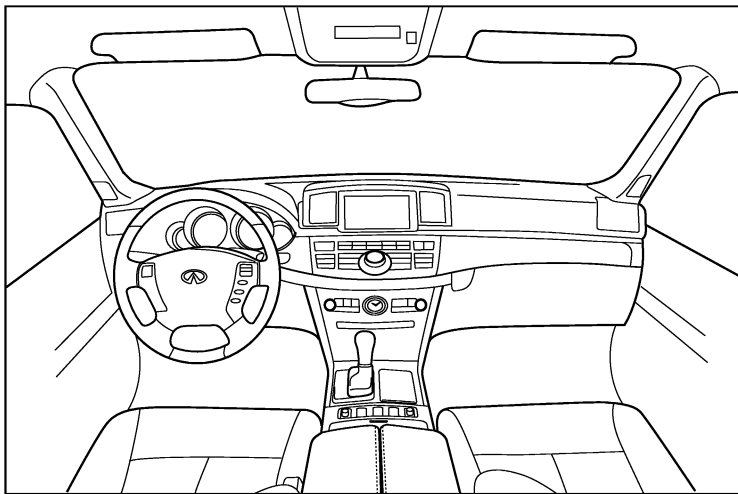
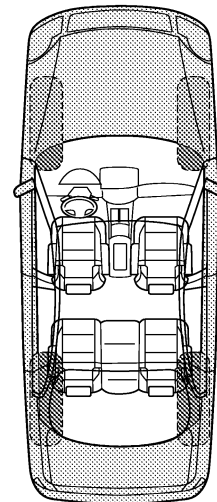
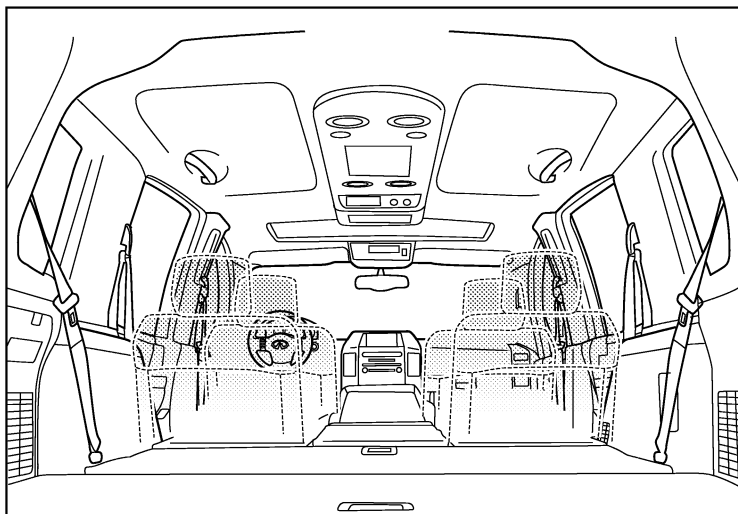
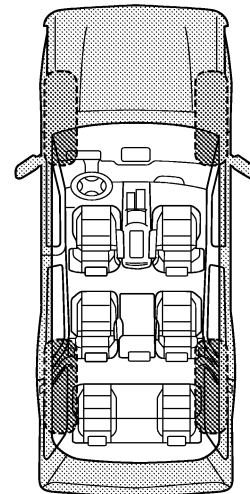
PIIB8741E

I. WHERE DOES THE NOISE COME FROM? (circle the area of the vehicle)

The illustrations are for reference only, and may not reflect the actual configuration of your vehicle.

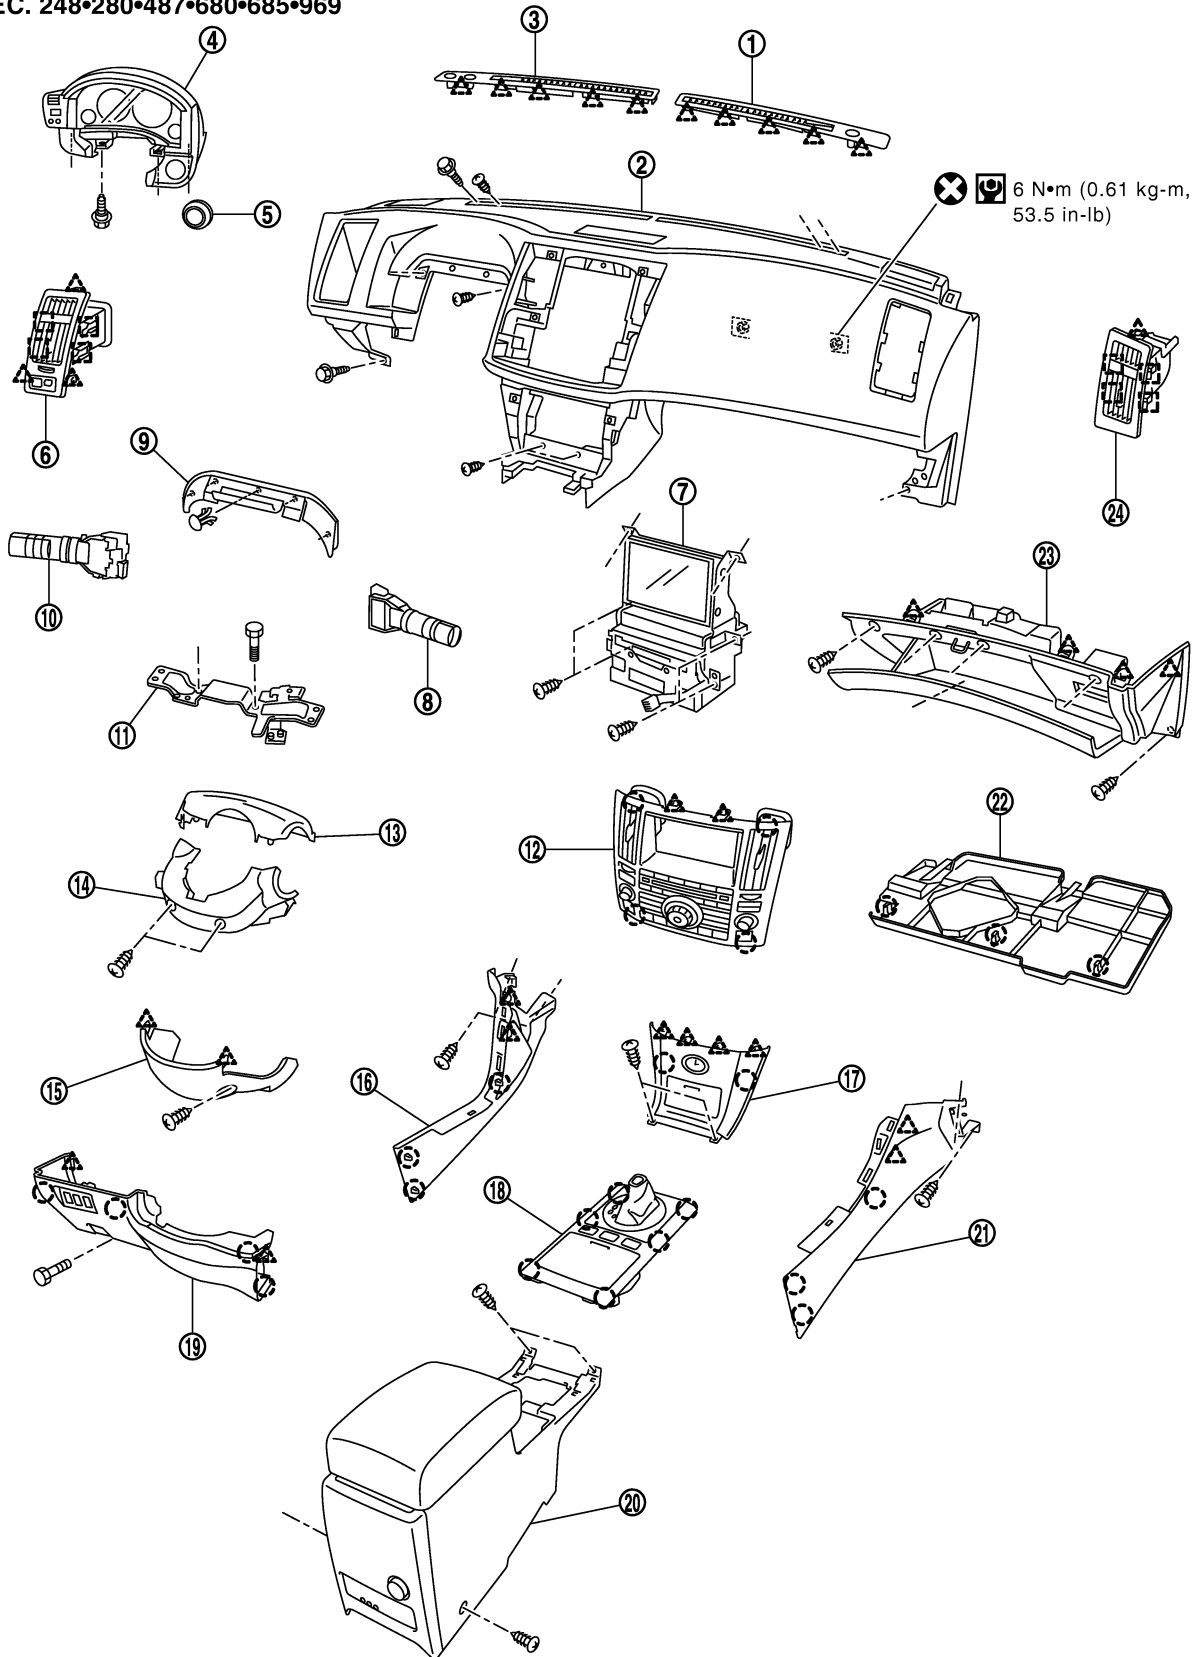
PIIB8532E

| 1. Front defroster grille (RH) | 2. Instrument panel and pad | 3. Front defroster grille (LH) |
| 4. Combination meter assembly | 5. Steering lock escutcheon | 6. Side ventilation (LH) |
| 7. Display unit and audio unit | 8. Wiper and washer switch | 9. Rubber |
| 10. Lighting and turn signal switch | 11. Combination meter bracket | 12. Cluster lid C |
| 13. Steering column upper cover | 14. Steering column lower cover | 15. Steering column front lower cover |
| 16. Instrument side panel (LH) | 17. Instrument clock finisher assembly | 18. A/T console finisher assembly |
| 19. Instrument driver lower panel | 20. Center console | 21. Instrument side panel (RH) |
| 22. Instrument lower cover | 23. Instrument passenger lower panel | 24. Side ventilation (RH) |

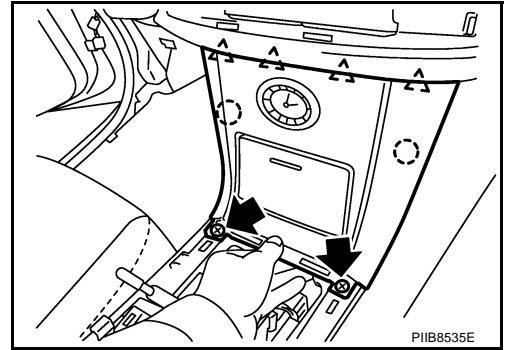
(E) Instrument Clock Finisher

1. Remove screw and then pull back to your side of instrument clock finisher.
2. Disconnect clips and harness connector, and remove instrument clock finisher.

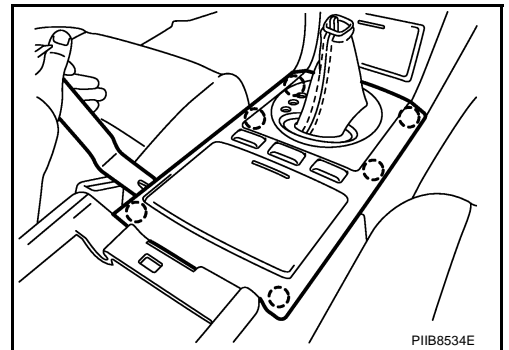
(F) A/T Console Finisher

1. Insert a remover into side between gaps of A/T console finisher assembly and remove by lifting A/T console finisher.
2. Disconnect harness connector.

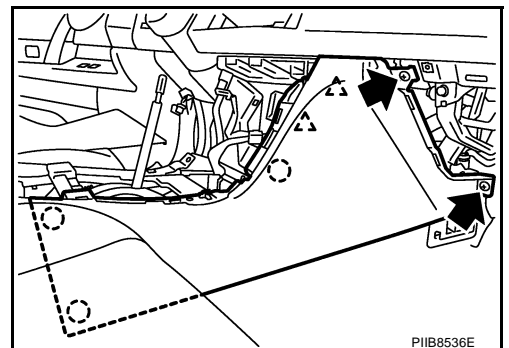
(G) Instrument Side Panel (RH/LH)

1. Remove screws with power tool.
2. Pull to the side, disconnect clip and pawls and remove instrument side panel (RH/LH).

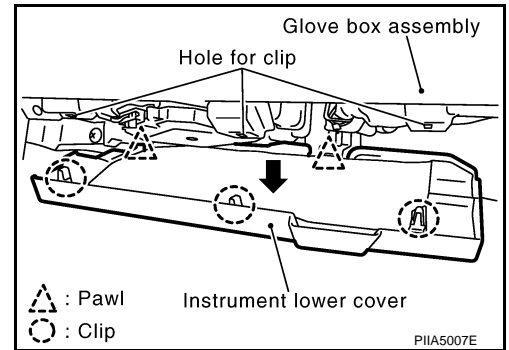
(I) Instrument Lower Cover

1. Pull down front instrument lower cover, and disconnect clips.
2. Pull it horizontally, and remove from lower cover pawls.

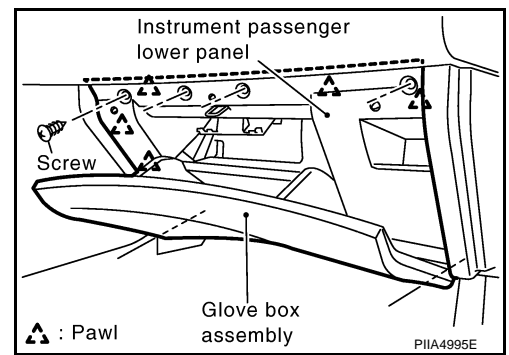
(J) Instrument Passenger Lower Panel

Remove screws with power tool, and disconnect harness connector, and remove instrument passenger lower panel.

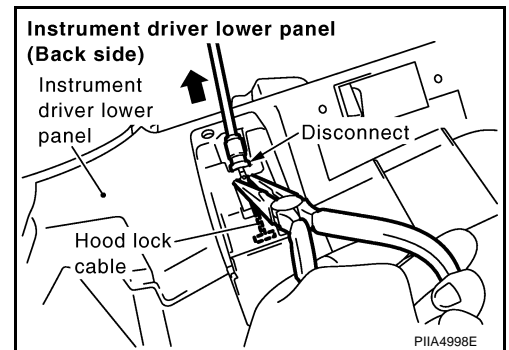
(K) Instrument Driver Lower Panel

1. Remove bolt and screws with power tool.
2. Remove data link connector.
3. Pull to disengage clip and pawl by removing panel in horizontal direction.
4. Disconnect in-vehicle sensor and each electrical parts.
5. Remove the grommet, and remove hood lock cable.

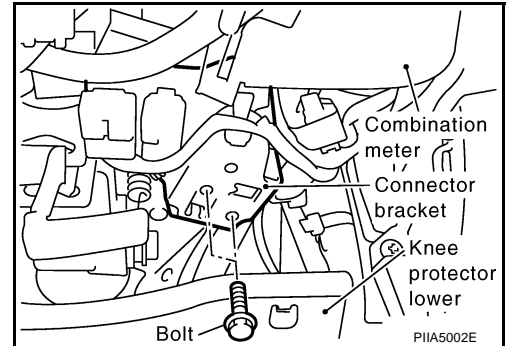
(R) Combination Meter Assembly

1. Remove bolts with power tool, and then remove connector bracket.

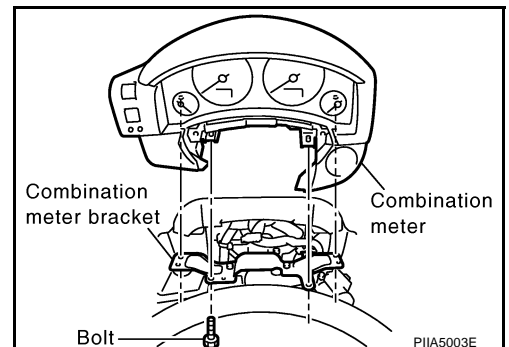
2. Remove bolts with power tool and then disconnect harness connector.

To prevent it from damaged by interference with the combination meter assembly, protect the combination meter assembly with cloths.

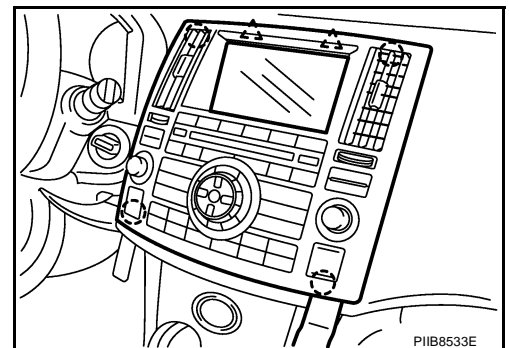
(S) Cluster Lid C

1. Insert a remover into gap between instrument panel and pad, pull back to your side, and disconnect metal clips below.
2. Disconnect harness connectors, and remove cluster lid C.

Cover surroundings with cloth to avoid scratches or damages.

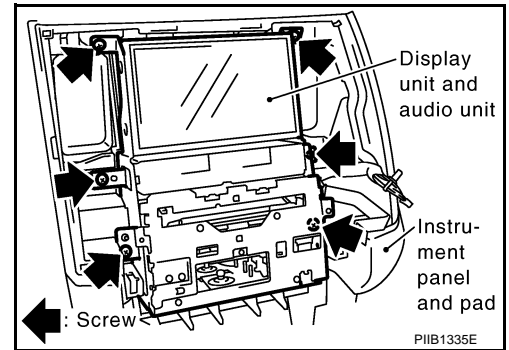
(T) Display Unit and Audio Unit

Unit is heavy, so be careful not to pinch your fingers when working.

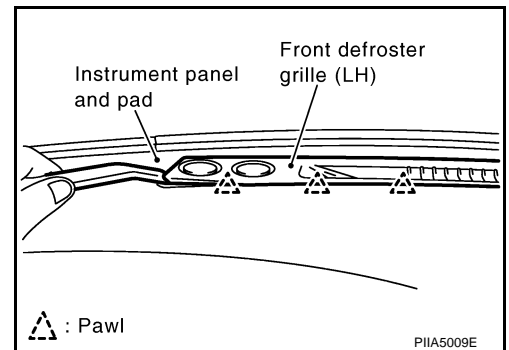
(U) Front Defroster Grille (RH/LH)

Insert a remover into gaps between front defroster grille (RH/LH) and instrument panel and pad, lift front defroster grille up, and remove front defroster grille (RH/LH).

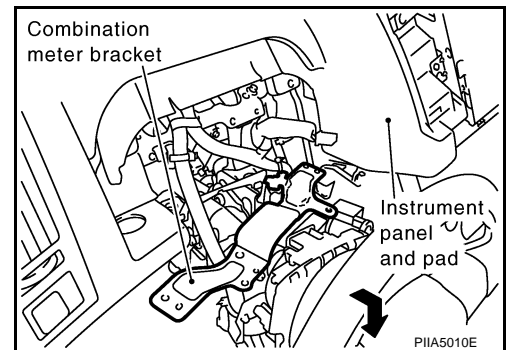
(V) Combination Meter Bracket

1. Remove bolts.
2. The installation bolts of the harness clip and steering column assembly is removed, steering column assembly is pulled backward, and set combination meter bracket free from the instrument panel and pad. Refer to [PS-13, "STEERING COLUMN"](#).

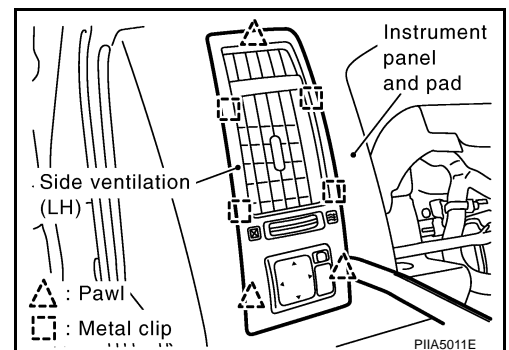
(W) Side Ventilation (RH/LH)

1. Insert a remover into gaps between instrument panel and pad, pull back to your side, and disconnect metal clips below.
2. Disconnect door mirror switch harness connectors, and remove side ventilation (RH/LH).

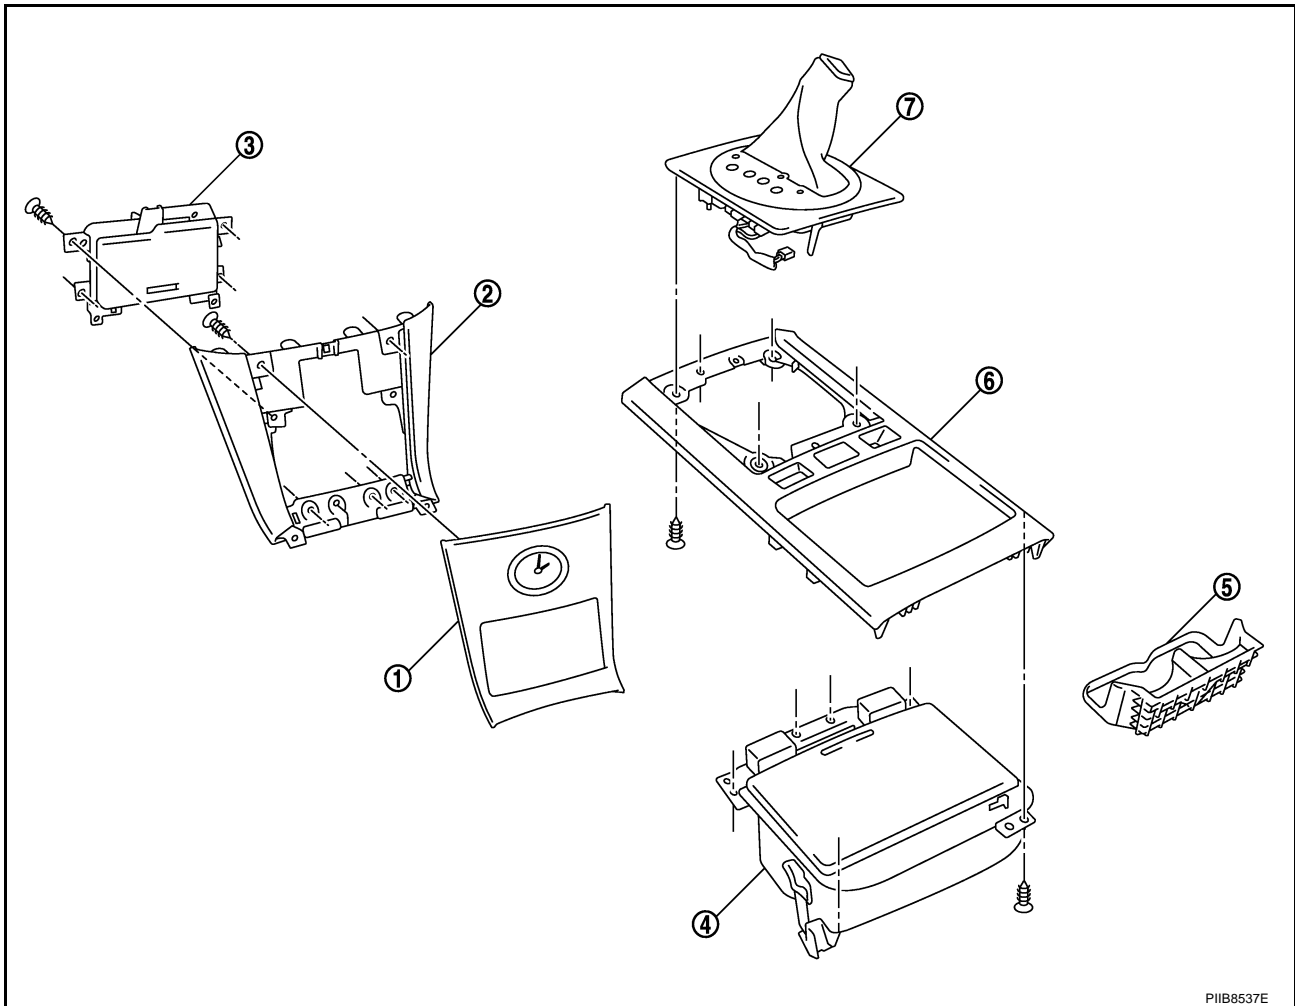
Disassembly and Assembly A/T CONSOLE FINISHER

| 1. Instrument clock panel | 2. Instrument clock finisher | 3. Ashtray |

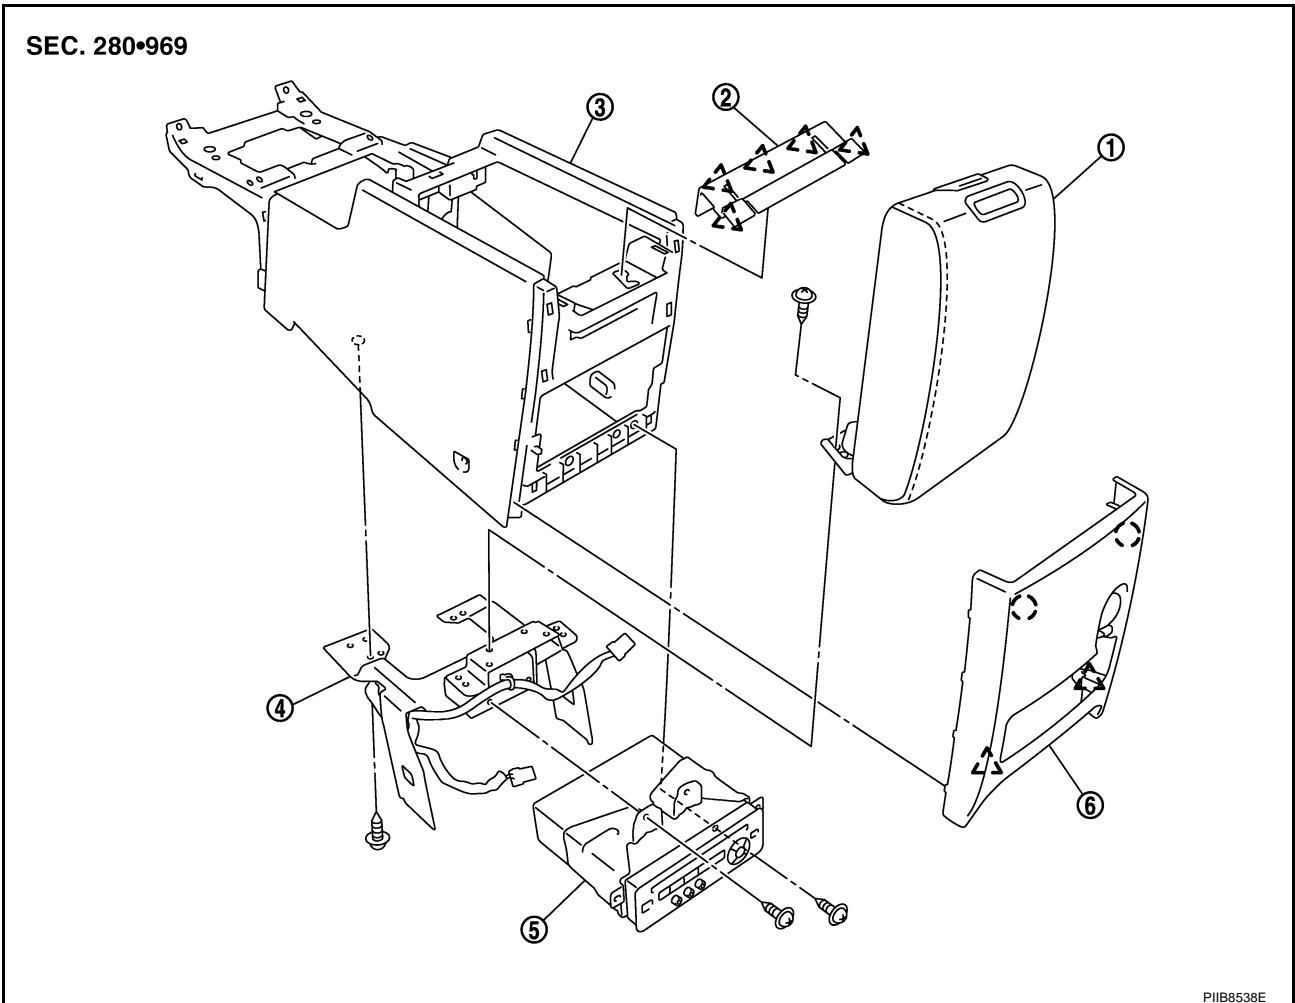
CENTER CONSOLE

| 1. Console lid | 2. Console mask | 3. Console body |

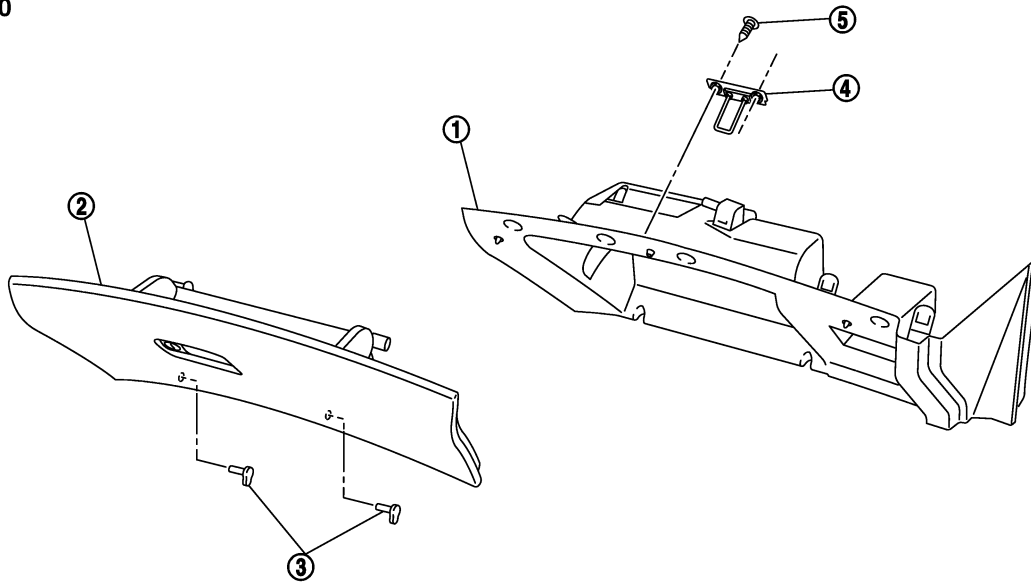
PIIA5012E

1. Instrument passenger lower panel
2. Glove box
3. Glove box pin
4. Glove box striker
5. Screw

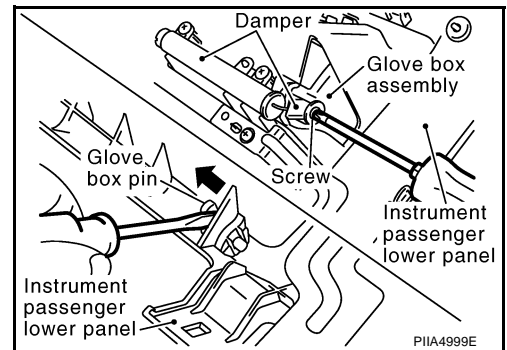
PIIA4999E

1. Detach the damper from glove box assembly right side.
2. Remove glove box pins and remove glove box assembly.

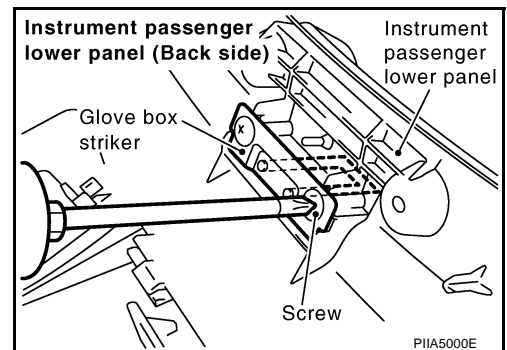
PIIA5000E

3. Remove screws with power tool and remove glove box striker.
