## SERVICE BULLETIN

**APPLICABILITY** ALL MODELS EQUIPPED WITH A POWER ANTENNA

**DATE** 10-08-92

**SUBJECT:** POWER ANTENNA SERVICING

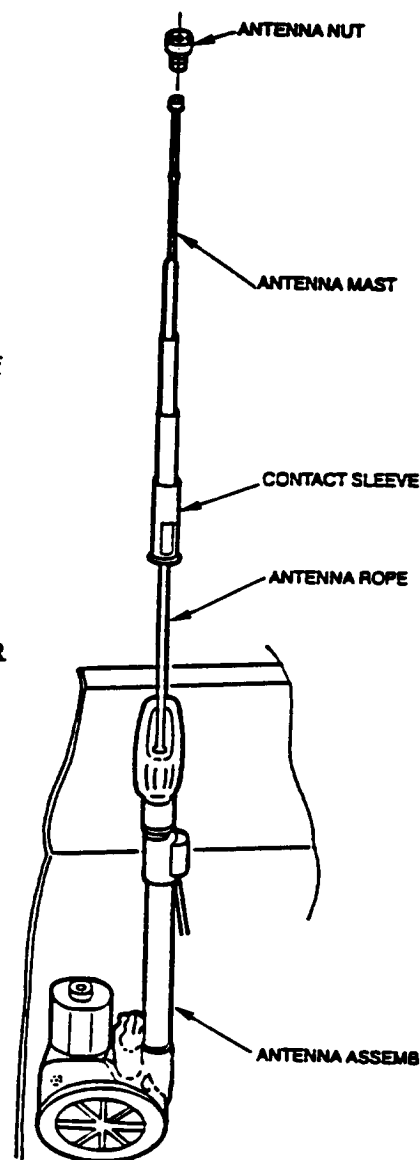
If you receive a customer complaint of improper power antenna operation, the cause may be a stuck, tight or binding mast.

### Inspect the removed mast.

1. Check the mast by manually extending and contracting by hand. Visually inspect the mast. A tight or binding mast may be caused by being bent or rusted. If either of these conditions exist, replace the mast.
2. Inspect the antenna rope for possible damage, such as stripped teeth or breakage. If damage is found, replace the mast.

The mast should be removed following the instructions which come with the part.
