3. Inspection Locations After a Collision

AIRBAG SYSTEM

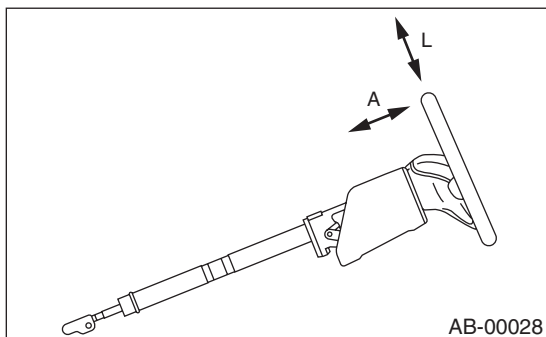
2) When installing a new driver's airbag module, check the following. If necessary, install a new airbag module and steering wheel.

- The clearance between the driver's airbag module and steering wheel is not constant.
- Free play of the steering wheel is over specifications in axial and radial directions.

Height deflection A

Less than 6 mm (0.24 in)

O.D. deflection L

Less than 7 mm (0.28 in) [Excluding steering offset 5 mm (0.20 in)]

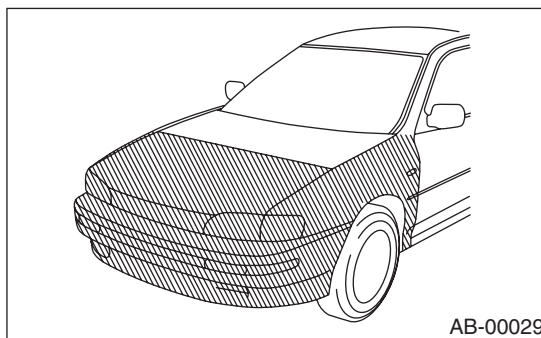
If the front section of vehicle as shown in the figure is damaged:

Check for the following, and replace damaged parts with new parts.

- Front sub sensor is cracked or deformed.
- Mounting bracket is cracked or deformed.
- Connector is scratched or cracked.
- Airbag is deployed.

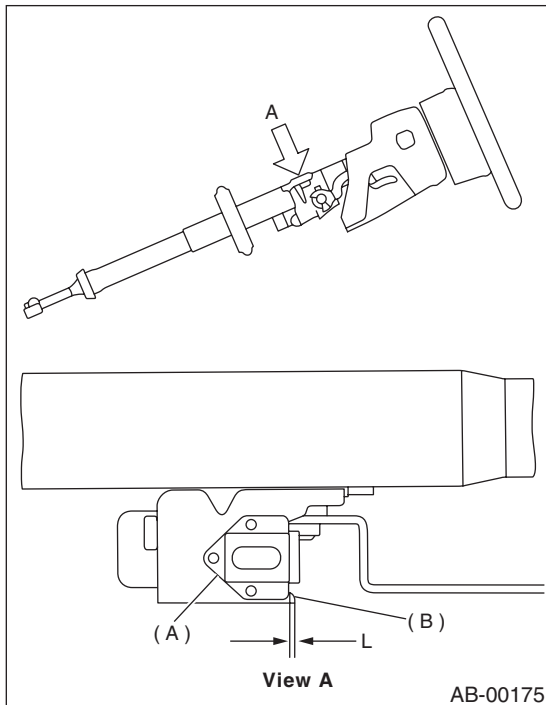
The clearance between capsule (A) and tip of column bracket (B) on steering column upper side should be within specifications.

Clearance between capsule and tip of column bracket L

More than 1.3 mm (0.051 in)

If necessary, replace them with new parts.
