STEERING GEARBOX

Power Assisted System (Power Steering)

5. Steering Gearbox S601545

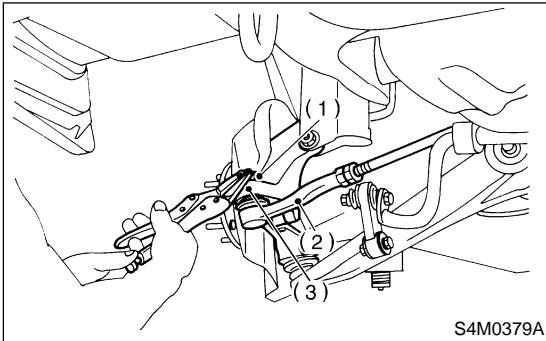
- 7) Using a puller, remove tie-rod end from knuckle arm after pulling off cotter pin and removing castle nut.

- (1) Castle nut
- (2) Tie-rod end
- (3) Knuckle arm

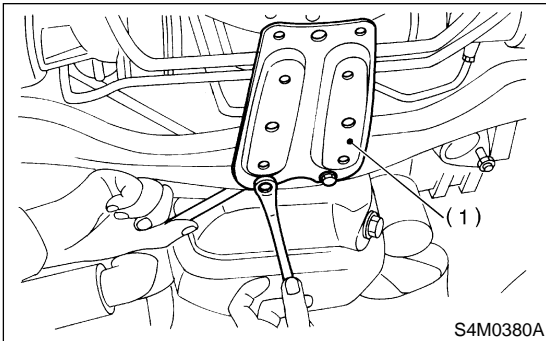
- 8) Remove jack-up plate and front stabilizer.

- (1) Jack-up plate

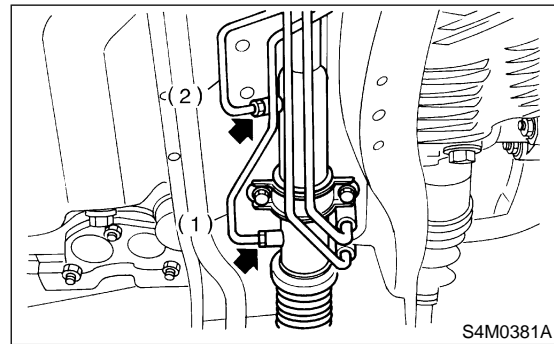
- 9) Remove one pipe joint at the center of gearbox, and connect vinyl hose to pipe and joint. Discharge fluid by turning steering wheel fully clockwise and counterclockwise. Discharge fluid similarly from the other pipe.

- (1) Pipe A
- (2) Pipe B

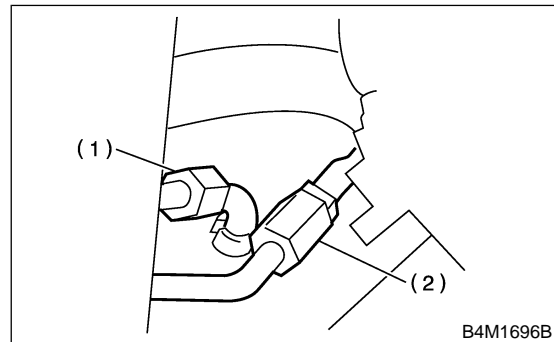
- 10) Remove universal joint. <Ref. to PS-18 REMOVAL, Universal Joint.>
- 11) Disconnect pipes C and D from pipe of gear-box.

Disconnect upper pipe D first, and lower pipe C second.

- (1) Pipe C
- (2) Pipe D

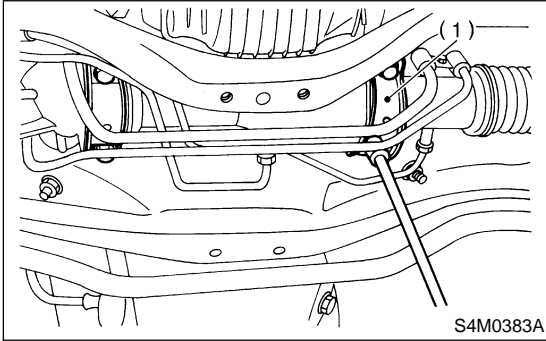
12) Remove clamp bolts securing gearbox to crossmember, and remove gearbox.

(1) Clamp

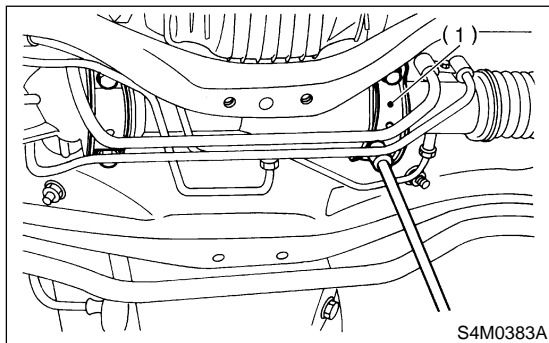
- 1) Insert gearbox into crossmember, being careful not to damage gearbox boot.
- 2) Tighten gearbox to crossmember bracket via clamp with bolt to the specified torque.

59 N·m (6.0 kgf·m, 43 ft·lb)

(1) Clamp

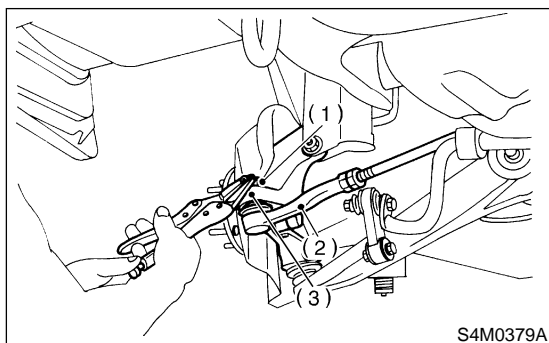
- 3) Install universal joint. <Ref. to PS-18 INSTALLATION, Universal Joint.>
- 4) Connect tie-rod end and knuckle arm, and tighten with castle nut. Fit cotter pin into the nut and bend the pin to lock.

Tighten to 27.0 N·m (2.75 kgf·m, 19.9 ft·lb), and tighten further within 60° until cotter pin hole is aligned with a slot in the nut.

- (1) Castle nut
- (2) Tie-rod end
- (3) Knuckle arm

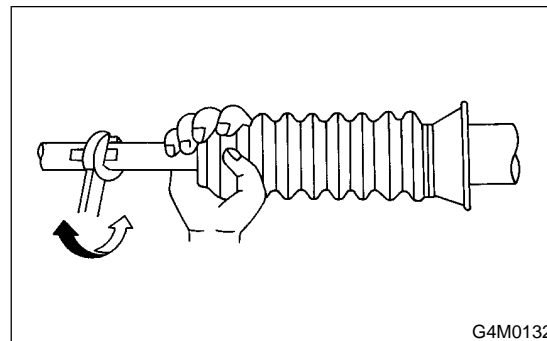
When adjusting toe-in, hold boot as shown to prevent it from being rotated or twisted. If twisted, straighten it.

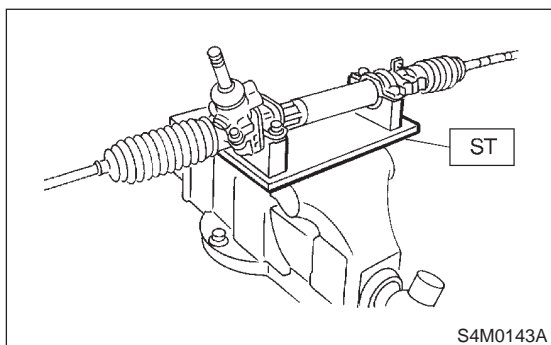
2) Secure gearbox removed from vehicle in vice using ST.

Secure the gearbox in a vice using the ST as shown. Do not attempt to secure it without this ST.

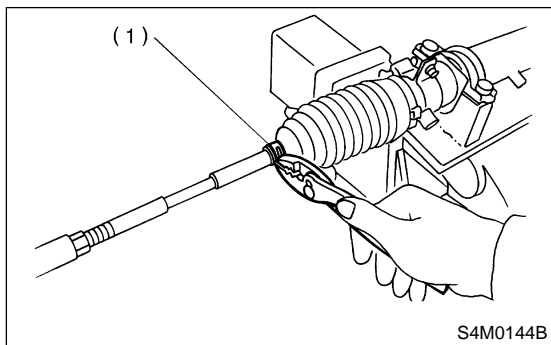
4) Remove small clip from boot using pliers, and move boot to tie-rod end side.

(1) Clip

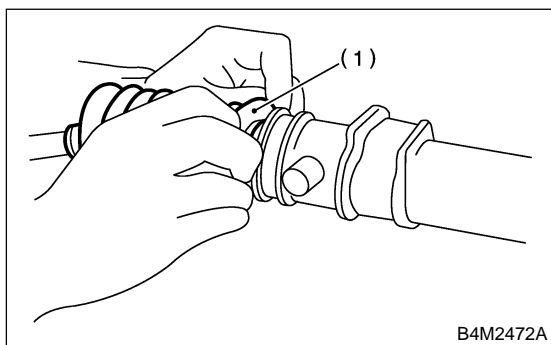
5) Remove boot together with large clips

(1) Boot

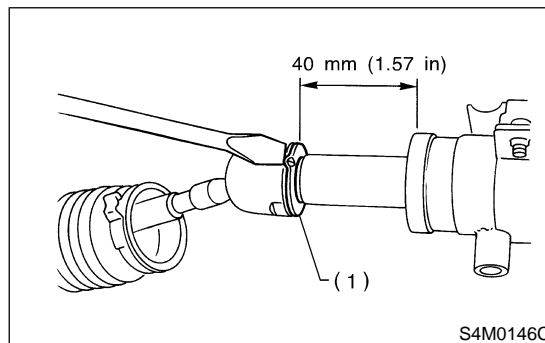
6) Extend rack approximately 40 mm (1.57 in) out. Unlock lock wire at lock washer on each side of tie-rod end using a standard screwdriver.

(1) Lock washer

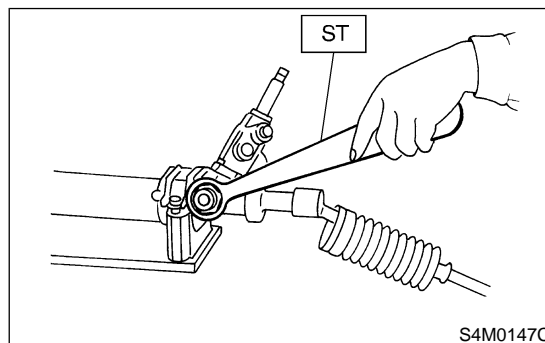
7) Using ST, loosen lock nut.

ST 926230000 SPANNER

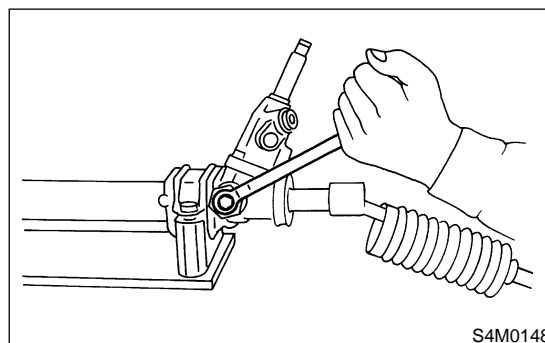
8) Tighten adjusting screw until it no longer tightens.

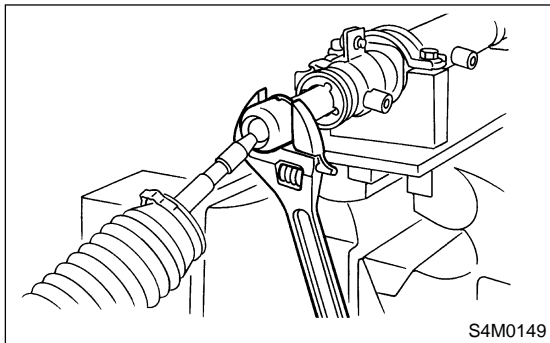
9) Using a wrench [32 mm (1.26 in) width across flats] or adjustable wrench, remove tie-rod.

- Check ball joint for free play, and tie-rod for bends. Replace if necessary.
- Check dust seals used with tie-rod end ball joint for damage or deterioration. Replace if necessary.

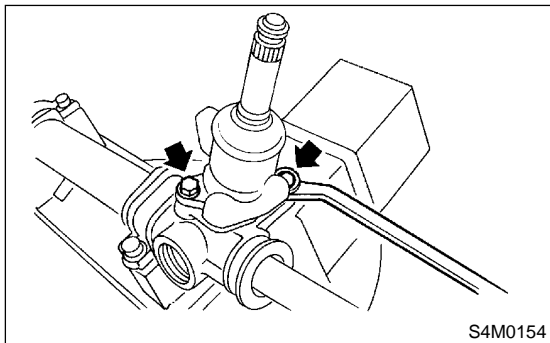
11) Remove two bolts securing valve assembly.

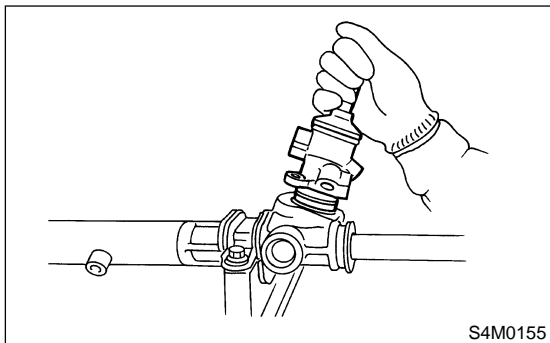
12) Carefully draw out input shaft and remove valve assembly.

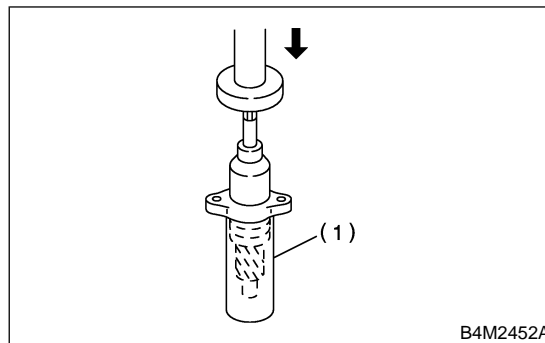
13) Draw out pinion and valve assembly from valve housing, as necessary, using pipe of I.D. 44 to 46 mm (1.73 to 1.81 in) and a press.

(1) Pipe

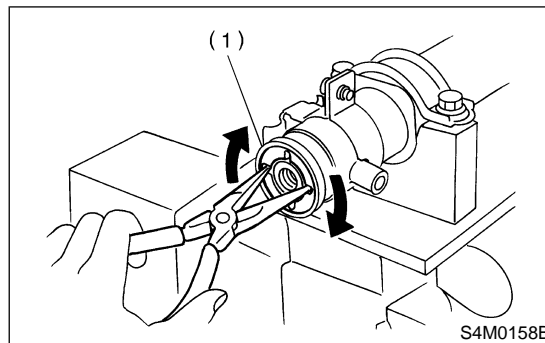
14) Using a sharp pointed pliers, rotate the rack stopper in the direction of the arrow until the end of the circlip comes out of the stopper. Rotate the circlip in the opposite direction and pull it out.

(1) Rack stopper

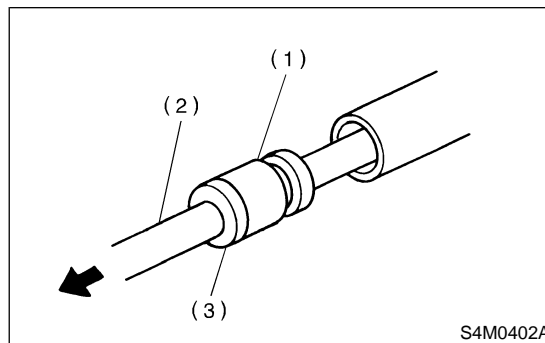
15) Pull rack assembly from cylinder side, and draw out rack bushing and rack stopper together with rack assembly.

Be careful not to contact rack to inner wall of cylinder when drawing out. Any scratch on cylinder inner wall will cause oil leakage.

- (1) Rack bushing
- (2) Rack ASSY
- (3) Rack stopper

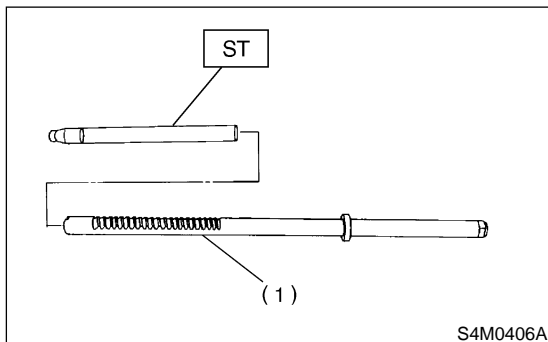
2) Fit ST over toothed portion of rack assembly, and check for binding or unsmooth insertion. If any deformation is noted on flats at the end of rack, shape by using file, and wash with cleaning fluid.

(1) Rack ASSY

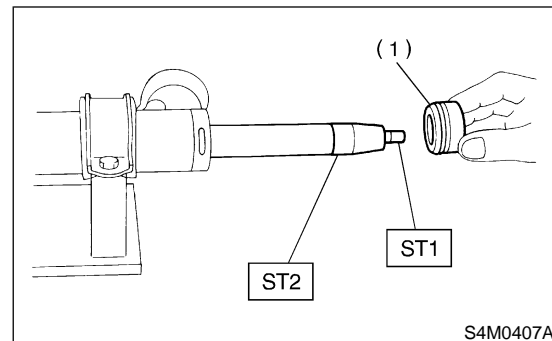
5) Fit ST1 and ST2 over the end of rack, and install rack bushing.

(1) Rack bushing ASSY

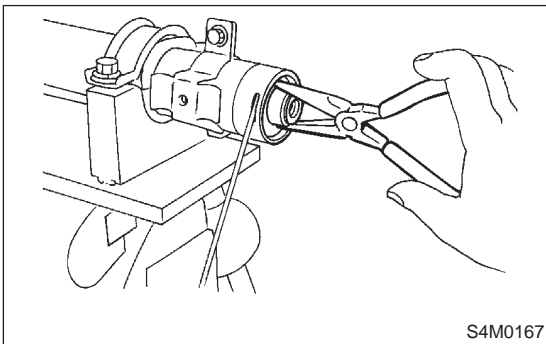
6) Insert rack stopper into cylinder tube until internal groove (on cylinder side) is aligned with external groove (on rack stopper). Turn rack stopper with ST so that rack stopper hole is seen through cylinder slits.

7) Insert rack stopper into rack housing, and wrap circlip using a sharp pointed pliers to secure rack stopper in position.

Rotate wrench another 90 to 180° after the end of circlip has been wrapped in.

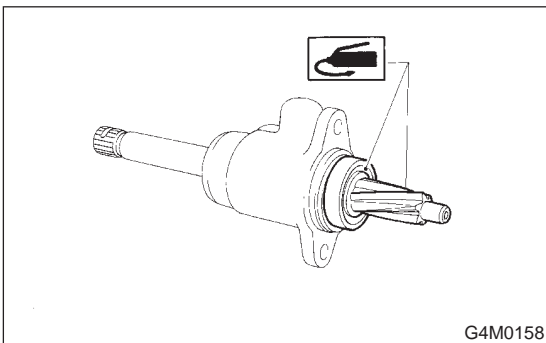
- 8) Fit mounting rubber onto rack housing.
9) Apply genuine grease to pinion gear and bearing of valve assembly.

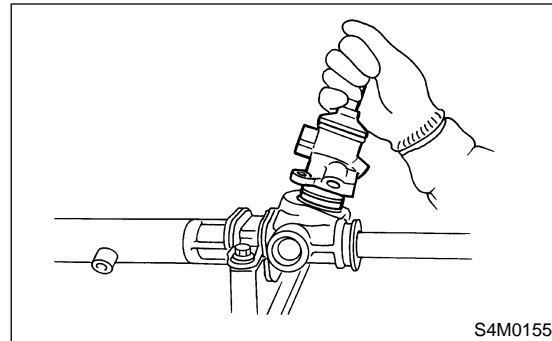
10) Install gasket on valve assembly. Insert valve assembly into place while facing rack teeth toward pinion.

Do not allow packing to be caught when installing valve assembly.

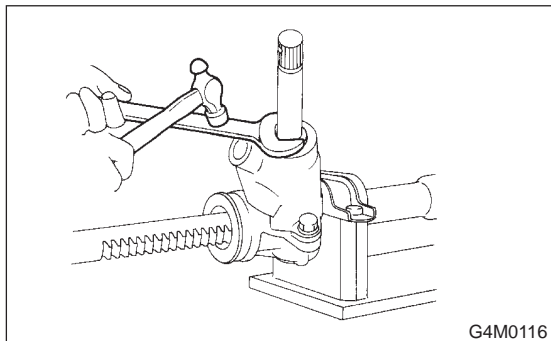
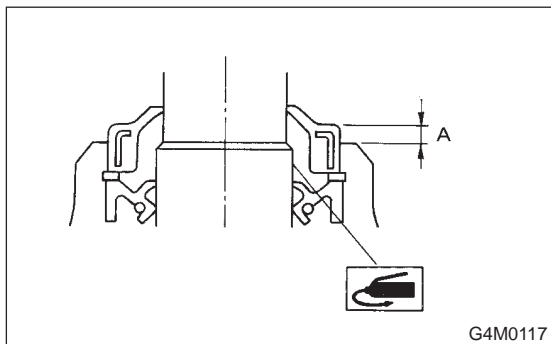
16) Press-fit dust seal into gearbox housing while tapping it via a spanner or the like so that stepping between gearbox and dust seal is normally 2 mm (0.08 in).

Depth: A
2 mm (0.08 in)

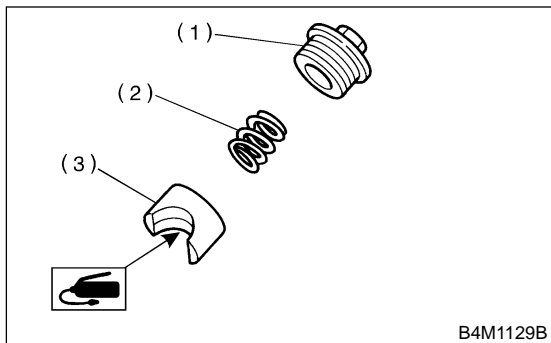
17) Apply grease to sliding surface of sleeve and spring seat, then insert sleeve into pinion housing. Fit spring into sleeve screw, pack grease inside of screw, then install the screw.

- (1) Adjusting screw
- (2) Spring
- (3) Sleeve

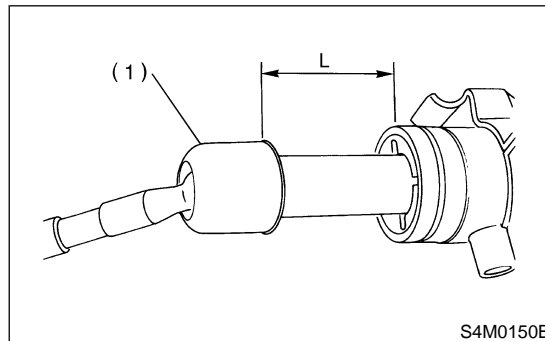
18) Install lock washers and tighten left and right tie-rods into rack ends.

On condition
L: Approximately 40 mm (1.57 in)

Tightening torque:
78±10 N·m (8.0±1.0 kgf·m, 58±7 ft·lb)

- (1) Tie-rod

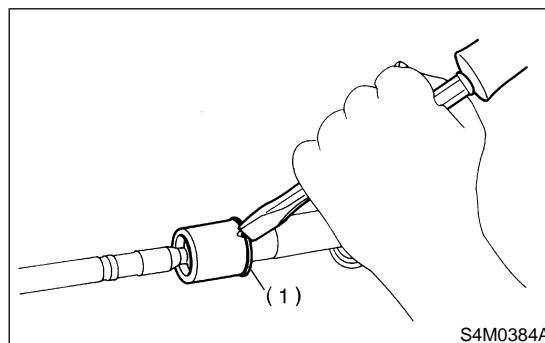
19) Bend lock washer using a chisel.

- (1) Lock washer

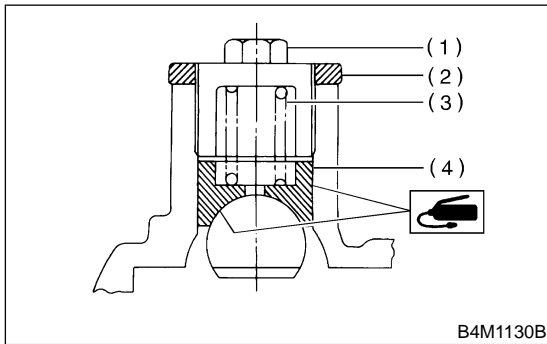
- (1) Loosen adjusting screw.
- (2) Rotate input shaft so that rack is in the straight ahead direction.
- (3) Apply grease to sleeve.

- (1) Adjusting screw
- (2) Lock nut
- (3) Spring
- (4) Sleeve

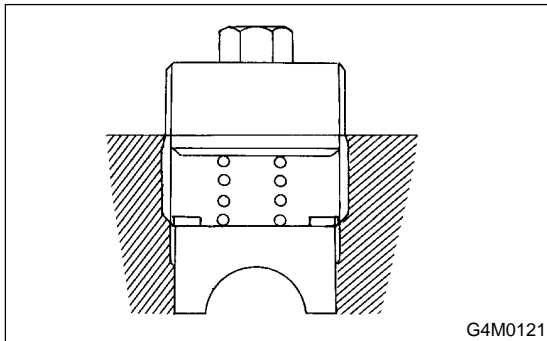
(4) Tighten adjusting screw by two threads.

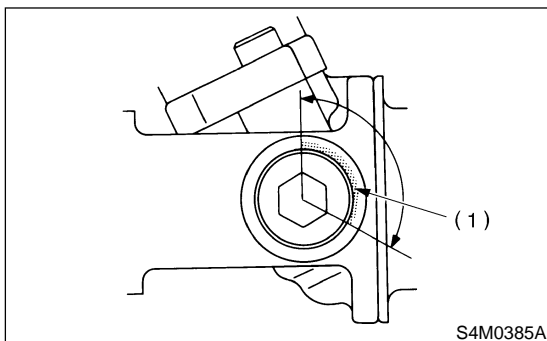
- (5) Apply liquid packing to at least 1/3 of entire perimeter of adjusting screw thread.

Liquid packing:
THREE BOND 1141

- (1) Apply liquid packing to at least 1/3 of entire perimeter.

- (6) Tighten adjusting screw to 7.4 N·m (0.75 kgf-m, 5.4 ft-lb) and back off 25°.
- (7) Install lock nut. While holding adjusting screw with a wrench, tighten lock nut using ST.

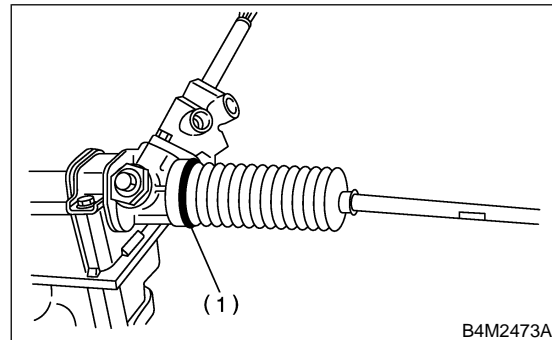
22) Fit clip (large) to boot, and then install boot to gearbox while holding boot flange. After installing boot, fold back boot flange to the extent that large clip cannot be seen.

- (1) Clip (large)

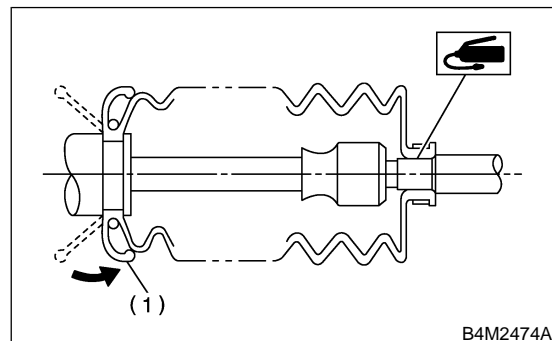
23) Turn boot until it seats well on gearbox and rubber mounting, then bend boot flange back.

- (1) Reverse after installing

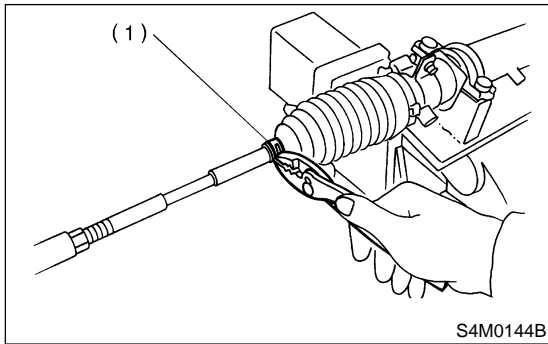
24) Fix boot end with clip (small).

After installing, check boot end is positioned into groove on tie-rod.

(1) Clip

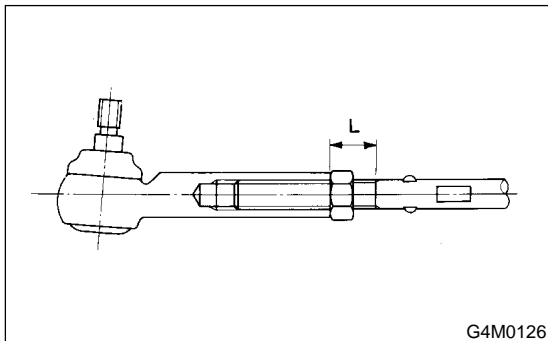
25) If tie-rod end was removed, screw in lock nut and tie-rod end to screwed portion of tie-rod, and tighten lock nut temporarily in a position as shown in figure.

Installed tie-rod length: L
15 mm (0.59 in)

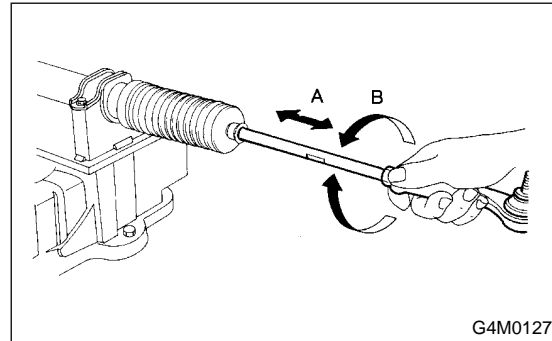
"A" Holding tie-rod end, repeat lock to lock two or three times as quickly as possible.

"B" Holding tie-rod end, turn it slowly at a radius one or two times as large as possible.

After all, make sure that boot is installed in the specified position without deflation.

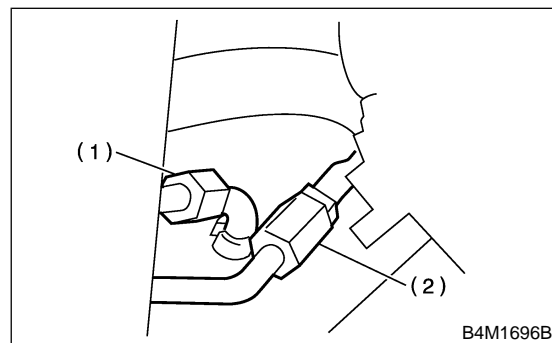
(2) Connect pipes C and D to gearbox.

Connect lower pipe C first, and upper pipe D second.

(1) Pipe C

(2) Pipe D

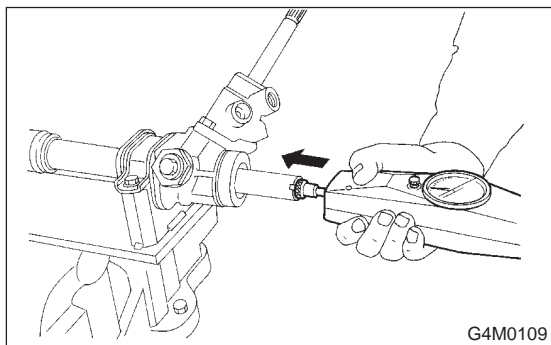
G4M0109

Sliding resistance of rack shaft:

304 N (31 kg, 68 lb) or less

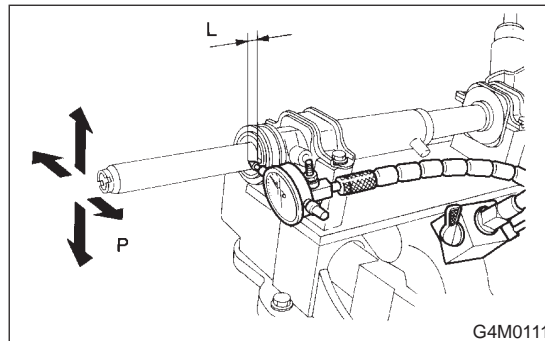
G4M0111

Right-turn steering:

0.19 mm (0.0075 in) or less

L: 5 mm (0.20 in)

P: 122.6 N (12.5 kg, 27.6 lb)

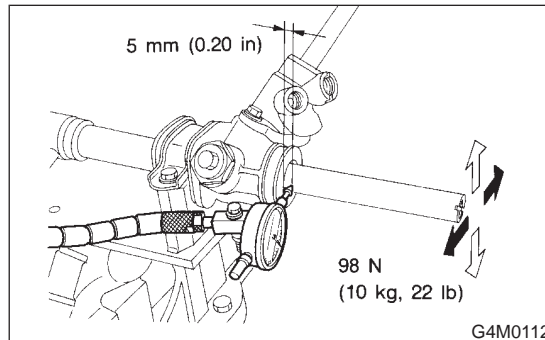
G4M0112

Left-turn steering:

0.3 mm (0.012 in) or less

0.15 mm (0.0059 in) or less

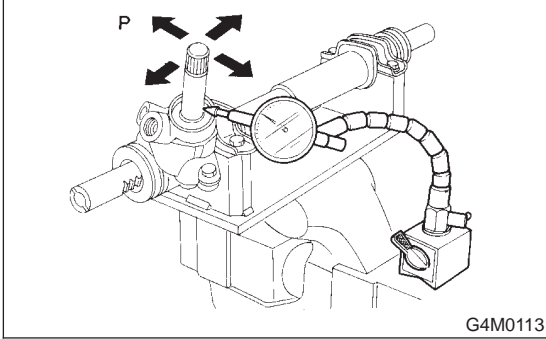
In radial direction:

0.18 mm (0.0071 in) or less

P: 98 N (10 kg, 22 lb)

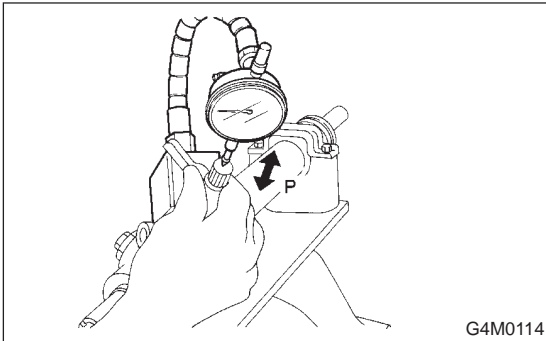
In axial direction:

0.5 mm (0.020 in) or less

P: 20 — 49 N (2 — 5 kg, 4 — 11 lb)

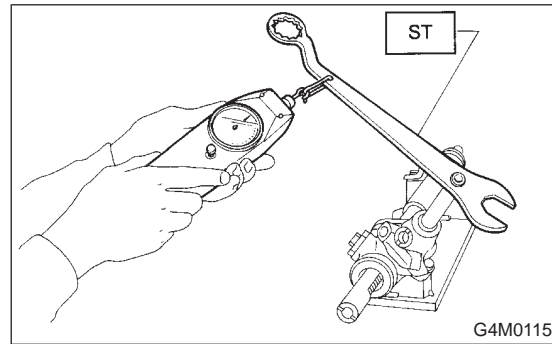
Using ST, measure gearbox turning resistance.

Straight-ahead position within 30 mm (1.18 in) from rack center

Less than 11.18 N (1.14 kg, 2.51 lb)

12.7 N (1.3 kg, 2.9 lb)

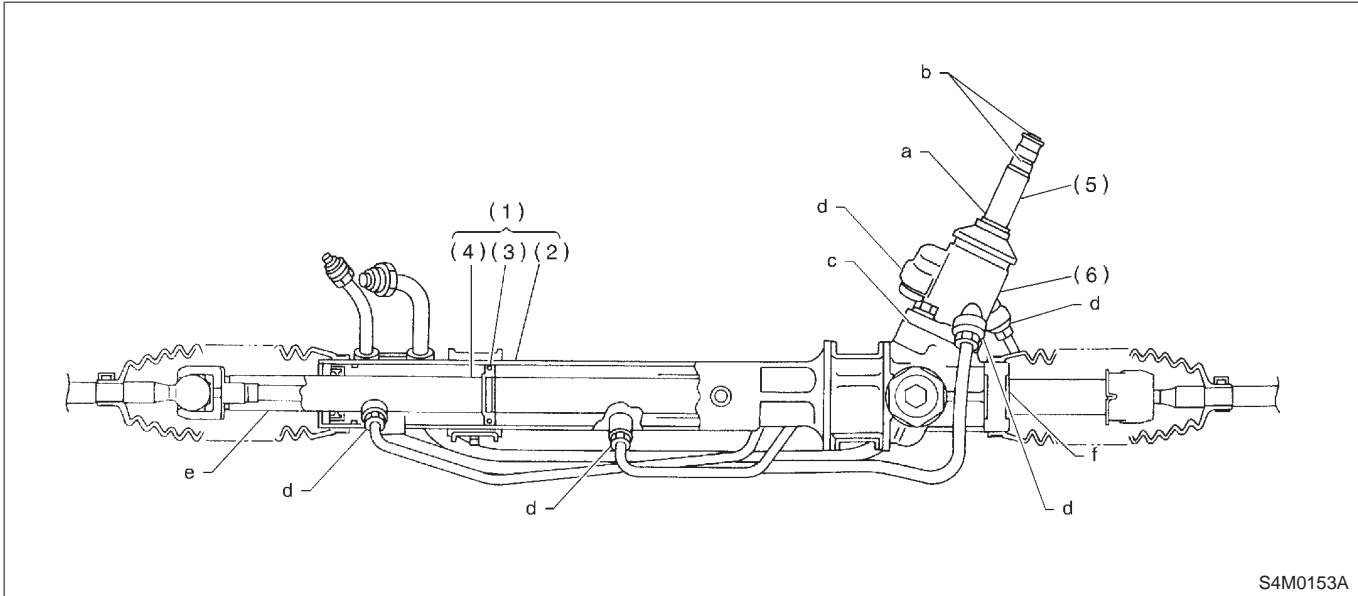
S4M0153A

| (1) Power cylinder | (3) Rack piston | (5) Input shaft |
| (2) Cylinder | (4) Rack axle | (6) Valve housing |

● Oil leaking points

1) Leakage from "a"

The oil seal is damaged. Replace valve assembly with a new one.

2) Leakage from "b"

The torsion bar O-ring is damaged. Replace valve assembly with a new one.

3) Leakage from "c"

The oil seal is damaged. Replace valve assembly or oil seal with a new one.

4) Leakage from "d"

The pipe is damaged. Replace the faulty pipe or O-ring.

(1) Leakage from "e"

The cylinder seal is damaged. Replace rack bush with a new one.

(2) Leakage from "f"

There are two possible causes. Take following step first. Remove the pipe assembly B from the valve housing, and close the circuit with ST.

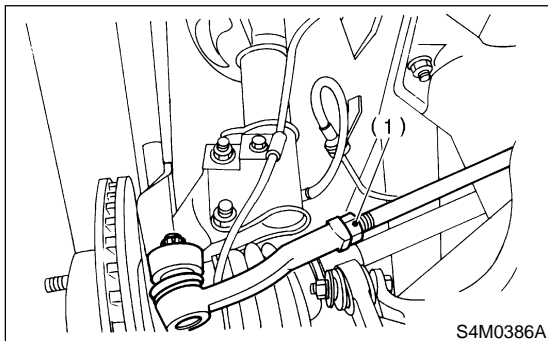
1) Adjust front toe.

IN 3 — OUT 3 mm (IN 0.12 — OUT 0.12 in)

(1) Lock nut

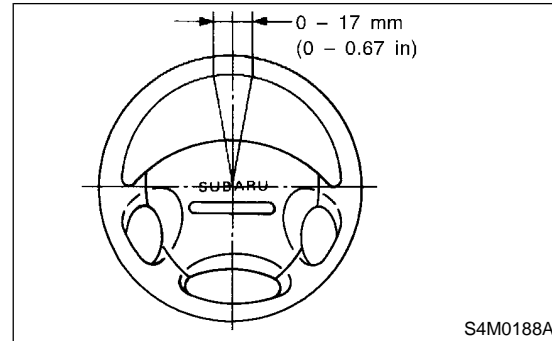
3) If steering wheel spokes are not horizontal when wheels are set in the straight ahead position, and error is more than 5° on the periphery of steering wheel, correctly re-install the steering wheel.

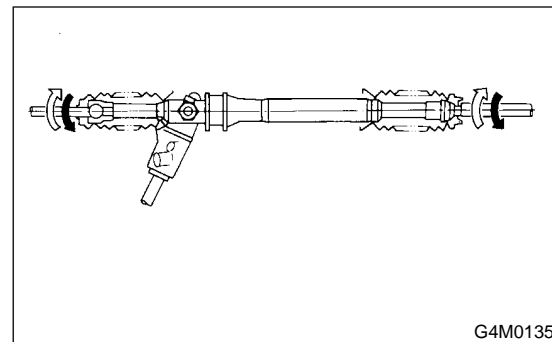
4) If steering wheel spokes are not horizontal with vehicle set in the straight ahead position after this adjustment, correct it by turning the right and left tie-rods in the same direction by the same turns.
