10. Side Airbag Sensor S802298

A: REMOVAL S802298A18

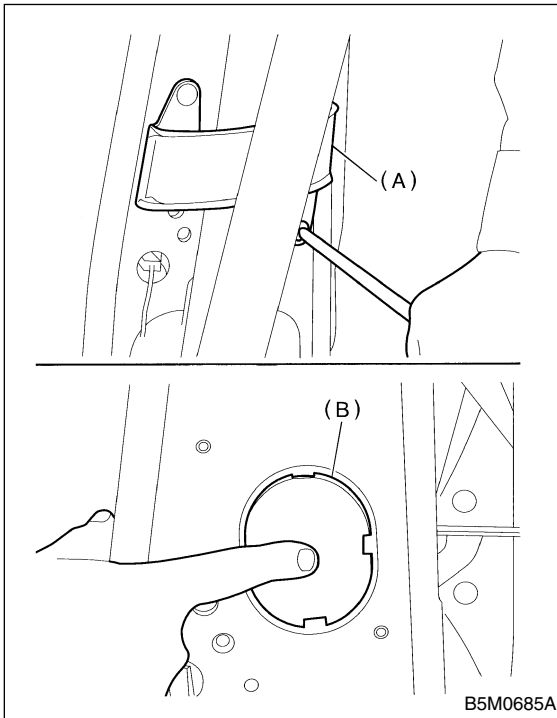
- 1) Turn ignition switch OFF.
- 2) Disconnect ground cable from battery, and wait for at least 20 seconds before starting work.
- 3) Remove center pillar lower trim. <Ref. to EI-43, REMOVAL, Lower Inner Trim.>
- 4) Remove Outer Belt (FRONT). <Ref. to SB-7, REMOVAL, Front Seat Belt.>
- 5) Remove bracket (A), and then remove cap (B).

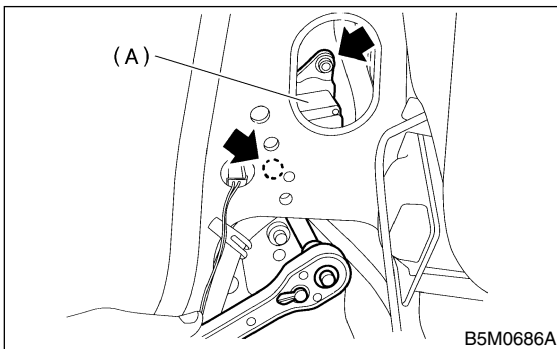
- 6) Using E12 TORX® remove two TORX® nuts, and then detach side airbag sensor (A).

CAUTION:
Use new TORX® nuts during re-assembly.
Install in the reverse order of removal.
