11. Side Airbag Sensor

A: REMOVAL

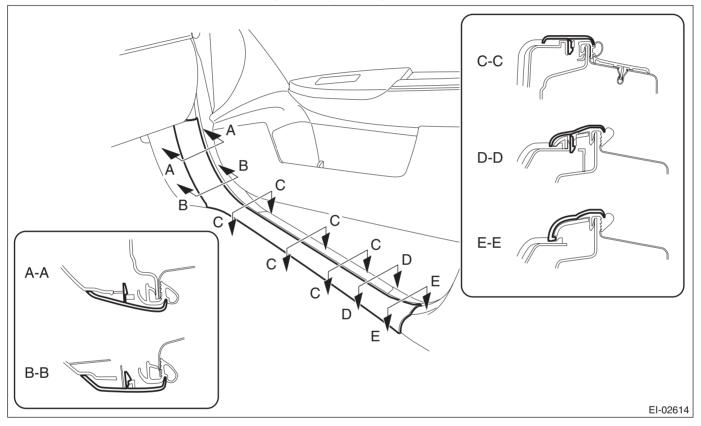
- 2) Turn the ignition switch to OFF.
- 3) Disconnect the ground cable from battery and wait for at least 60 seconds before starting work.
- 4) Release the claws, and then remove the side sill cover front INN. (On the side where airbag sensor is removed)

To release the claws of the side sill cover INN, the following steps are recommended.

- 1. Take out the weather strip from under the side sill cover INN.
- 2. Turn over the floor mat and release the claw (C-C) by accessing from behind the side sill cover INN.

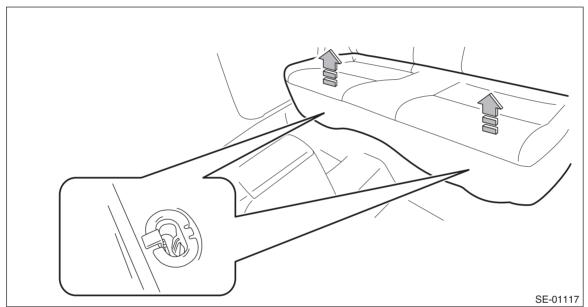
- 5) Remove the rear seat cushion assembly.
 - (1) Pull up the seat cushion and release the hook.

If the hook is disconnected from the vehicle body, replace the hook with the new part to prevent the decline of the fixed force of the seat.

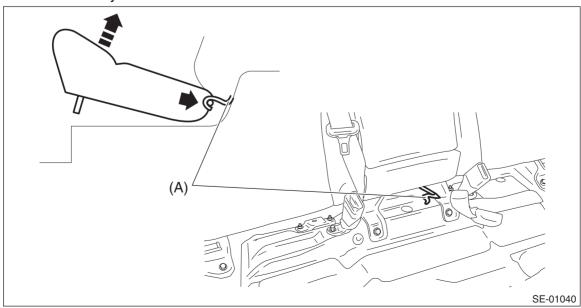
(2) Remove the hook (A) by pushing it back while lifting the front side of the seat cushion, and remove the seat cushion assembly.

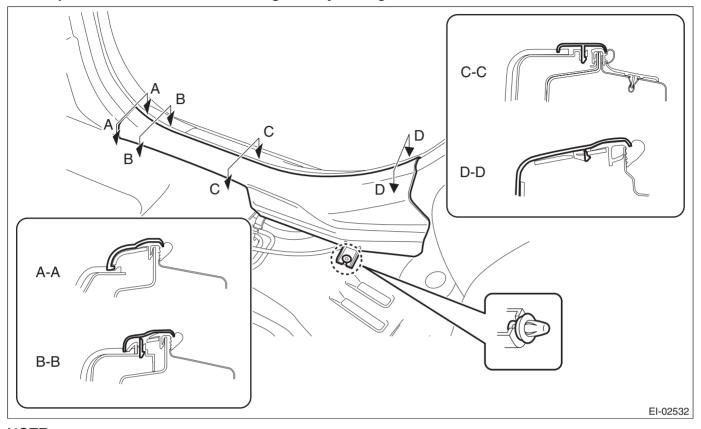
6) Release the clips and claws, and then remove the side sill cover - rear INN. (On the side where airbag sensor is removed)

To release the claws of the side sill cover INN, the following steps are recommended.

- 1. Take out the weather strip from under the side sill cover INN.
- 2. Turn over the floor mat and release the claw (C-C and D-D) by accessing from behind the side sill cover INN.

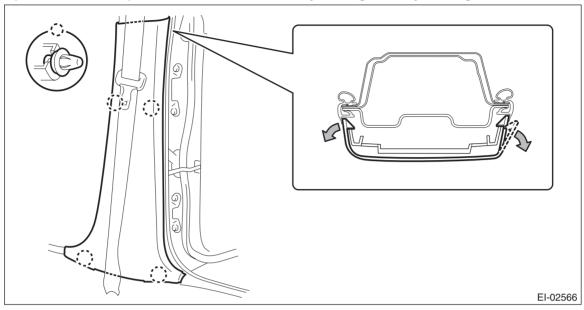
- 7) Remove the center pillar trim LWR. (On the side where airbag sensor is removed)
 - (1) Release the clip by pulling the center pillar trim LWR toward you.
 - (2) Expand the claws of center pillar trim LWR outward and remove it from the center pillar trim UPR.

Do not expand the center pillar trim LWR excessively. Doing so may damage the trim.

First release the claw located to the rear of the vehicle.

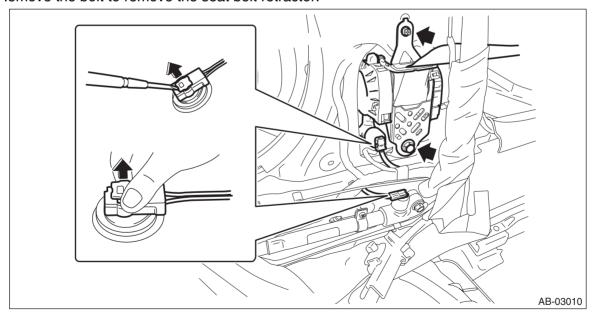
- 8) Remove the seat belt retractor. (On the side where airbag sensor is removed)
 - (1) Turn over the floor mat and disconnect the connectors of pretensioner and lap seat belt pretensioner.
 - (2) Remove the bolt to remove the seat belt retractor.

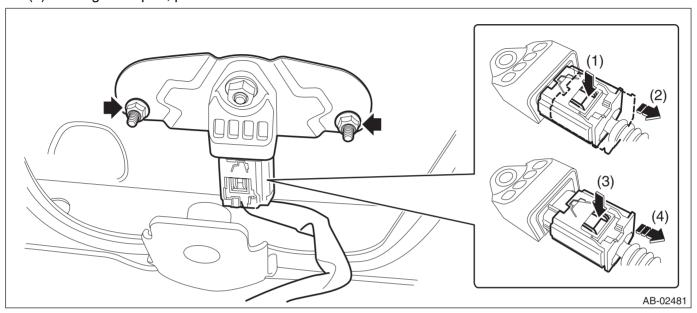
9) Remove the nuts and then remove the side airbag sensor assembly.

- Do not separate the side airbag sensor and bracket. It causes the airbag system malfunction.
- If the sensor is removed from the bracket, be sure to replace with a new part.
 - (1) Push the lock arm.
 - (2) Holding outer part, pull it one step in the direction of arrow.
 - (3) Push the lock arm again.
 - (4) Holding outer part, pull it in the direction of arrow to disconnect the connector.

Side airbag sensor: 7.5 N·m (0.76 kgf-m, 5.5 ft-lb)

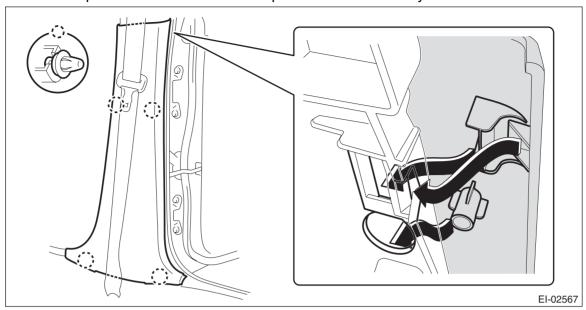
Assemble the center pillar trim LWR to the center pillar trim UPR securely.
